Documentation strategies for a non-invasive structural and decay analysis of medieval civil towers: an application on the Clock Tower in Pavia

Sandro Parrinello, Raffaella De Marco, Alessia Miceli

DICAr - Dipartimento di Ingegneria Civile e Architettura, Università degli Studi di Pavia, Italia

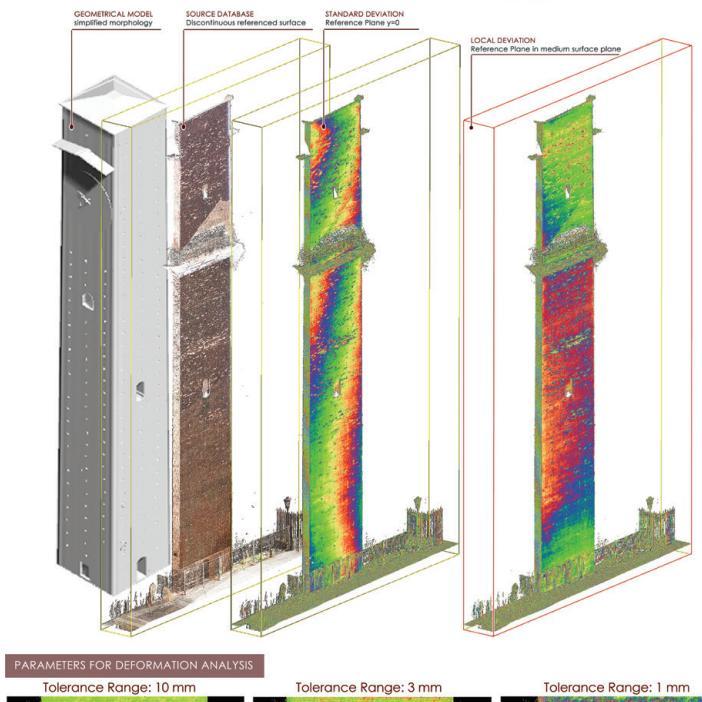
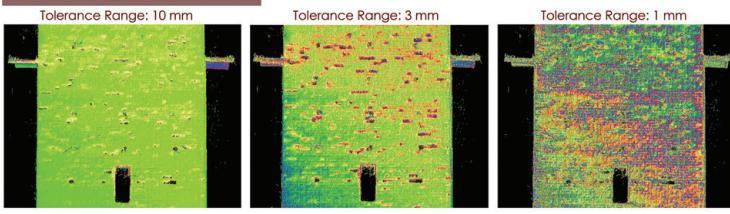
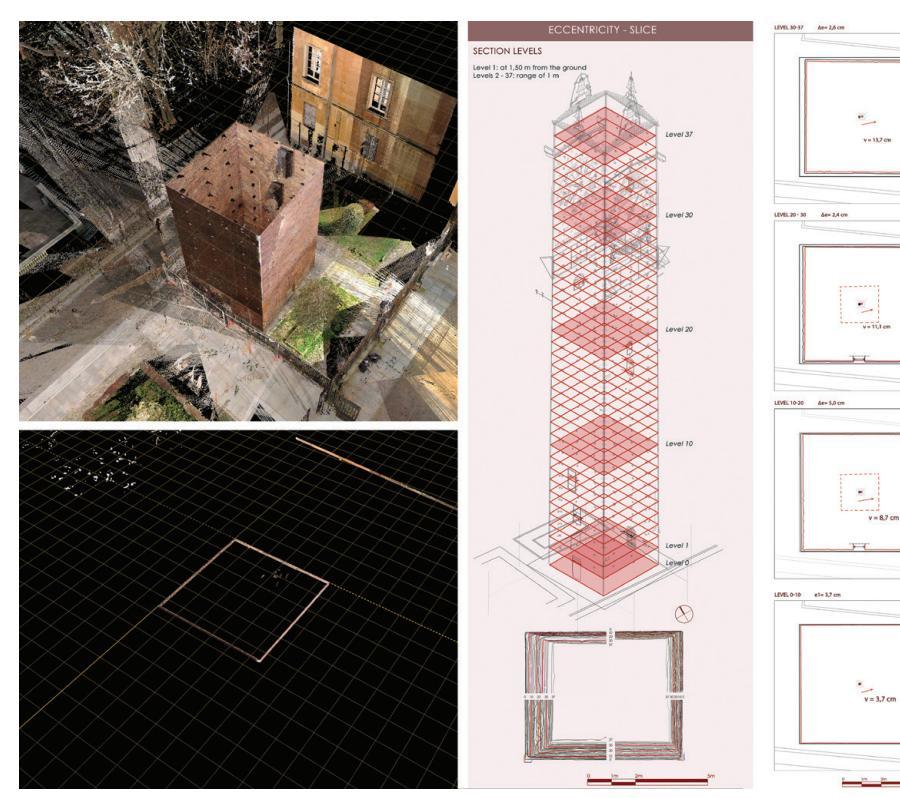
opposite page above Fig. 12

Calibration and interpretation of the elevation maps for structural and conservation analysis. Considering the constructive tapering of the tower, coordinates settings have been conducted to reference the fronts analysis specifically to the masonry surfaces (graphic elaboration S. Parrinello, R. De Marco, A. Miceli, 2020). *below*

Eccentricity analysis developed from the TLS/ UAV survey, with the slice extraction from point clouds (on the left). The survey has provided both a local report on the inclination of fronts and a global consideration on the deviation of the center of eccentricity of the entire tower (graphic elaboration S. Parrinello, R. De Marco, A. Miceli, 2020). The completed database integrated the geometrical peculiarities of the exterior⁸ structural masonry of the Tower to the material and texture characteristics of the elevations, defining a comprehensive base on which to conduct the conservative and structural analyses.

In order to evaluate the eccentricity conditions developed along the structure, the action of sectioning of the point cloud allowed to obtain the corresponding slices at a range of 1m between the multiple levels, with the aim of interpolating and highlighting possible alterations in drift and surface integrity of the tower due to unstable conditions.

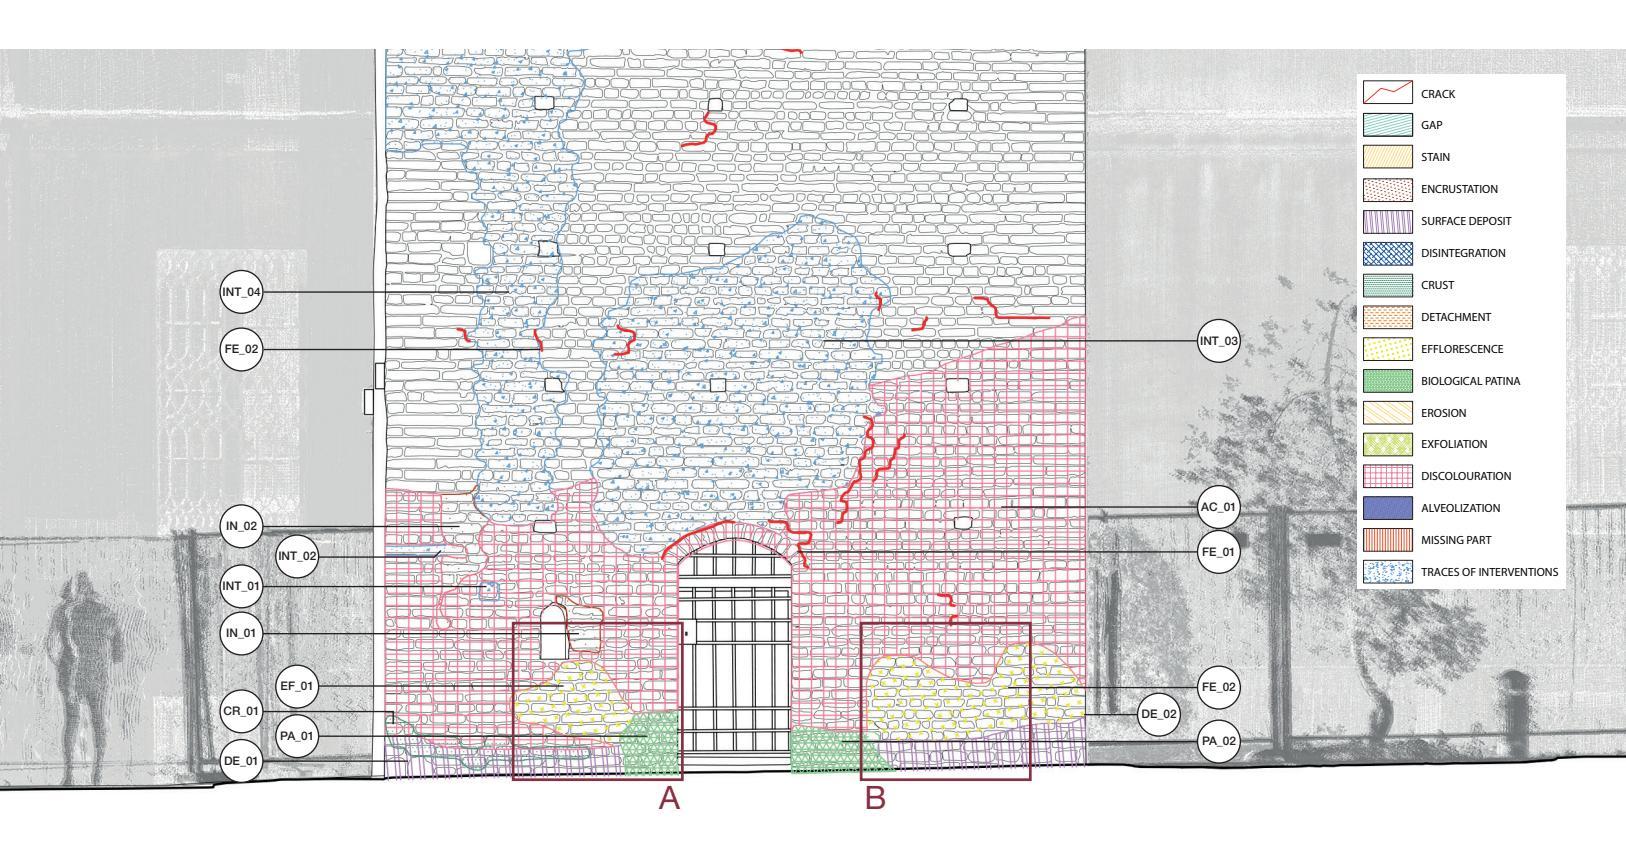
In the basement area, a large diffusion of phenomena supposedly due to rising damp can be observed: the masonry appears darker and more saturated and shows colours and surface morphologies referable to biological colonization, alveolarization and weathering, the latter both affecting the mortar joints and the bricks (Fig. 14).

Fig. 14 Detail of decay map of the East front. The map shows severe alterations such as discolouration (a) and biolog-ical colonization (b) (graphic elaboration Parrinello S., De Marco R., Miceli A., 2020).

The hypothesis deriving from a visual survey should be validated by means of instrumental analysis, such as thermo-hygrometric measurements, in order to punctually confirm and quantify the presence of water in the masonry.

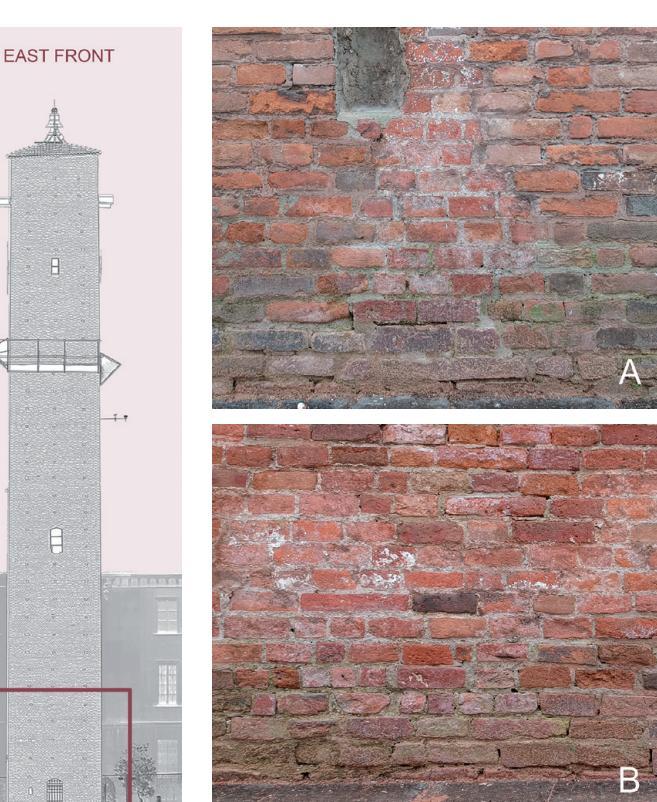
opposite page above Fig. 15

At high altitudes, brick discolouration becomes widely observable. The colour variation seems to be related to erosion and disintegration of the bricks surface. The lighter-coloured areas visible in the photographs match with good approximation to the local deviation areas highlighted by the elevation maps, which show a depression (up to 36mm) calculated according to the chromatic variation along the colour scale (Fig. 15, p. 19).

These alterations are significantly more diffused starting from an altitude ranging between 16 and 18 meters. The study of historical events noted that below the aforementioned altitude, the tower was once embedded in the San Matteo Hospital building, and thus less exposed to weathering.

Details of photo plane and elevation map of the North front. The process of layering and comparing the two outputs allowed for an accurate mapping of the erosion areas (graphic elaboration Parrinello S., De Marco R., Miceli A., 2020).

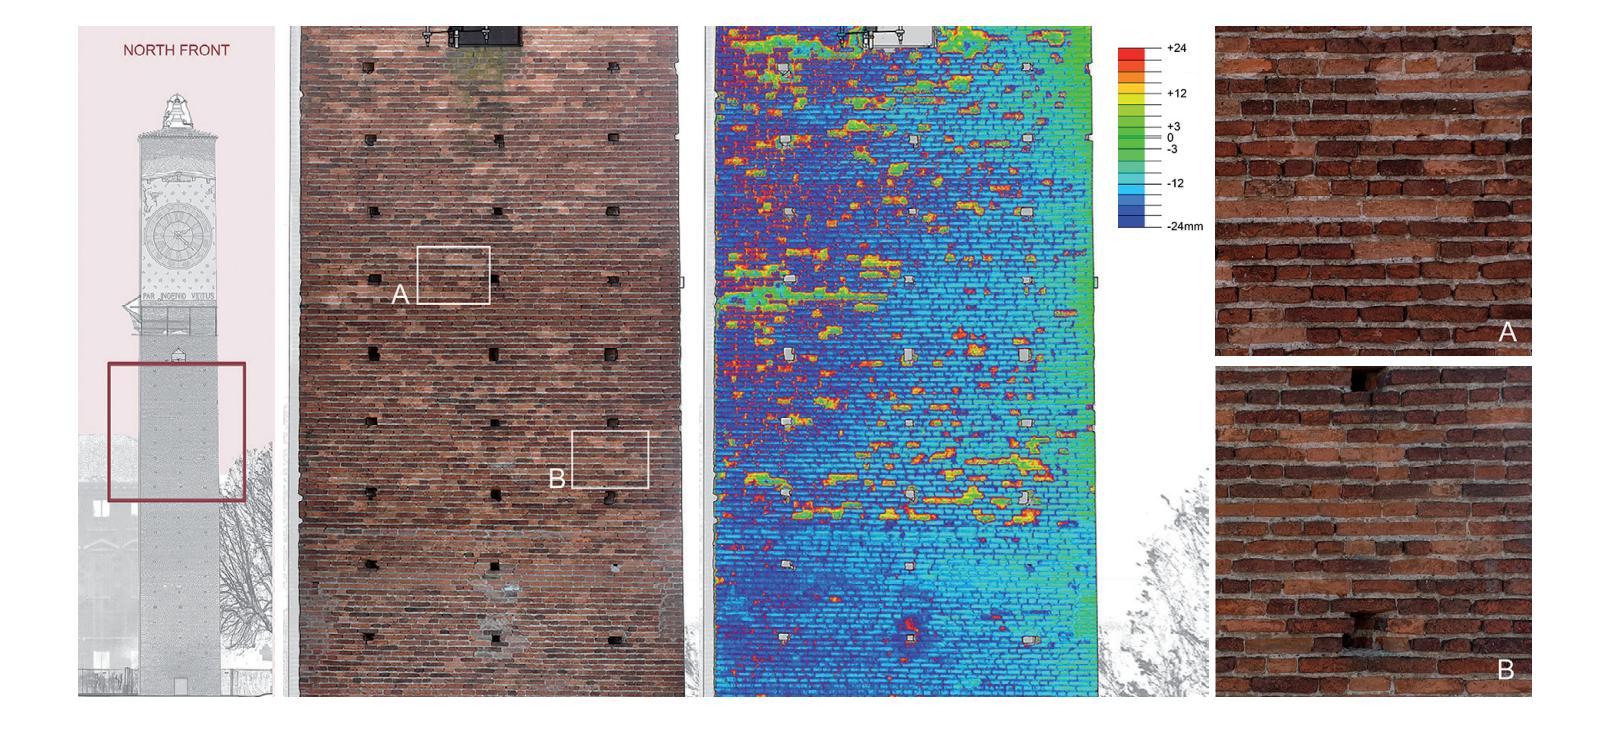
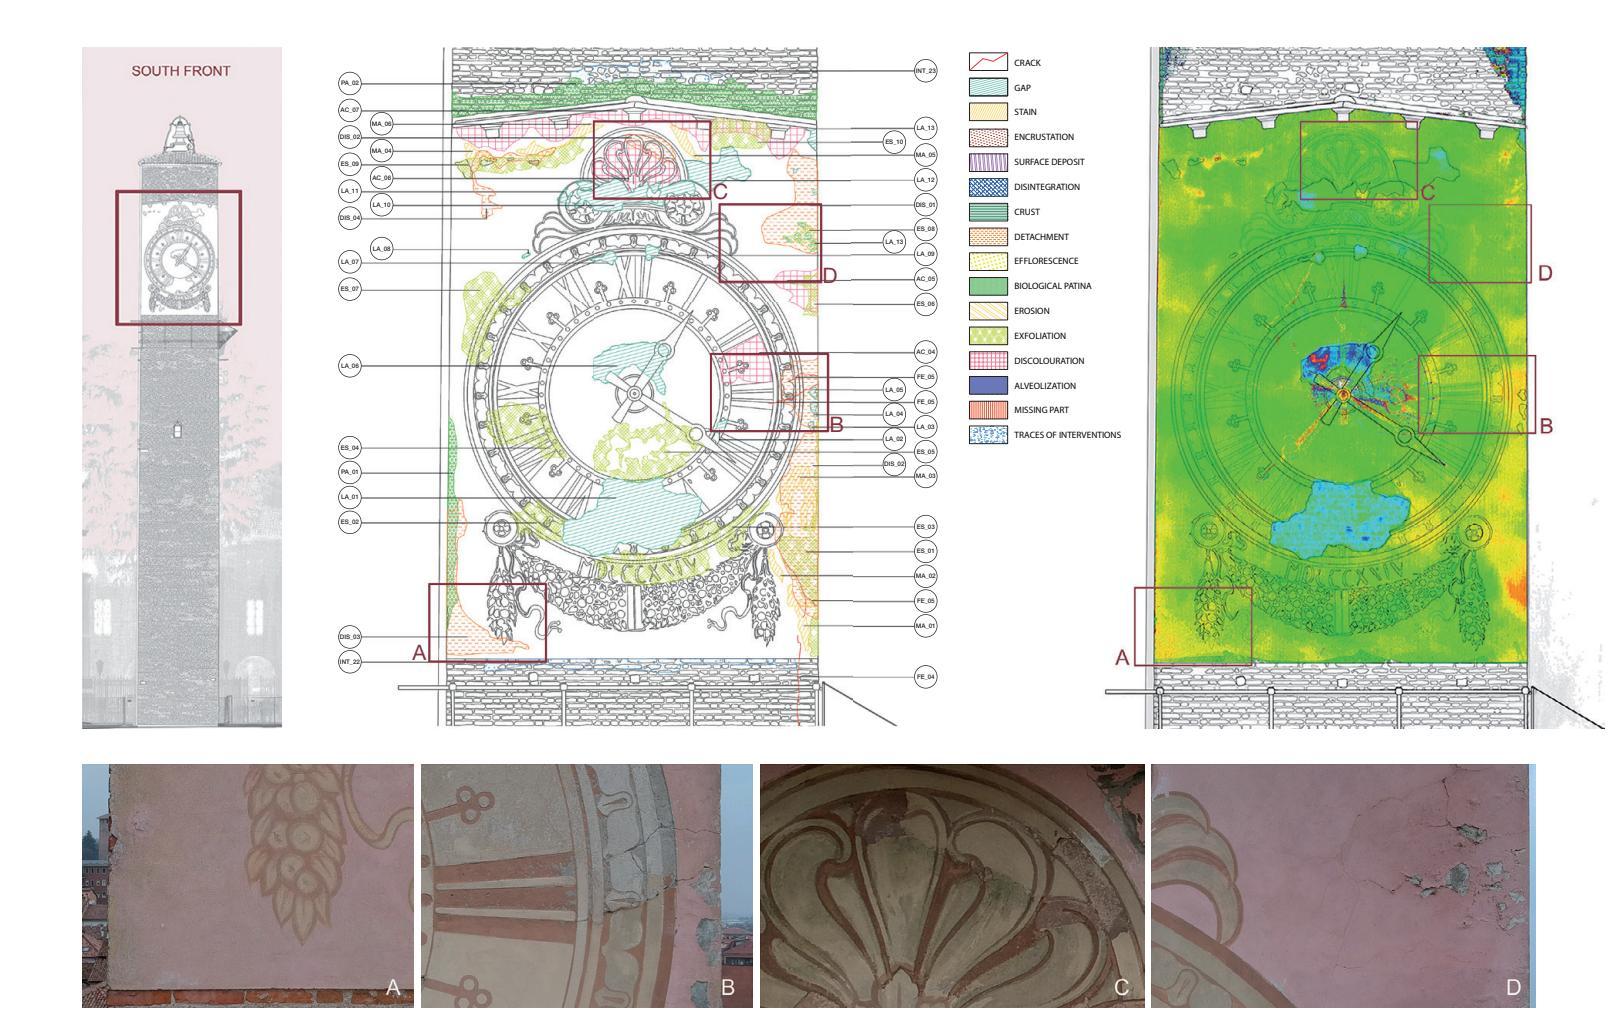
opposite page Fig. 17

The traces of the military station of Caserma Menabrea are immediately recognizable because of discolourations and patches visible in the wall surfaces: several traces are observable, which, according to the pitched roof, are sloped in the East and Western elevation, and horizontal in the North and South elevation; under these, a number of patches were made, presumably to restore the slots where the wooden beams once connected to the walls.

Moreover, in the West elevation, it is possible to notice horizontal traces where the masonry has a lighter colour compared to the surrounding texture: the marks allegedly point out the two floors of the pre-existing building.

Fig. 17 Detail of alteration maps of South (above) and East (below) elevation. The patches and discolouration of masonry are evidence of buildings once leaned to the tower (graphic elaboration Parrinello S., De Marco R., Miceli A., 2020). While these traces are confirmed by the study of historical sources, other evidences of previous actions are present, and not relatable to the aforementioned Caserma: in particular, the patches and discolourations visible on the South and East elevations, at 17 and 11.5m high respectively, made clear the presence of pitched roofs once attached to the tower (Fig. 17).

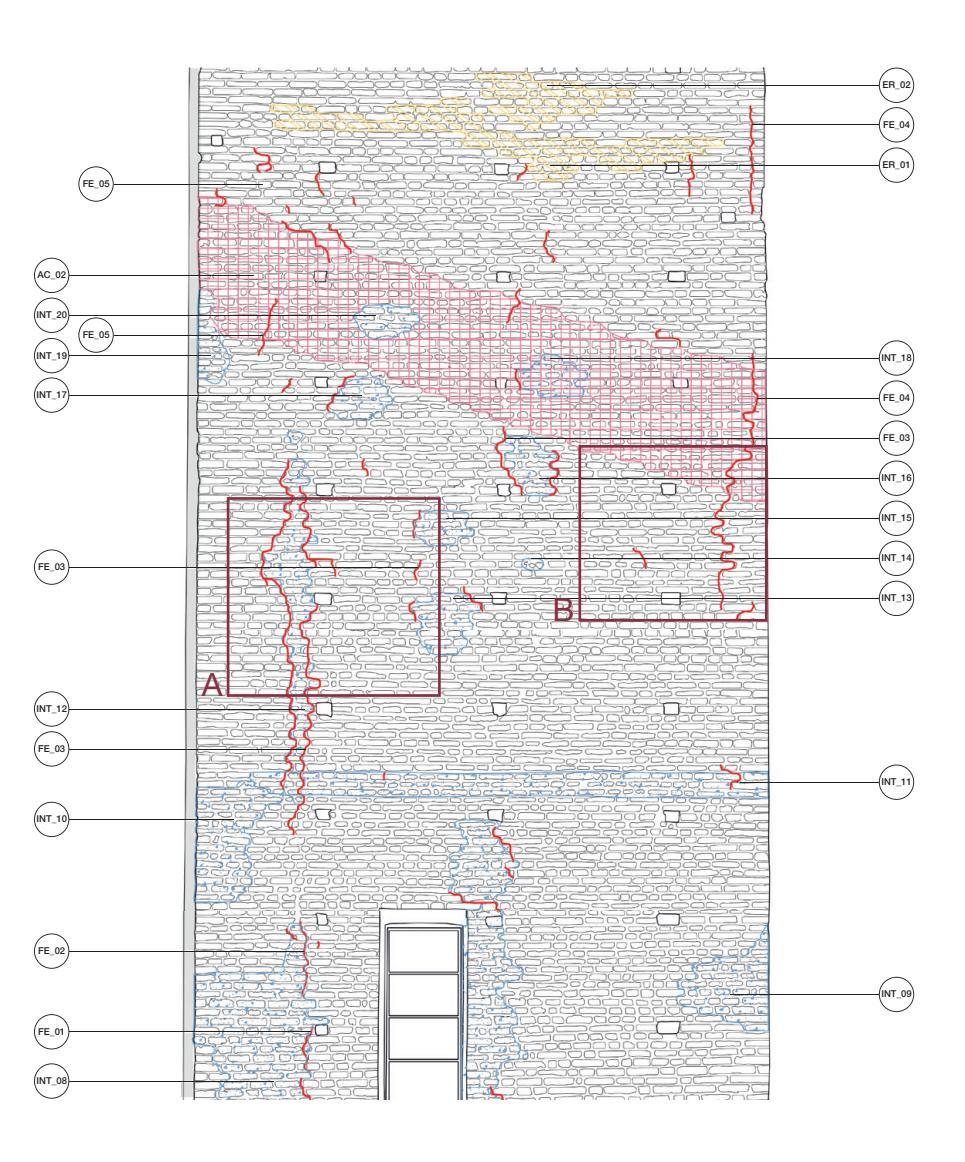
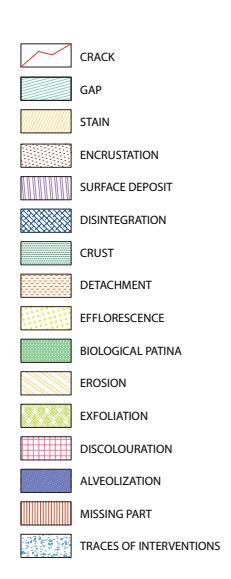
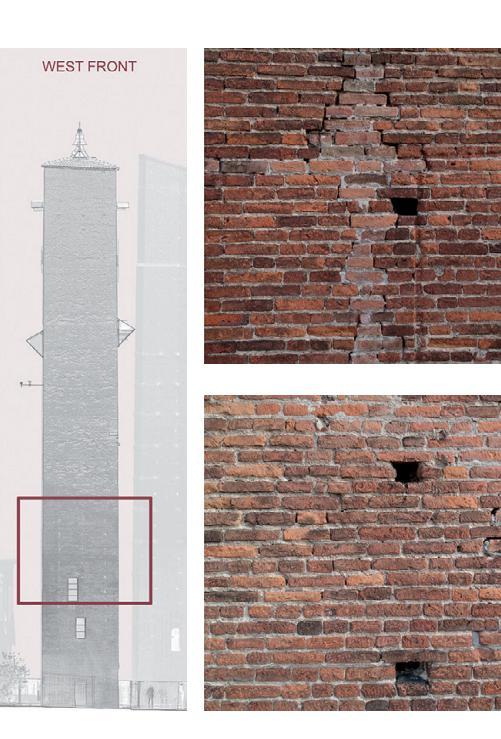
Fig. 19

The deviational analysis allowed to match cracks and cracks families to the specific effects of the same structural mechanism, providing a preliminary mapping of damages (Fig. 19, p. 23). In fact, by comparing the 3D point cloud with an ideal morphological model, it is possible to highlight possible macroscopic on-going kinematic events. For example, at the base of the North front; the wide colour variation suggests the presence of a plastic hinge to which the cracks in the same area could be related. Other fractures in the West front seem to be related to corner failings; additionally, in the East front compression stresses and an extensive corner failing are suggested by the colour variation in the elevation maps, possibly relating with the cracks visible at 7.5 meter height (Fig. 20, p. 23).

Elevation maps, obtained by processing the morphological database collected during the on-site survey stage, highlight macroscopic deformations and possible kinematisms affecting the structure (graphic elaboration Parrinello S., De Marco R., Miceli A., 2020). *below*

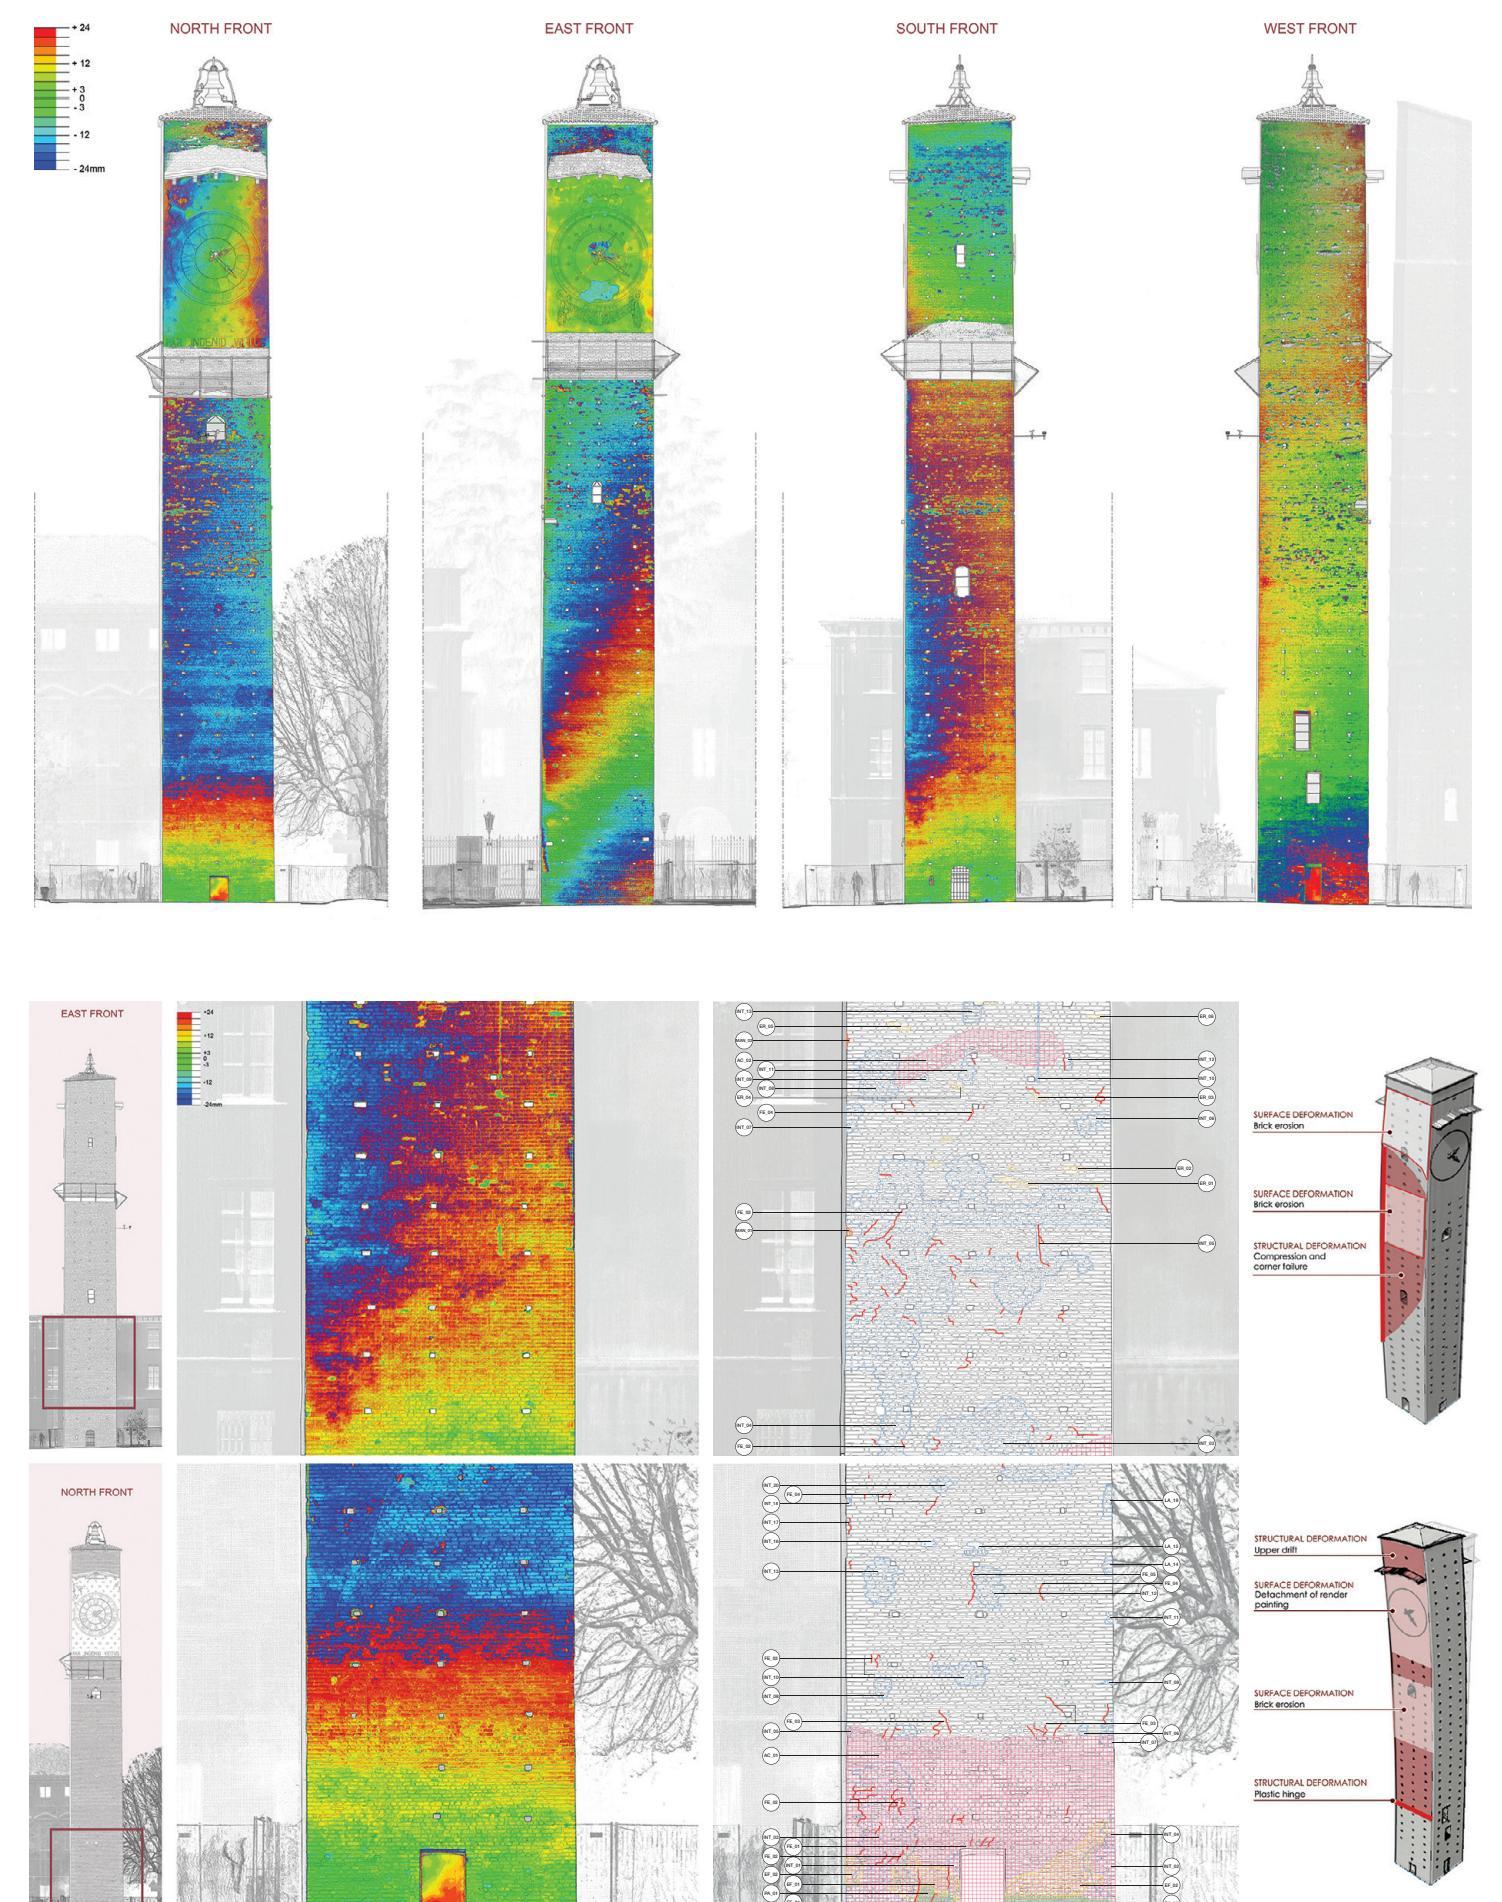
Fig. 20

The comparison between crack maps and elevation maps highlighted the possible relationships between surface deteriorations and structural deformations. For example, crushing, corner failure and hinges highlighted by elevation maps usually correspond to cracks and crack groups observable in the photo planes (graphic elaboration Parrinello S., De Marco R., Miceli A., 2020).
