INFRA REDable. Thermography for the diagnosis and conservation of frescoed walls: the case of the Templar Church of San Bevignate

Riccardo Liberotti, Vittorio Gusella

Department of Civil and Environmental Engineering, University of Perugia, Italy

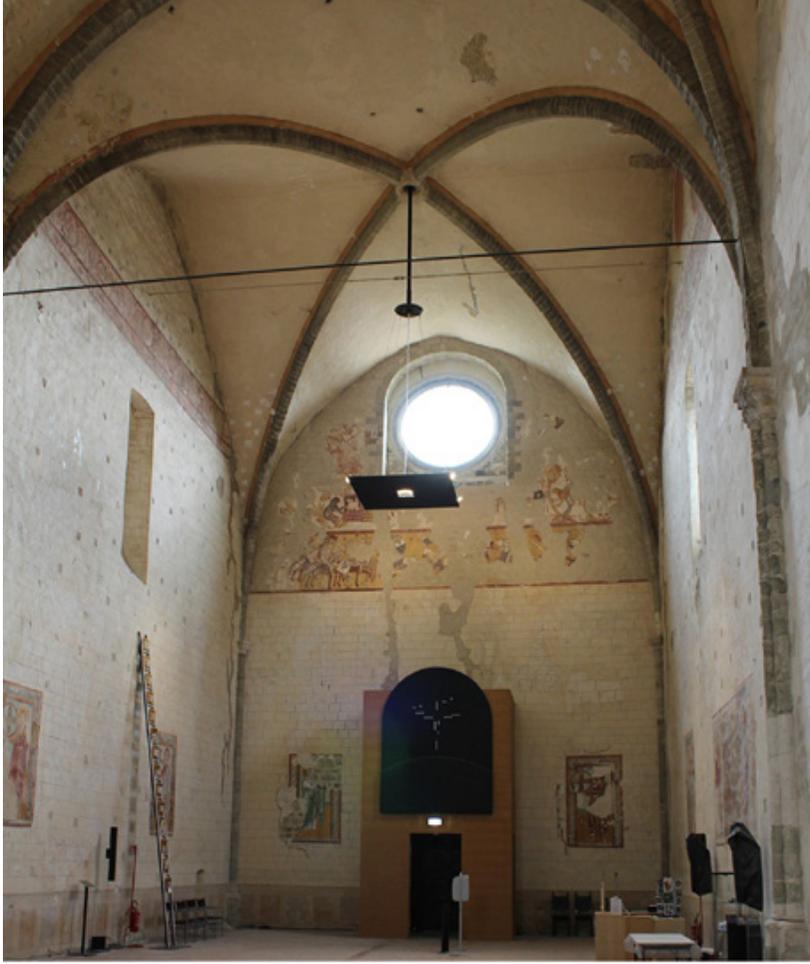
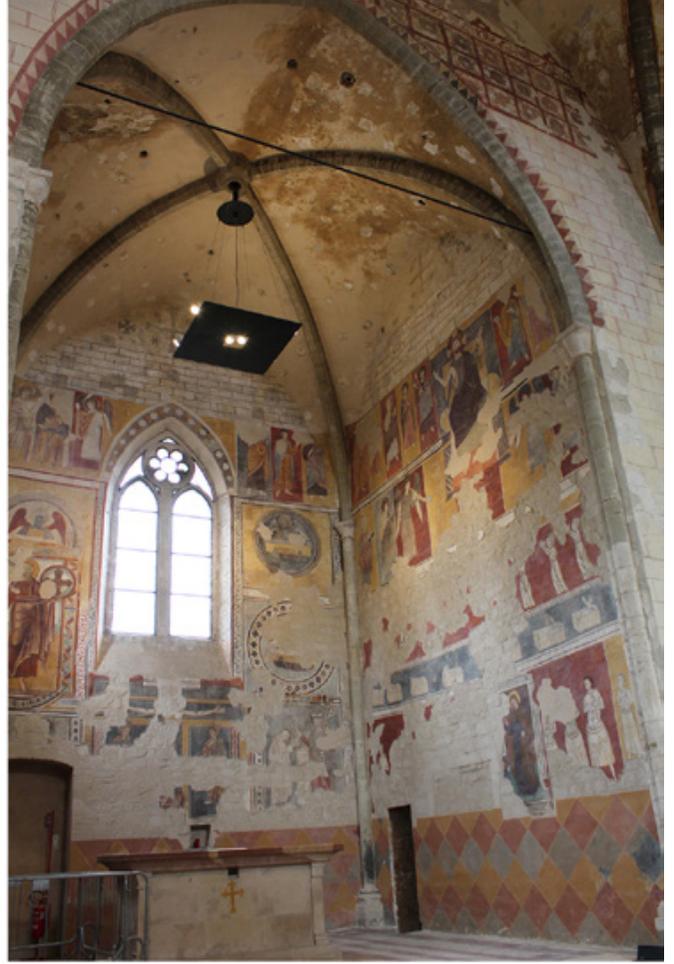
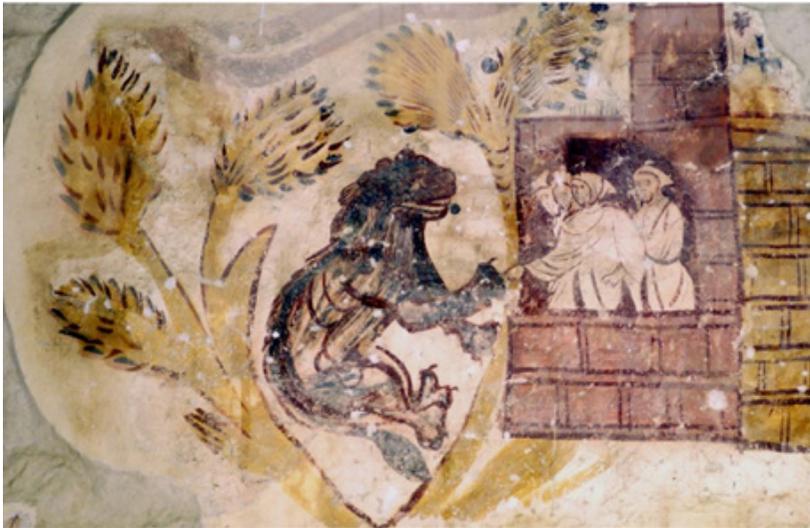
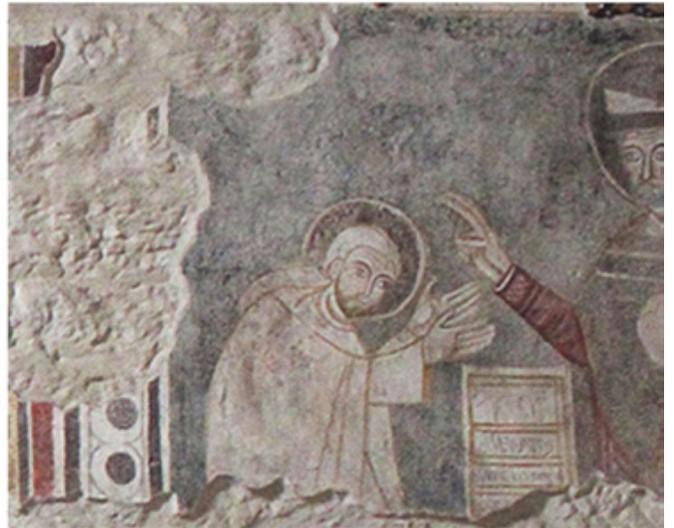
Fig. 2
Starting from the left, counter-façade and the apse after the restoration. Below, respectively, representation, among swaying palm trees, of a lion facing a group of monks, in a convent, dressed in white; the friar Bevignate depicted with a halo as if he were already a Saint and with the white habit consistently with the Templars in the counter-façade.
Photos: authors

In 1262 the construction of the Church was completed and also that of the Romanesque bell tower with a square plan, flanking the apse area, and of considerable size (7×7m). In addition to warehouses, deposits for equipment and shelters for animals, in the immediate vicinity there was also a chapel of more ancient foundation, dedicated to San Girolamo, documented as early as 1243 and mentioned by Lancellotti (Santanicchia 2016). It is also hypothesized that, given the extra-urban location of the preceptory, the area located in the southeast of the building was anciently protected by a wall and moreover was put in direct communication with the cenobitic area of the Church through a small door, now walled up (as well as other windows and accesses). A similar dating is proposed for the monumental octagonal stone well located behind the apse area (still visible today in the center of a garden of private property) and for the remaining buildings of the architectural complex now, as mentioned, used as a private residence. In 1312, with the suppression of the Templar Order, the monastery passed to the knights of San Giovanni of Jerusalem and in 1324 Ricco di Corbolo, a merchant of Perugia, bought the complex and established a female monastic community there, likewise placed under the rule of the Order of San Giovanni. In 1517, due to economic problems, the nuns were forced to abandon the monastery which returned to the full possession of the Order of San Giovanni. From that date the Church gradually lost its importance and in 1860, with the suppression of various religious bodies, became the property of the Municipality of Perugia and was deconsecrated. In the last century had various uses, a wood storage, a kennel and even a fire station and such peculiar circumstances permitted to preserve – strikingly – the frescoes because they have been covered by plaster for decades. After a long and complex intervention plan of consolidation and restoration started following the 1997 earthquake, in 2009 the monumental complex reopened to the public and the original decorative apparatus have also secured; result of an agreement between the municipality and the superintendence of fine arts of Perugia. In addition, in 2021 another restoration plan concerning the frescoes of the counter-façade and part of the side walls was completed, with particular attention paid to restoring the original tones to the wall paintings (Vallerani 2004). To present day, a restoration work is still in progress concerning the cross vaults covering nave, subject to infiltration and degradation phenomena. The restoration activities – and the establishment of synergies with their perpetrators – confirmed what emerged from the historical-iconographic researches (to name a few, Santanicchia 2016, Merli 2008a): the paintings inside the Church (fig. 2) are realized with the fresco technique, ideal for making murals because it lends itself to a monumental style, is durable, and has a matte surface (result of pigments set with the freshly applied plaster to become a permanent part of the wall).

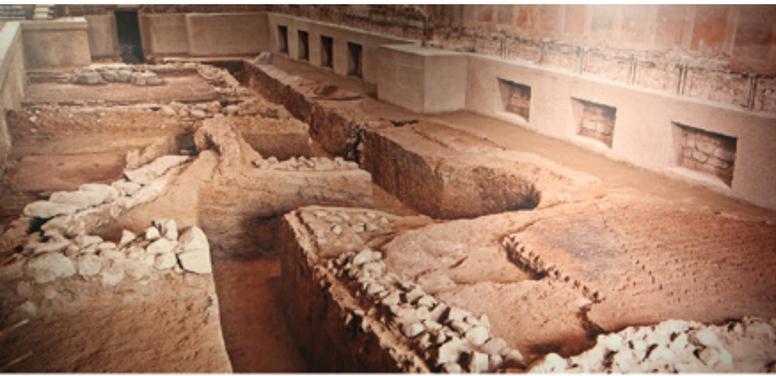
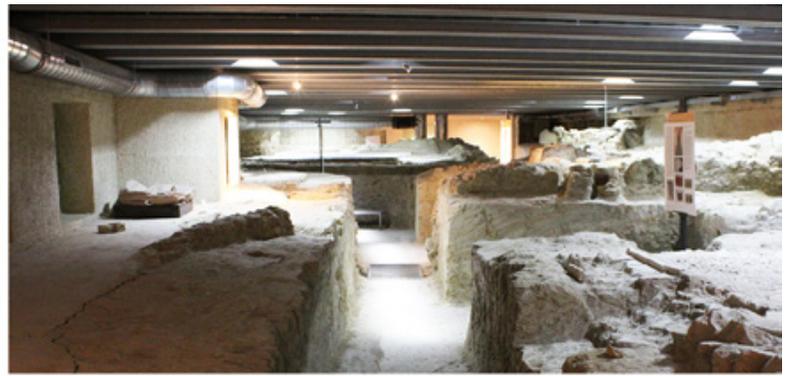
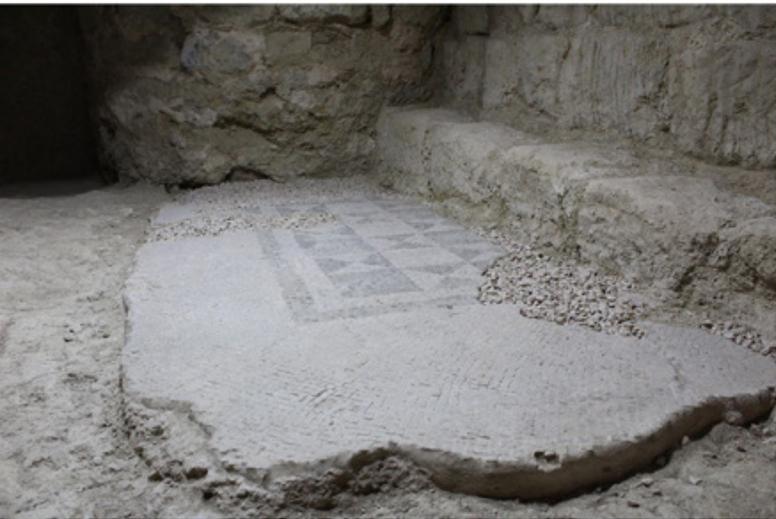
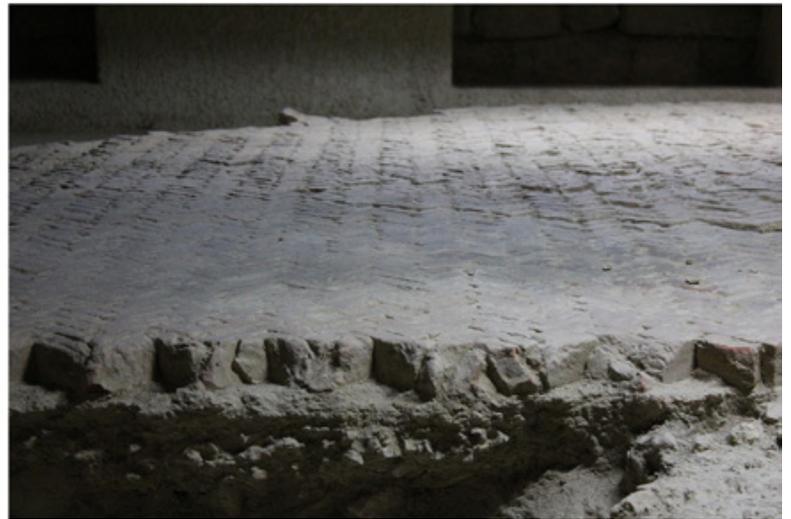
*opposite page***Fig. 3**

Above, comparison of the Roman ruins at the time of their discovery and current state with the museum space. Below, details of the different types of floorings observed in the archeological site. Photos: authors.

In conclusion of this section, it behoves to bring up that at the same time as the restoration works following the '97 earthquake started, valuable Roman ruins were discovered by the Superintendency under the Church's floorings. The finds extend for almost the entire width of the nave and consist in an ancient fullonica⁴: an artisanal site characterized, in this case, by the presence of five basins. Two of them are connected to each other and have a brick pavement arranged with a herringbone pattern. In one of these, a bronze coin was also recovered, datable between the 3rd and 2nd centuries BC. Were also found channels similar to modern sewer systems. Indeed, anciently the area of San Bevignate was rich in water and in Roman times the fabrics were washed and dyed in this workshop, where the wool was processed for the use of both winter cloaks and armour. The system made of the various drains is still visible, as can be seen in the background the red colour used for dyeing (Merli 2008b). The discovery of the Roman ruins caused a change in the initial project: a new metal structure holding up the terracotta paving, at the floor area of the Church, was introduced under which a narrow walkway through the ruins for visitors was opened (fig. 3).

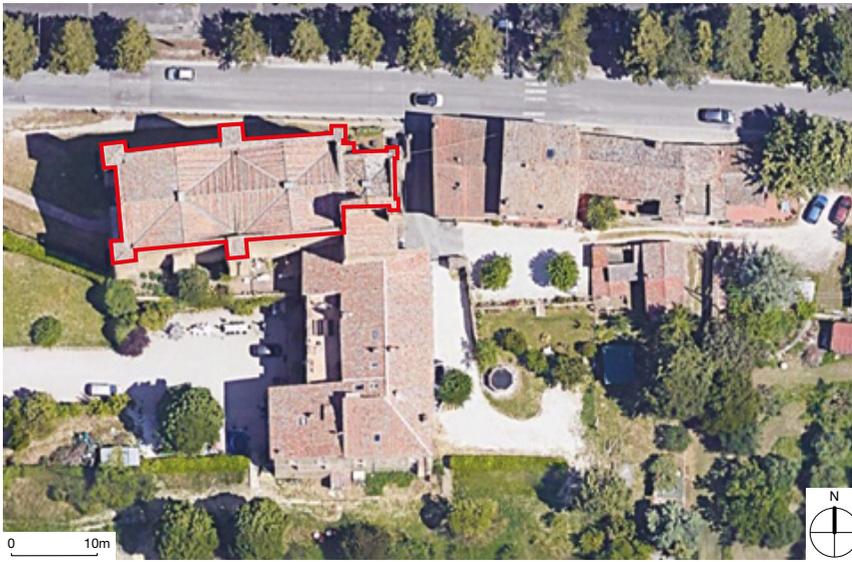
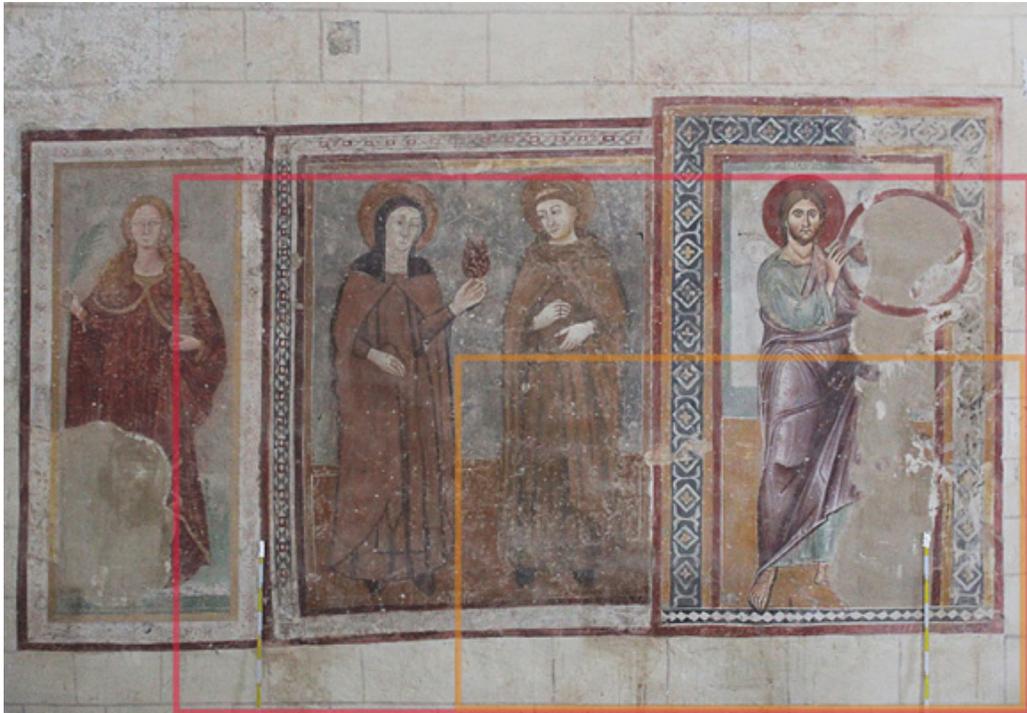
Fig. 6

Experimental results on the fresco depicting Magdalene, Stefano and Lorenzo. See in fig. 5 the cone of vision 1 for the ordinary photo and, respectively, the cones A and B for the thermographic shots. The elaborations are reported, at two different scales, starting from the visible frescoes to the main phases of the post-processing method. Photos: authors.

The Church is one of the most important Templar Church in the world, since there is no such cycle of frescoes not even in the Chapelle des templiers de Cressac, a Templar chapel located in southwestern France that shows a valuable cycle of frescoes of reference on this theme. As mentioned in the previous sections, the main objective of the experimental investigations was the acquisition of information, without damaging the frescoes, about the non-visible masonry texture of the Church's walls. Concerning the survey methodology, thermographic "shots" were taken under passive conditions on different internal walls and thermal reflective elements – made of stiff wands – were placed to overlay, at a later time, the acquisitions and the ordinary photos in order to get dimensional information. This results in different responses from each construction or decorative material, in particular by identifying with black pixels the mortar and with the white ones the stone elements made of tuff, a soft reddish coloured rock – consisting of consolidated volcanic ash ejected from vents during a volcanic eruption – especially common in the area of central Italy where the regions of Lazio, Umbria and Tuscany meet (Raspa, 1987). Moreover, dealing with a real architecture, it was necessary to add to the procedure a new step to enhance the final binary image quality: an adjust contrast tool aimed at improving the black-to-white mapping of the thermographic greyscale image by which the recorded thermal images are preliminarily modified, consequently the differences between black and white appear sharper, filling the entire range of intensities [0, 255]. As mentioned, the restoration interventions in this last phase were concentrated only on the north wall of the masonry shell and in the same way – before the works started – the thermographic surveys were carried out precisely on its internal face⁶ (fig. 5). Referring to the frescoes that decorate the examined wall, rows of overlapping ashlars are reproduced to imitate an austere wall face made of stone, a typical decoration of the Templar churches aimed to recall the poverty of the holy land. Above such decorations, the series of the twelve apostles stand out, distributed also on the other side wall, on the facade and on the back walls of the apse; such pictorial cycle was superimposed on the original decoration during a second phase, between 1283 and 1285. In particular, the last tranche of thermographic surveys was focused on some of the mural paintings concerning such cycle. Among the many examples, only the more substantial – with reference to the subsequent design of the restoration project – are described, starting from the triptych in which, in addition to one of the apostles, three saints were depicted: Magdalene, Stefano and Lorenzo. By means of straightening photographic and measurements digital techniques, and considering that in this first case the meter-sticks were placed with a wheelbase equal to 2.70 m, it was possible not only to seize the quality of the masonry texture but also to characterize its dimensional features: a quasi-periodic texture made of stone blocks with different widths, ranging from 25 to 60 cm, but similar heights, of about 20 cm, has been observed.

Such results match with what was surveyed in the apse in other instances, concerning the areas where the fresco peeled off and on the external facades. In addition, it was possible to contextually ascertain that there are no detachments or infiltration phenomena in place that can afflict the health of the frescoes. On this, recalling the historical-iconographical researches from which emerged that the Apostles' cycle was superimposed to the pre-existing ones, the mortar distribution and the presence of few fragments of mortar out of the joints (in those areas) suggests a trace of the fresco-makers' ancient technique: the surfaces of the previous frescoes have been "excavated" by hand

and without an exact pattern by the masons, allowing the fresh plaster (of the new fresco) to cling to the holes on the ancient mortar below (fig. 6). Finally, it must be pointed out that, in a previous publication antecedent to the design phase, the criteria and the numerical procedures conceived to correlate the masonry recognition to the mechanical properties identification have been described (Gusella 2021a). All these considerations found a match with the restoration activity that involved the frescoes during the just-passed year. In fact, the interventions, albeit oriented at restoring the original tones of the frescoes, through the use of different restoration techniques (Botticelli 1992, De Vita 2015; Caccia Gherardini 2020a), revealed the evidence of the different pre-existing layers of mortar, regarding not only the cycle of frescoes of the apostles. Also, the painted ashlar motif has been completely traced over the original one over at a later stage, today the scratches necessary for the successive additions are visible along with previously unknown engravings and mural paintings depicting animals, probably testimony of the outlines of preparatory drawings traced at first by the artist onto the wall and then covered. This, therefore, testifies the capability of the proposed thermographic method (Sec. 3.1) to gain information even about masonries subjected to various superimposed layers of plaster, considering also that fresco technique consists of three successive coats – two rough and the last smooth – of specially prepared plaster, sand, and sometimes marble dust trowelled as much of a wall as can be painted in one session.
