# Archaeology and earthquakes in Siena (Italy). Preliminary results from the survey of the historical buildings in the Terzo di Citt 

Andrea Arrighetti<sup>1</sup>, Valeria Razzante<sup>2</sup>, H el ene Dessales<sup>3</sup>

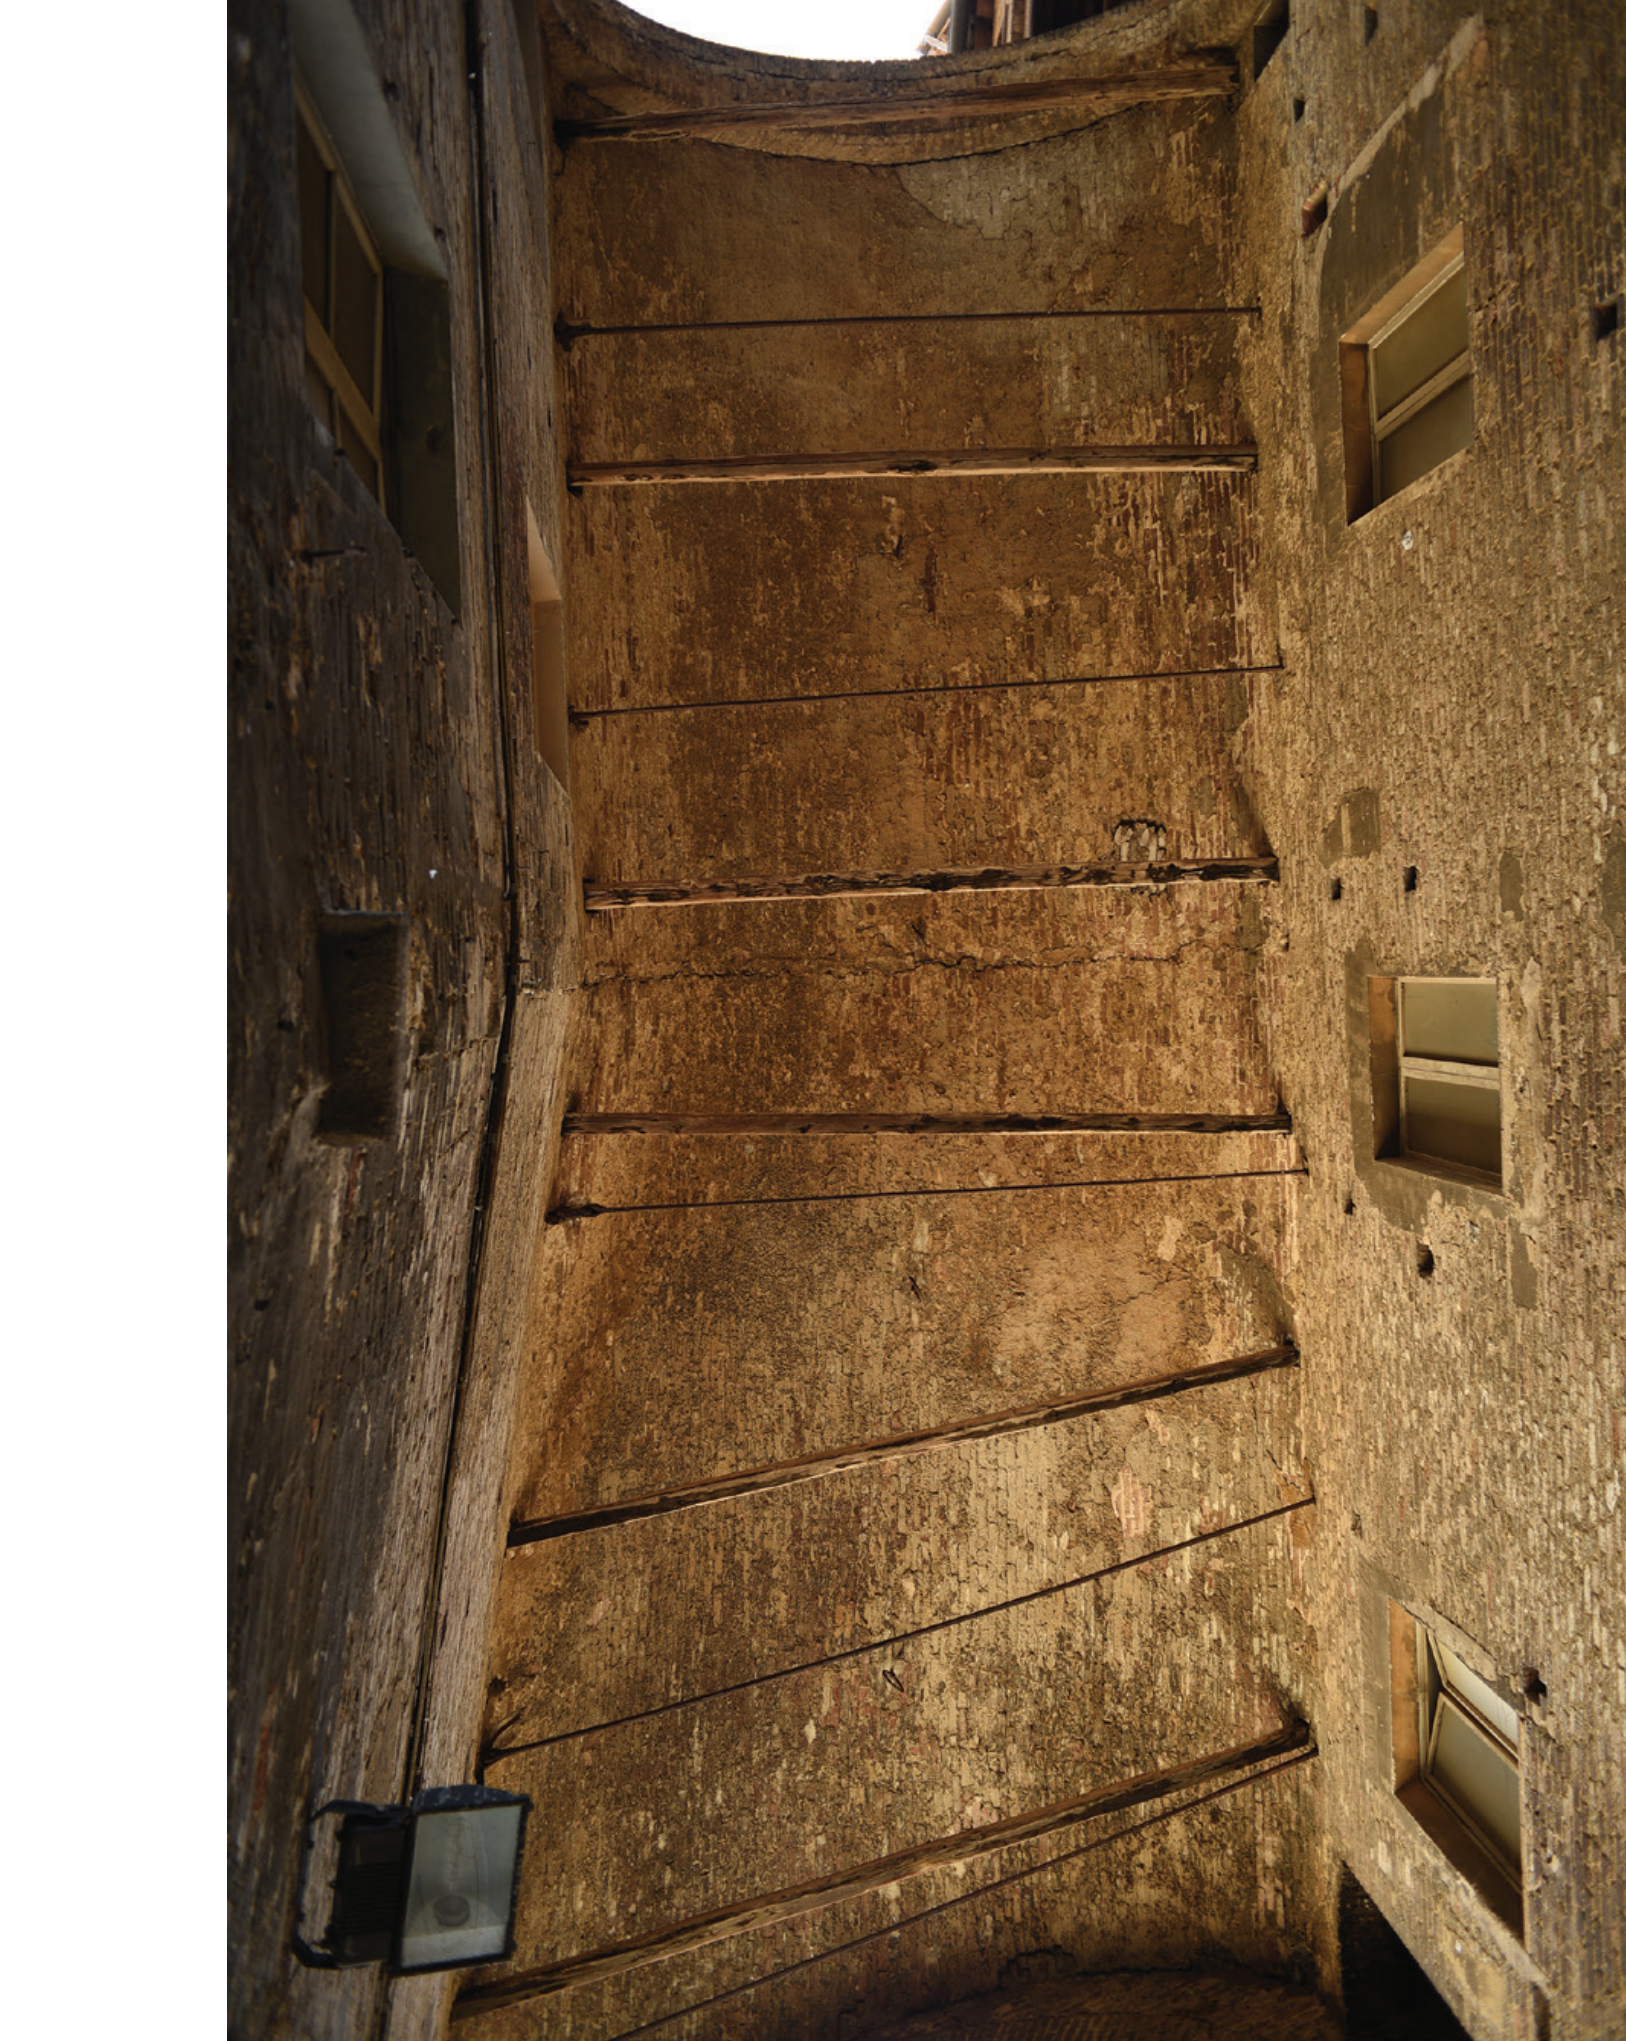
Example of a wooden beam set inside wall masonry.

archaeology and the archaeology of architecture, supplemented by stratigraphic observations carried out only on a select number of sites (Nucciotti, Vannini, 2020). Starting from these methodological premises and with the aim to materially identify the archaeological and seismic traces in the city of Siena, a vast and complex area from both an historical and architectural standpoint, it was decided to prefer for a survey of the urban context within the walls and limited to the area known as Terzo di Città. Approaching a macro-scale work, it was important to establish the level of detail, which consequently led to a district-type of research. The following is a critical review of the data collected from the urban survey and recording of the four categories of restoration interventions with preventive functions, documented in the elevations of the buildings analyzed along the roads of the Terzo di Città. Among the various roles played within buildings, metal tie-rods and wooden beams (fig. 5) make it possible to counteract anomalous thrusts that occur in vaulted structures. Specifically, the introduction of metal tie-rods increases the degree of connectivity between the walls and contrasts potential overturning phenomena<sup>11</sup>. In order to join these elements to the wall face, key heads are used, designed according to the type of architectural element to which they are connected (wall, column or pillar) (MIBAC, 2011). Four types of interventions were identified during the survey that can be included in this first group. The process of recording tie-rods and beams followed a more elementary, schematic approach, also due to the low number of elements distributed in the area of interest. As for chronologies, it was possible to advance some hypotheses of relative chronology<sup>12</sup> for two of the recorded elements. The first case concerns the metal tie-rods and wooden beams in Via Fusari, for which it is hypothesized that they were put in place after 1408; the construction of the brick overpass which runs over the same street, commissioned by the Opera del Duomo, dates to this period (Gabbriellini, 2010, p. 277). The second dated element consists in the installment of wooden beams and buttressing arches in Vicolo di Vallepiatta. The *Statuto dei Viari*<sup>13</sup> refers to a number of works that between 1290 and 1298 involved Via del Costone, Via and Vicolo di Vallepiatta and Via del Pozzo (Balestracci, Piccinni, 1977, p. 48). By correlating this information with *in situ* observations, it would be possible to chronologically ascribe both intervention features to a temporal phase after 1290.

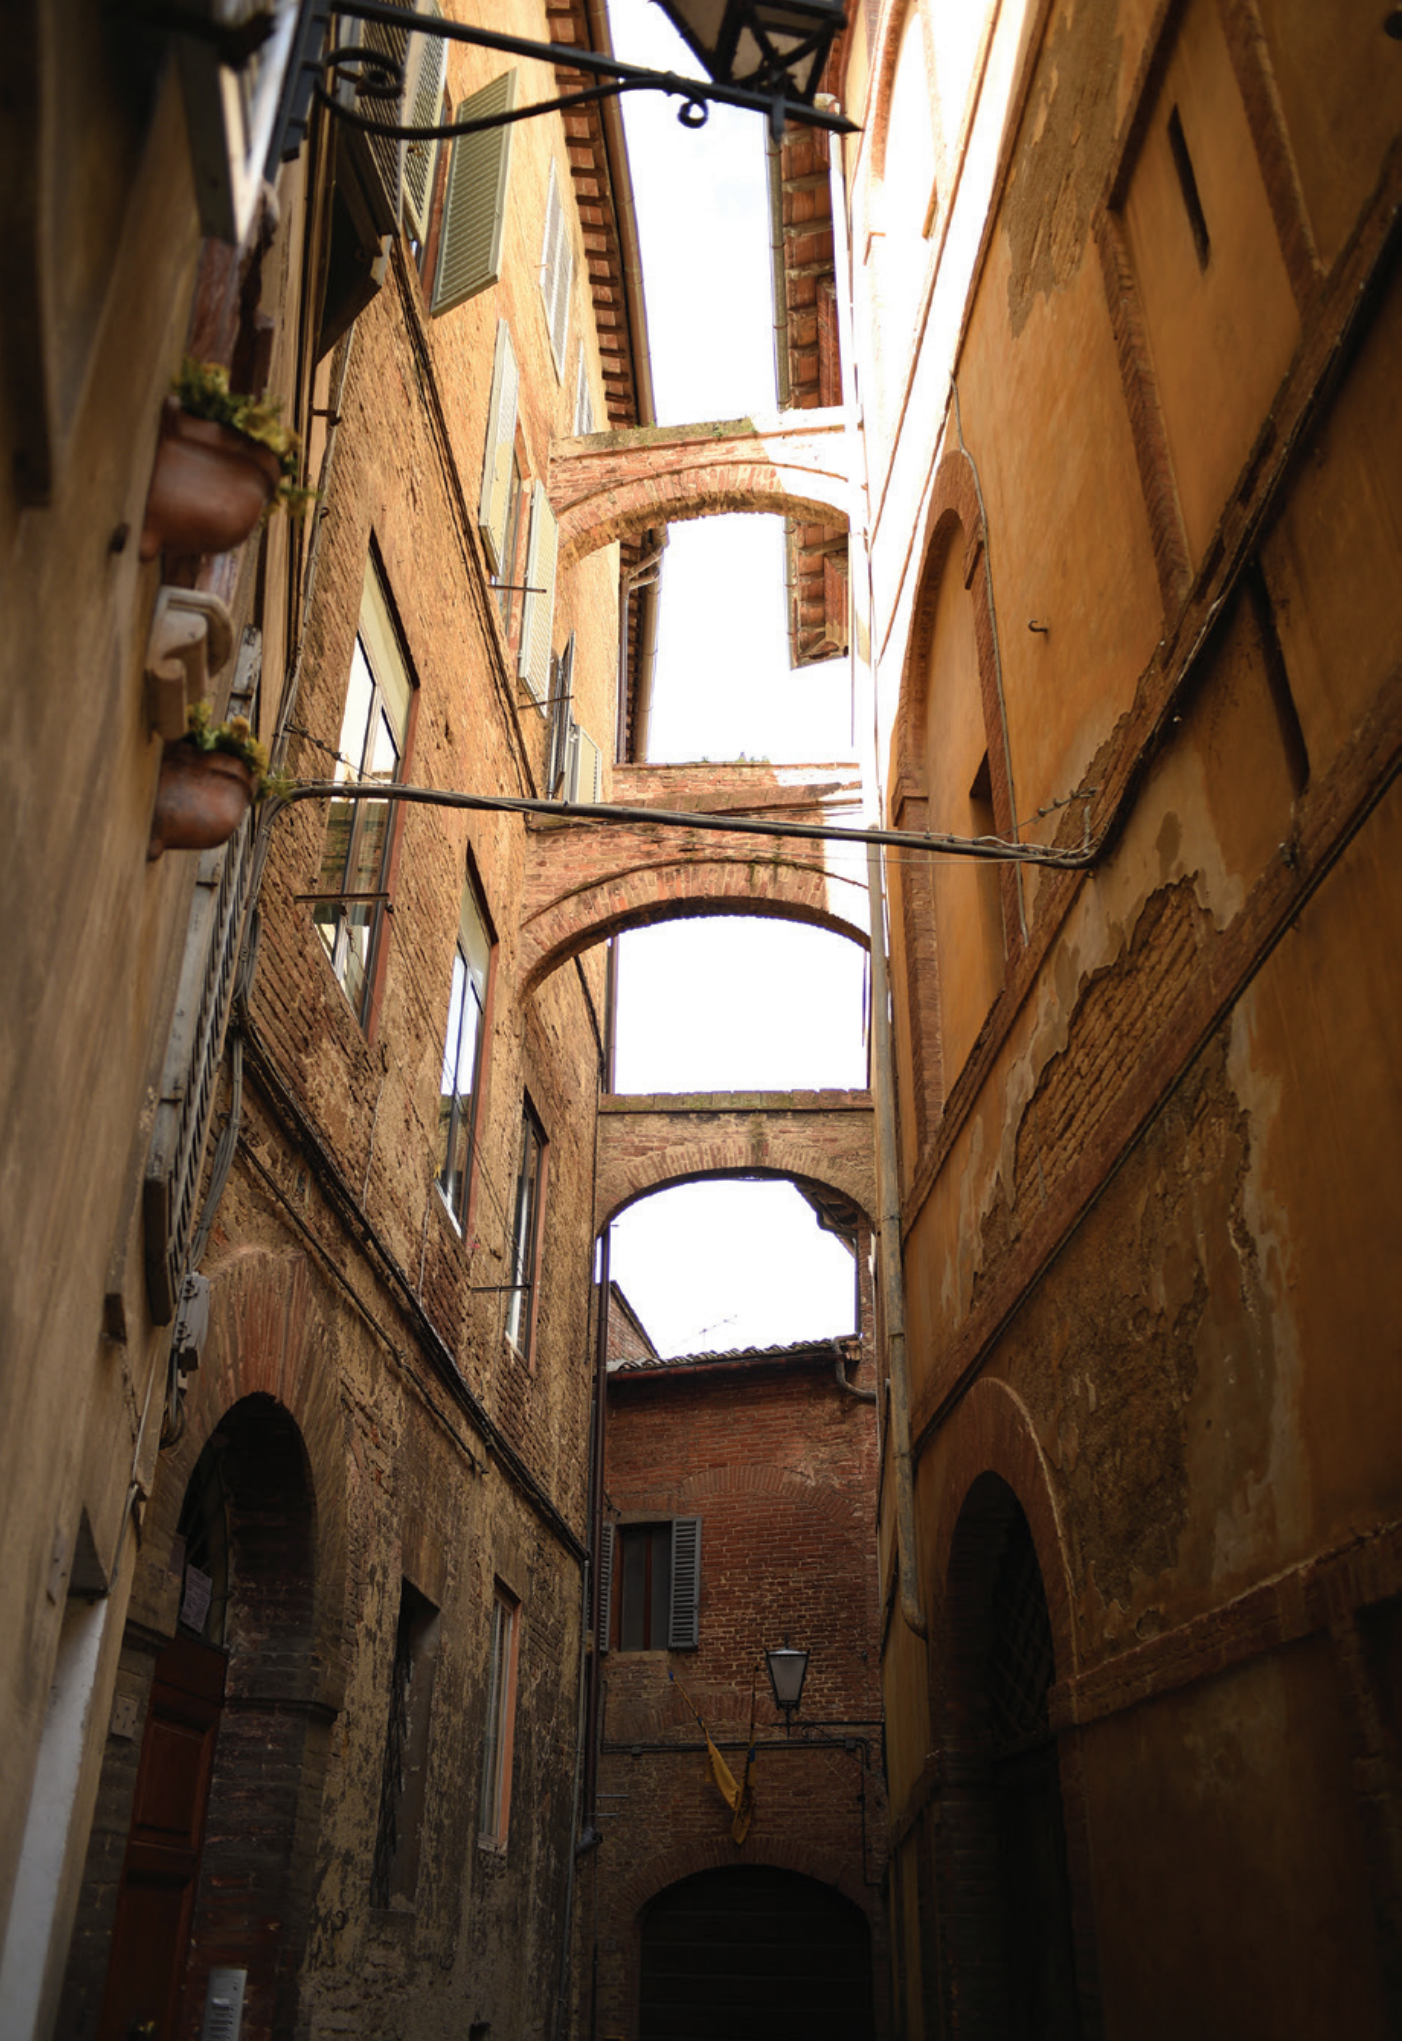
Example of contrast arches.

The buttress arches (fig. 6) can be defined as masonry or brick elements, the use of which is functional to counteract overturning mechanisms (Arrighetti, 2015, p. 78). In the past these elements were widely used as structural supports between two buildings. Once put in place they could undergo further changes and from a single arch it was possible to proceed with the construction of entire overpasses: in this way, while counteracting the horizontal thrusts caused by earthquakes, it was also possible to enlarge living areas inside the buildings (Ferrigni et al., 2005, p. 304). In the Sienese context of the Terzo di Città such interventions appear to be the most widespread, confirmed during the field survey that allowed the documentation of a total of seventeen. Among the records identified, once again interrogated on GIS through qualitative and quantitative characterization parameter datasheets, only in two cases was it possible to advance a proposal of relative chronology: the already cited case of Vicolo di Vallepiatta, in association with wooden beams which had been dated to after 1290, and the walkway built near Chiasso del Bargello which is considered as subsequent to the enlargement of the road section that occurred in 1328 (Balestracci, Piccinni, 1977, pp. 48-49). A narrow passageway inside a building can determine a break in its linear continuity.

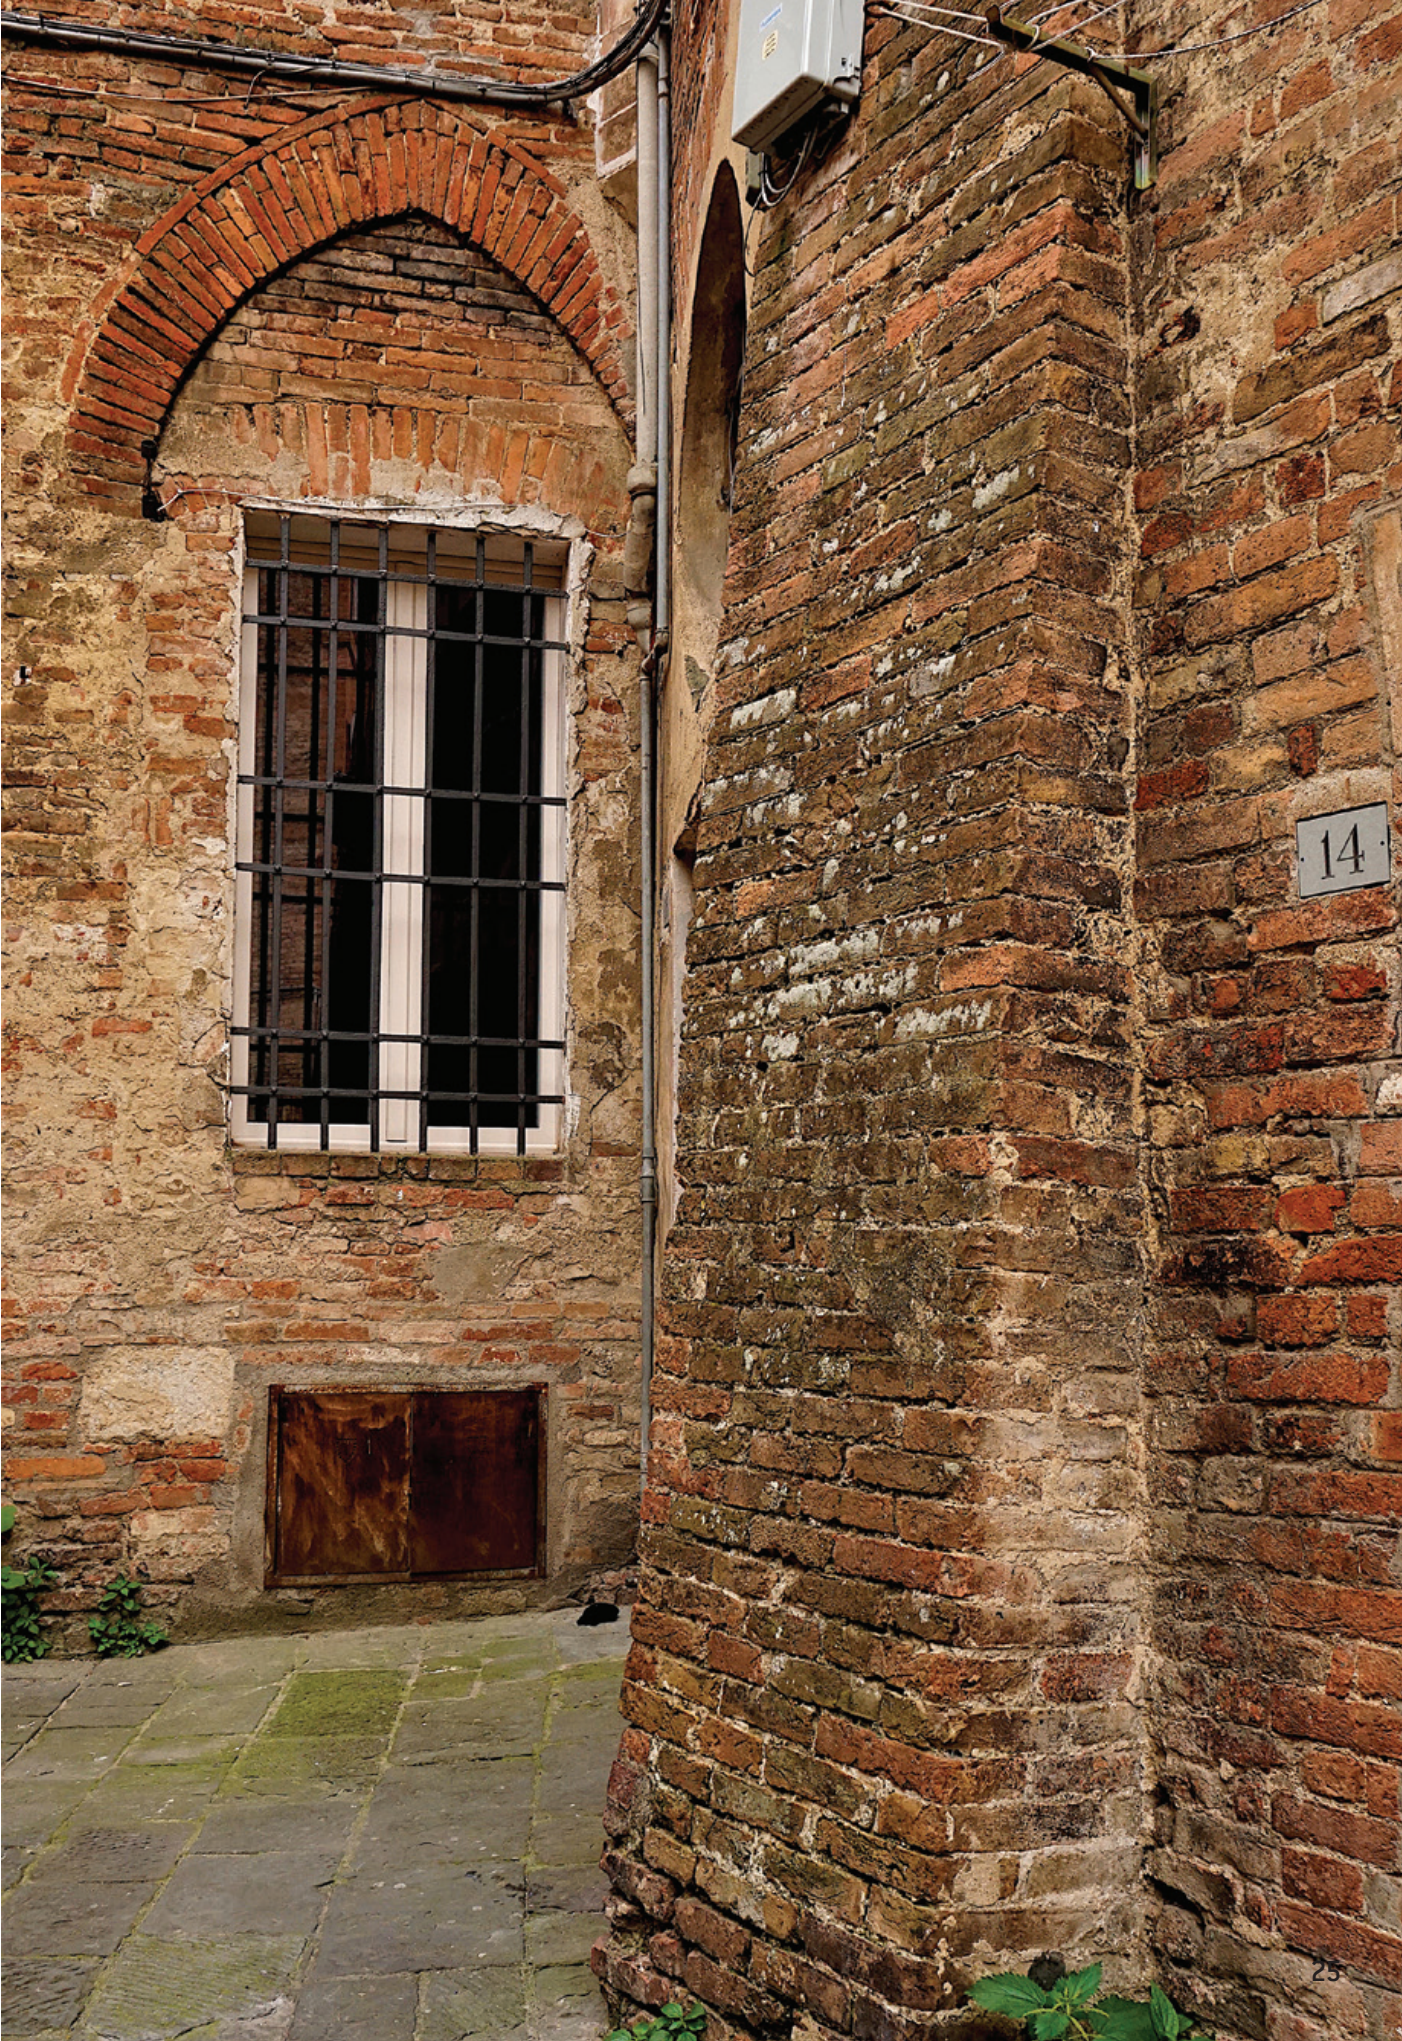
Example of buttress inserted above wall.

Buttresses and spurs (fig. 7) ideally create a truncated-pyramidal geometry that absorbs horizontal seismic actions. Referring to the aforementioned 'virtual arch model', these structures counteract the thrust that the angular semi-arches exert on the corners of the building. The increased use and spread of these elements in the pre-Modern Age can be attributed to the technical simplicity of their construction and the availability of material. For Siena, the building of buttresses and scarp walls provide the opportunity to observe concrete examples of how an entire group of adjacent buildings can respond to telluric stresses through compression and distention. Indeed the city responded to the presence of natural slopes with the spread of building nuclei that, when subjected to seismic stress, perform an "containment dam effect" (Cangi, 2018). In relation to the survey activities carried out in the Terzo di Città, 67 units were documented as buttresses and scarp walls. Also in this case, the primary recording parameters were accompanied by observations on the materials employed. While most of the structures are made of brick, only in four buttresses the alternation of sandstone and locally quarried cavernous limestone was used. As far as dimensional aspects are concerned, if the longitudinal development and occupation of the road surface were measured directly from the ground, the maximum height is related to the alignments of the buildings examined. Lastly, regarding the more strictly structural aspects, in fourteen cases it was noted that buttresses in elevation are associated with metal chains that, as Cangi (2018) points out, might be interpreted as additional containment elements.

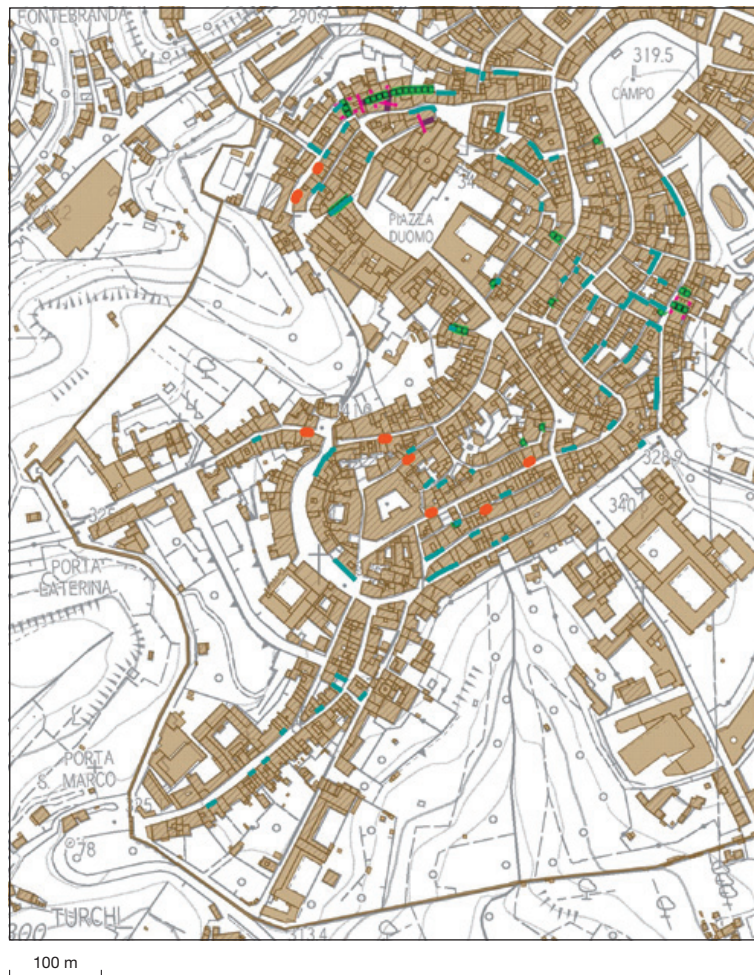
**Fig. 9**  
GIS-based framing of the Terzo di Città.

After completing the survey of evidence related to the seismic history of Siena and the recording of restoration interventions with preventive functions, the data obtained was organized and returned in the form of digital cartography (figg. 8-9) through the use of QGIS software. In application terms, an initial response of content structuring and drafting the datasheet was followed by the graphic and geographical restitution of this information. The data obtained from the field survey was then interpolated in the software through a join operation of the field "ID presidio", specific for each intervention and present both in the vector file drawn in GIS and the datasheets of the four categories of interventions, separately pre-compiled in an Excel file.

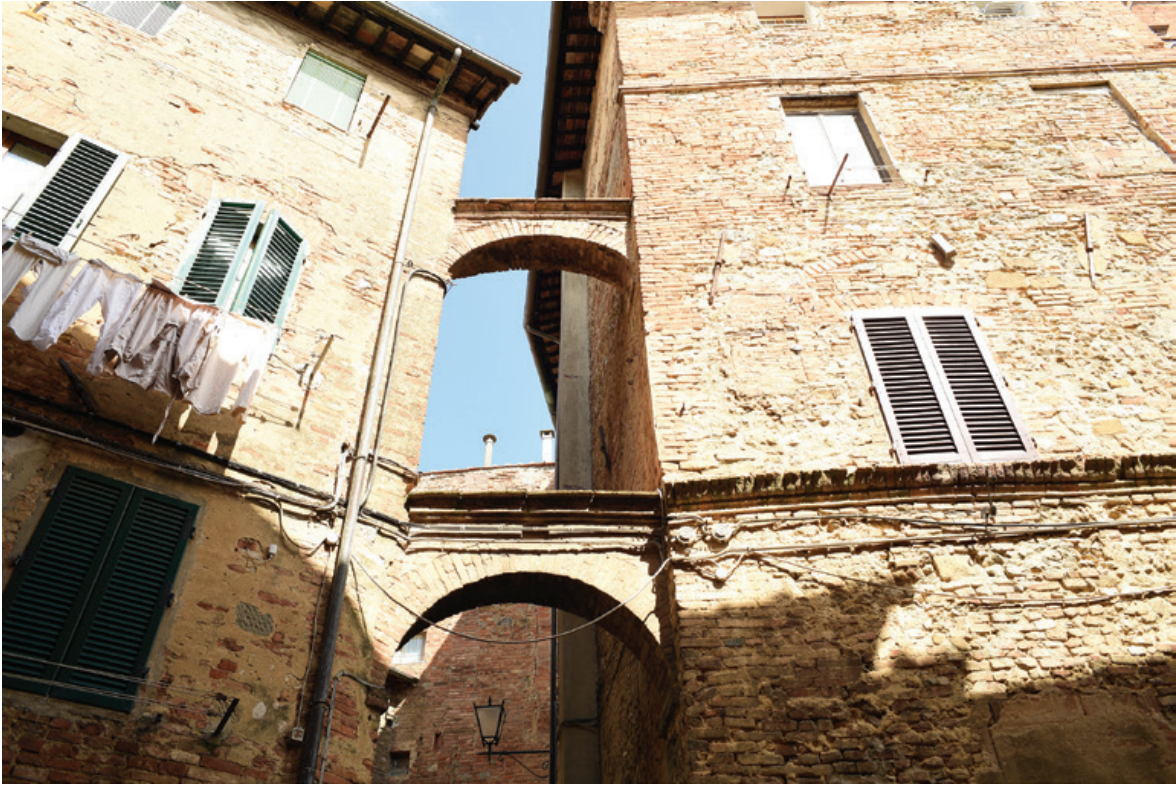
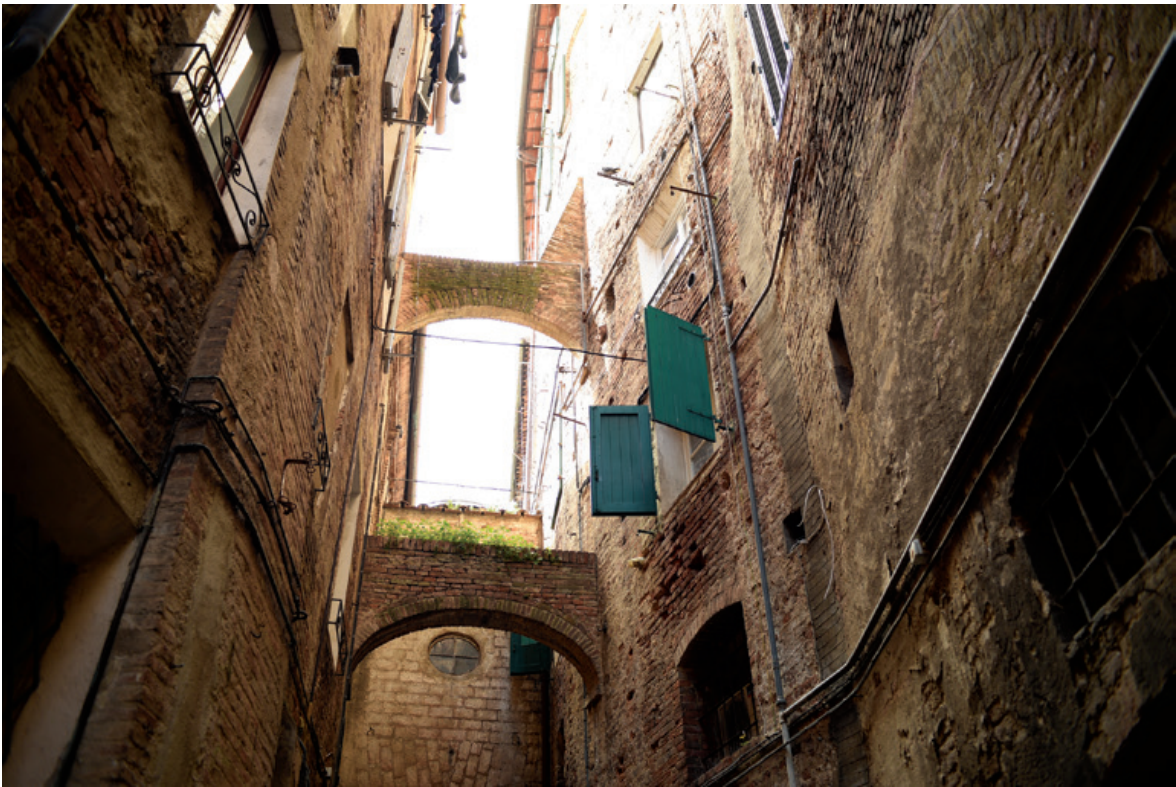
The two types of contrast arches present in the Terzo di Città. Photo: A. Attighetti.

soil and layout of the city center. The presence of specific areas in which these features are used is evident, probably referable to areas where the effects of earthquakes or other structural issues were especially amplified, as the area behind the Duomo or the neighborhood of Castelvechio. Another point to be taken into consideration in relation to the evidence which emerged during this research is the probable precariousness of the state of conservation of some of the architecture, that has certainly contributed to the formation of instabilities (both of natural and structural origin), conditioning the choice in the use of certain protective expedients for the structures involved. Moreover, it is interesting how the use of certain techniques to the detriment of others allows us to understand the probable correspondence between a post-seismic intervention and an earthquake, thus allowing the formulation of some hypotheses on the use of specific expedients as chronological reference markers. In this sense, from the macro-area reading of the data, an integrated use of the buttress arches and wooden tie-rods seems to be visible in the area near the Duomo, with an almost total absence of wood in the external wall surfaces throughout all the other parts of the Terzo di Città. The buttresses, on the other hand, show an almost homogenous distribution in the whole area but represent, for the purpose of this work, an element that is of little use for chronological characterization. Conversely, an element of significant interest is the extensive use of buttressing arches, which apparently saw greater employment in the area near the city center. Given their constructional characteristics, these can be classified into two macro-types (fig. 10): simple arches, characterized by a rounded or lowered arch made with vertically set bricks and an upper wall surface of 10-15 rows of bricks with no further decorative apparatus, and complex arches composed of rounded or lowered arches with a well characterized decorative apparatus, sometimes featuring a small cover in the upper portion. In both cases there are sub-variants based on the size of the section of the arch, which could in some cases present a passage located above, useful for connecting rooms between buildings, or on the curvatures of the intrados, if rounded or lowered. From a chronological point of view there is little information that permits a periodization of the identified elements. Only for the buttress arches some dates are available linked to documents produced in the wake of the earthquake of 1798, allowing us to identify the complex arch type as contemporary to the reconstructions that took place following the late 18th century earthquake. On the contrary, the use of the simple form in this type of intervention appears to be backdated.
