# Lost and found: the water-based settlement of the historic city of Ayutthaya

## Abstract

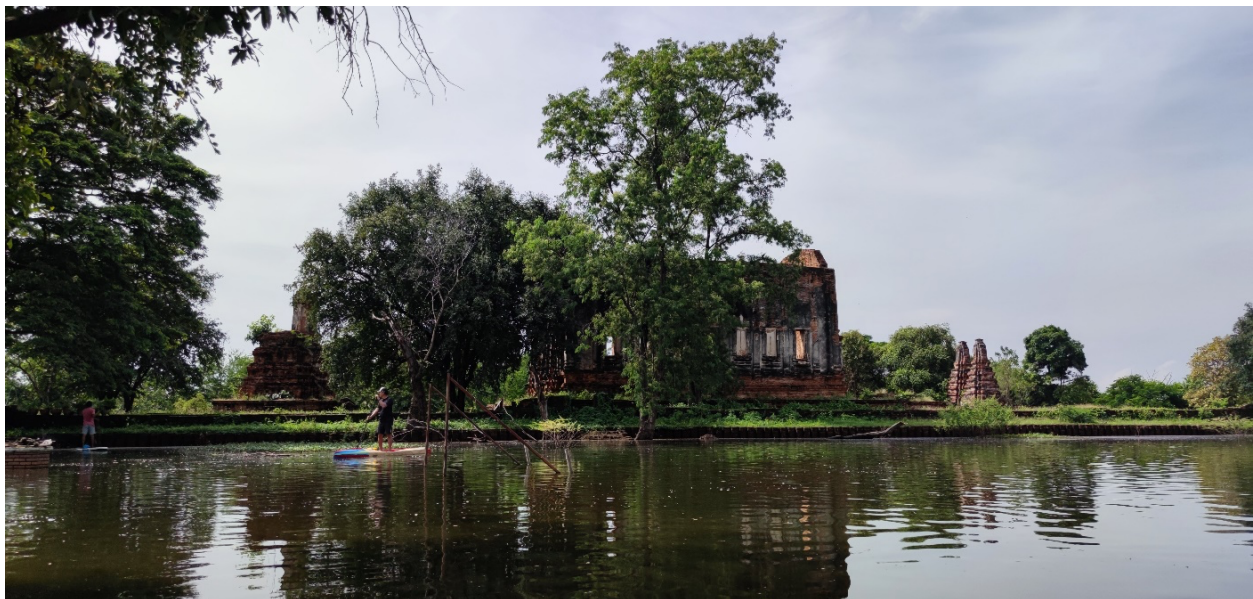
Fig. 3 *Wat Phrayaman* during the flood in September 2021 (Image source: author, 2021).

*Tung Lumplee*, a historic field located in the northwest of the city island, was previously a rice field and an important historic battlefield. It has been inhabited since 1600, and after Ayutthaya was disconnected, this area became abandoned. Most of the area is lowland, with a wide field and canals on all four sides. *Wat Na-Phramane*, *Wat Phrangam*, *Wat Chongkrom*, *Wat Phrayaman*, etc., were some of the fields' most outstanding monuments. The flood in September 2021 revealed a strong relationship between monuments and the water overflow level. Water from the *Chao Phraya* and *Lopburi* Rivers overflowed through several fields in the northern part of the city, *Thung Lumplee* being one of them, and many monuments and surrounding communities were inundated when the water level rose to between 80 and 120 cm for two weeks. The historic structure floated over the water's surface. The monument is surrounded by ditches alongside or at the edge of monument boundary, where most of the water collects. The main structures are set on high ground, elevated from the surrounding flat terrain. A large *Ubosot* (grand shrine) is located in the center of the axis with the coupled octagonal chedi on the rear side. All structures are sitting on the same plinth, which has been raised from one to three steps with the main building located on top. This design method can be found in *Wat Phrangam*, *Wat Chongkrom*, *Wat Phrayaman*, and another inundated area of the central flood plain. The special structures of the temple compound consist of *Kumpeang kunkluekratag* <<wave protection wall>> surrounding the boundary walls, like those of *Wat Phrayaman*, which is located at the top north of the field. Interestingly, the north side has indented corners, combining a stretcher bond brick wall to receive the lateral force of the waves.<sup>9</sup> This demonstrates how traditional design can prevent flood damage to the structure through precise leveling and topographic surveying as in the past.

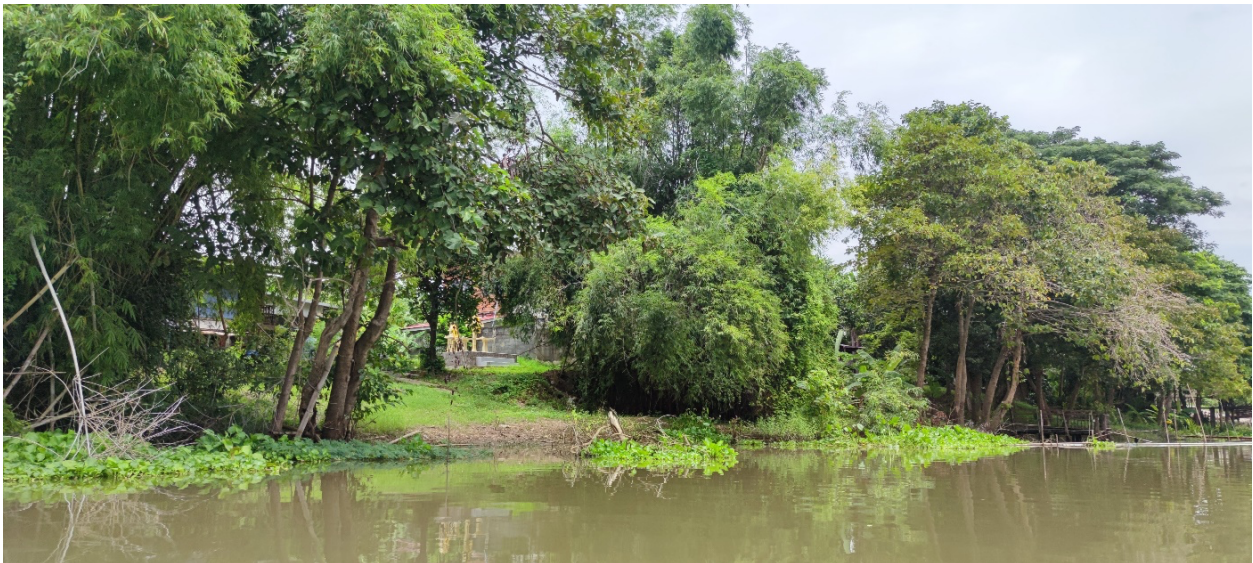
Fig. 4 Settlements along the *Lopburi* River remain have retained their traditions and natural characteristics (Image source: author, 2022).

The riverfront settlement along the *Lopburi* River remains related to water-based settlement. The river is of great historical importance. The 14 km stretch along the *Lopburi* River from city island to *Bangpahun* Sluiceway is testimony to the cultural tradition remaining on the natural embankment of almost the entire river course. A group of houses is settled apart 20–50 m from the river. The natural riverbank gradually slopes upward from the river to the houses, with different slopes creating variations in water overflow levels. There is a backyard area at the side of the riverfront and a rice field to the rear. However, two-story houses on high stilts can still be found with open spaces underneath to provide ventilation. Temporary multi-level wooden platforms have been set up in this space to cope with different water conditions. The house has a terrace on the riverside and a staircase leading to the pier. These physical elements represent the culture of the agricultural community in the central region, where they are responsible for day-to-day livelihoods during any season.

One of the most outstanding features rarely found anywhere else is the naturally-formed embankment resulting from water overflows and the evolution of human living culture over time. The sediment from the river has become part of the embankment, helping household agriculture to grow. These natural barriers represent the outstanding riverine cultural landscape of the *Chao Phraya* River Basin, with the steps and slopes evidencing how local dwellers understand the changes and have utilized their adjacent environment through time. This can be seen in the local environment where architecture, monuments, and community characteristics help to combine traditions with modernity. Living in communities, local dwellers have changed, improved, adapted, and applied themselves to the current environment and the flow of water over time.
