# The challenges in the restoration of the Capanema Palace, Rio de Janeiro

## Abstract

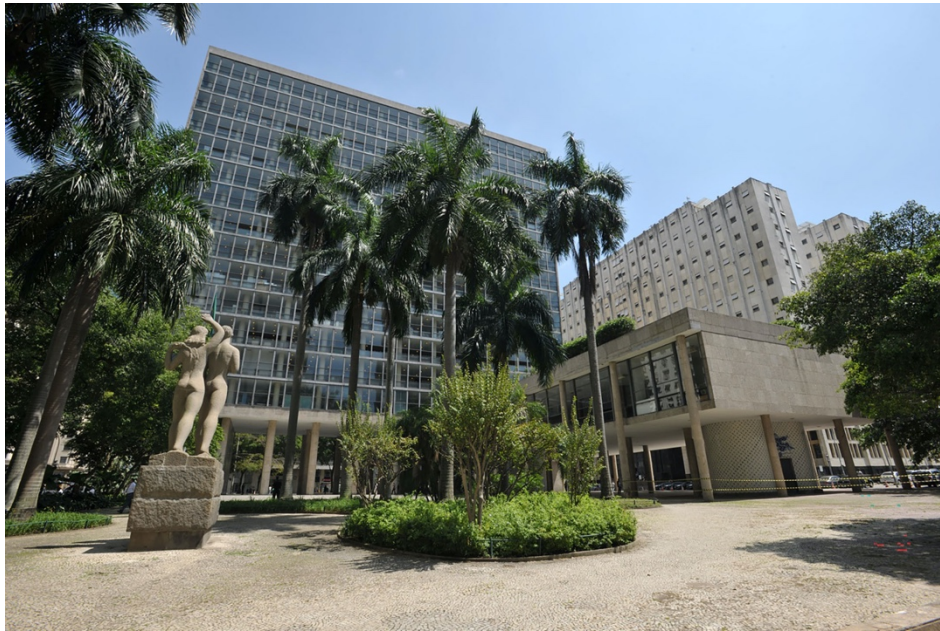
Fig. 1 Rio de Janeiro, Gustavo Capanema Palace (photo by O. Liberal, 2012).

This collaboration resulted in a design that embodies the modernist principles: a composition of two perpendicular rectangular blocks with approximately 27,500 m<sup>2</sup>, 10-meter-high *pilotis* in the 16-story tower, free-plan interior, modular structural systems, a rooftop garden, cross-ventilation strategies, and the pioneering use of *brise-soleils* on the highest building north façade alongside a vast glass curtain wall on the south (Figure 1). These sun-shading elements, originally developed by Le Corbusier, were employed at an unprecedented scale. Beyond architectural advancements, the design anticipated modern concerns with environmental sustainability. Long before such considerations became standard, the Capanema Palace incorporated passive design strategies that enhanced natural lighting and ventilation, contributing to a more rational and efficient use of electricity. The structural innovation, engineered by Emílio Baumgart, featured an inverted mushroom-slab technique that eliminated beams, creating flexible interior spaces. Additionally, a counterweight mechanism installed on the façades allowed for the effortless

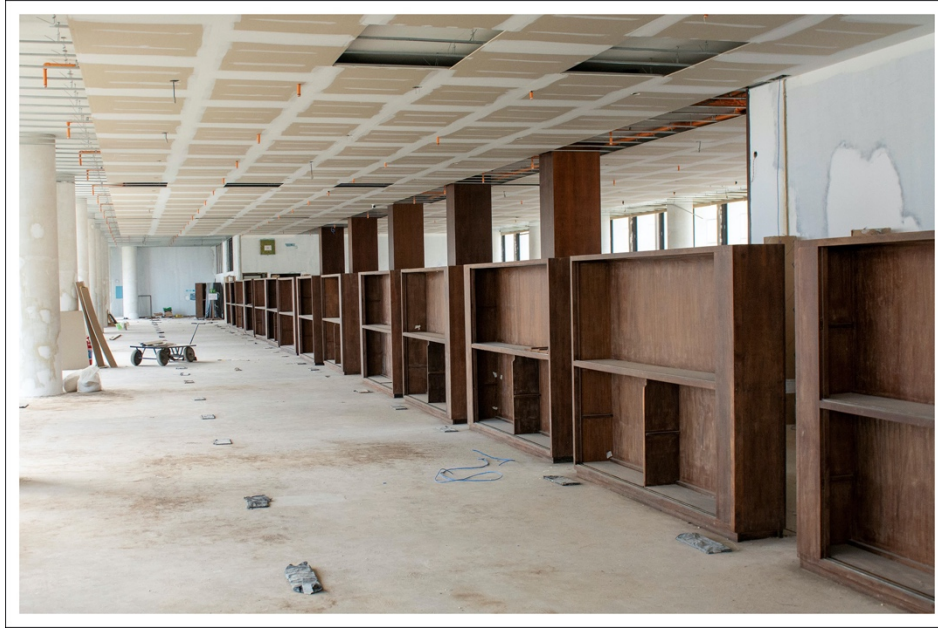
Fig. 2 Rio de Janeiro, Gustavo Capanema Palace. Details of the cabinets where the air conditioning was supposed to be installed previously, and of the 15 cm false ceiling being made for its installation (photo by O. Liberal, 2023).

This philosophy mirrored the approach taken with the restoration of Candido Portinari's integrated tile panels. The existing pieces were recovered, and the missing pieces were custom-made. Different historical interventions used distinct tiles, each identifiable by its specific base tile (e.g., thickness, straight or curved edges), creating a documented technical reserve that allows experts to differentiate between original and reproduced elements. The structural system of the immense steel window frames and the *brise-soleils* was another critical point (Figure 4). Despite their colossal dimensions, all movement was managed by an advanced counterweight system, which was restored to full function. Although aluminium substitution had been considered for decades, the decision to restore the steel-framed windows prevailed, justified by their durability and, crucially, their originality. But the most complex dilemma, unanimously highlighted by interviewees and extensively documented in the process, was integrating an active climate control system. An old requirement, driven by changing microclimates in Rio de Janeiro's centre and the impracticality of manually operating the building's heavy, counterweighted windows for cross-ventilation<sup>16</sup>. The initial 2012 project proposed a VRF (variable refrigerant flow) split system, which posed significant problems: irreversible alterations to historic timber cupboards to house units and pumps, impractical floor-embedded piping that would alter floor levels, and future maintenance issues (Figure 2)<sup>17</sup>. Consequently, the 2019 project scope included seeking a new solution. A consensus proved elusive until 2023, with most options involving visible equipment that would cause visual pollution. The adoption of a new technology, low-profile cassette evaporators embeddable in a minimal 15 cm false ceiling, was ultimately selected as the least impactful, most reversible, and

maintainable solution. These units were positioned between pillars near the windows, discharging air inward and remaining largely concealed. In addition, each floor operates independently, facilitating choice and emphasising a hybrid system. This prioritises the building's original passive climate control strategies (cross-ventilation, solar shading blinds) supplemented by active cooling primarily in summer months, aiming for energy efficiency, thermal comfort, and system longevity.

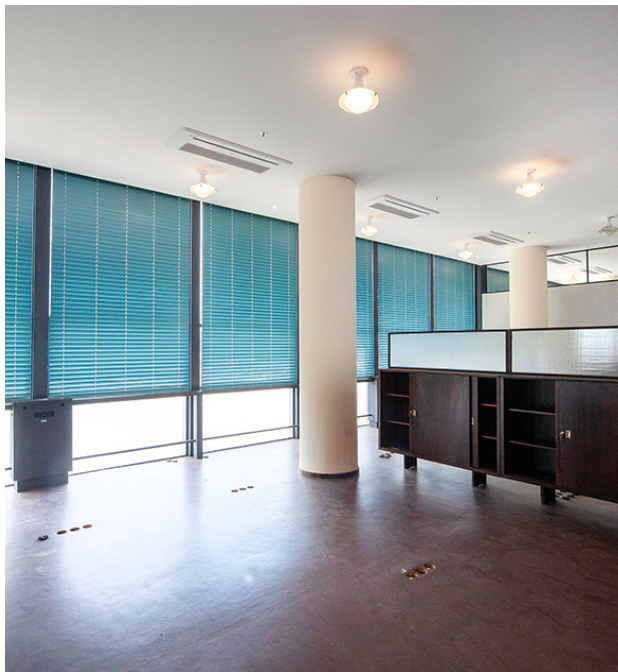
Fig. 3 Rio de Janeiro, Gustavo Capanema Palace. The south façade and its blue blinds. Details of the air conditioning already installed between the pillars and the linoleum flooring (photo by O. Liberal, 2025).

A quintessential challenge of modern heritage is replacing obsolete industrial materials. The extensive linoleum flooring was severely deteriorated. While tests proved modern vinyl's superior resistance and durability<sup>12</sup>, the maintenance of linoleum prevailed (Figure 3). Since the 1970s, during earlier intervention attempts, the architect Lúcio Costa emphatically opposed replacement, stating, «while I am here, no one will touch these floors. These signs of time are natural and make them very beautiful»<sup>13</sup>. Consequently, the decision was to maintain the same pavement and new linoleum was commissioned from the original Dutch supplier, accepting higher costs, longer lead times and inferior durability, to preserve authenticity, even though an exact colour match was unattainable. This philosophy extended to other elements. The blinds were custom-made by the original manufacturer but updated with automated operation (Figure 3). As Vidal notes, «material obsolescence is a critical issue in modern heritage: industrial materials lacking continuous production are complex to reproduce, often requiring semi-artisanal, semi-industrial methods for small quantities, sometimes using obsolete machinery»<sup>14</sup>. This was exemplified by the hall's glass brick panel, which had missing and damaged pieces. Originally made from colourless French glass (unavailable in Brazil, where glass has a greenish tint), the decision was made to disassemble the panel, salvage sound original pieces, and have new pieces custom-cast using the clearest available domestic glass. These new pieces were intentionally installed in a distinct tonal range. As architect Paulo Vidal stated, «Will a specialist notice? Yes, and that is good. It is good because they are not the originals»<sup>15</sup>.
