# Roman Construction and Seismic Damage. Insights from the Capitolium of Ostia Antica

Laura Pecchioli

Institut für Kunstgeschichte, Bauforschung und Denkmalpflege,  
Technische Universität Wien, Austria

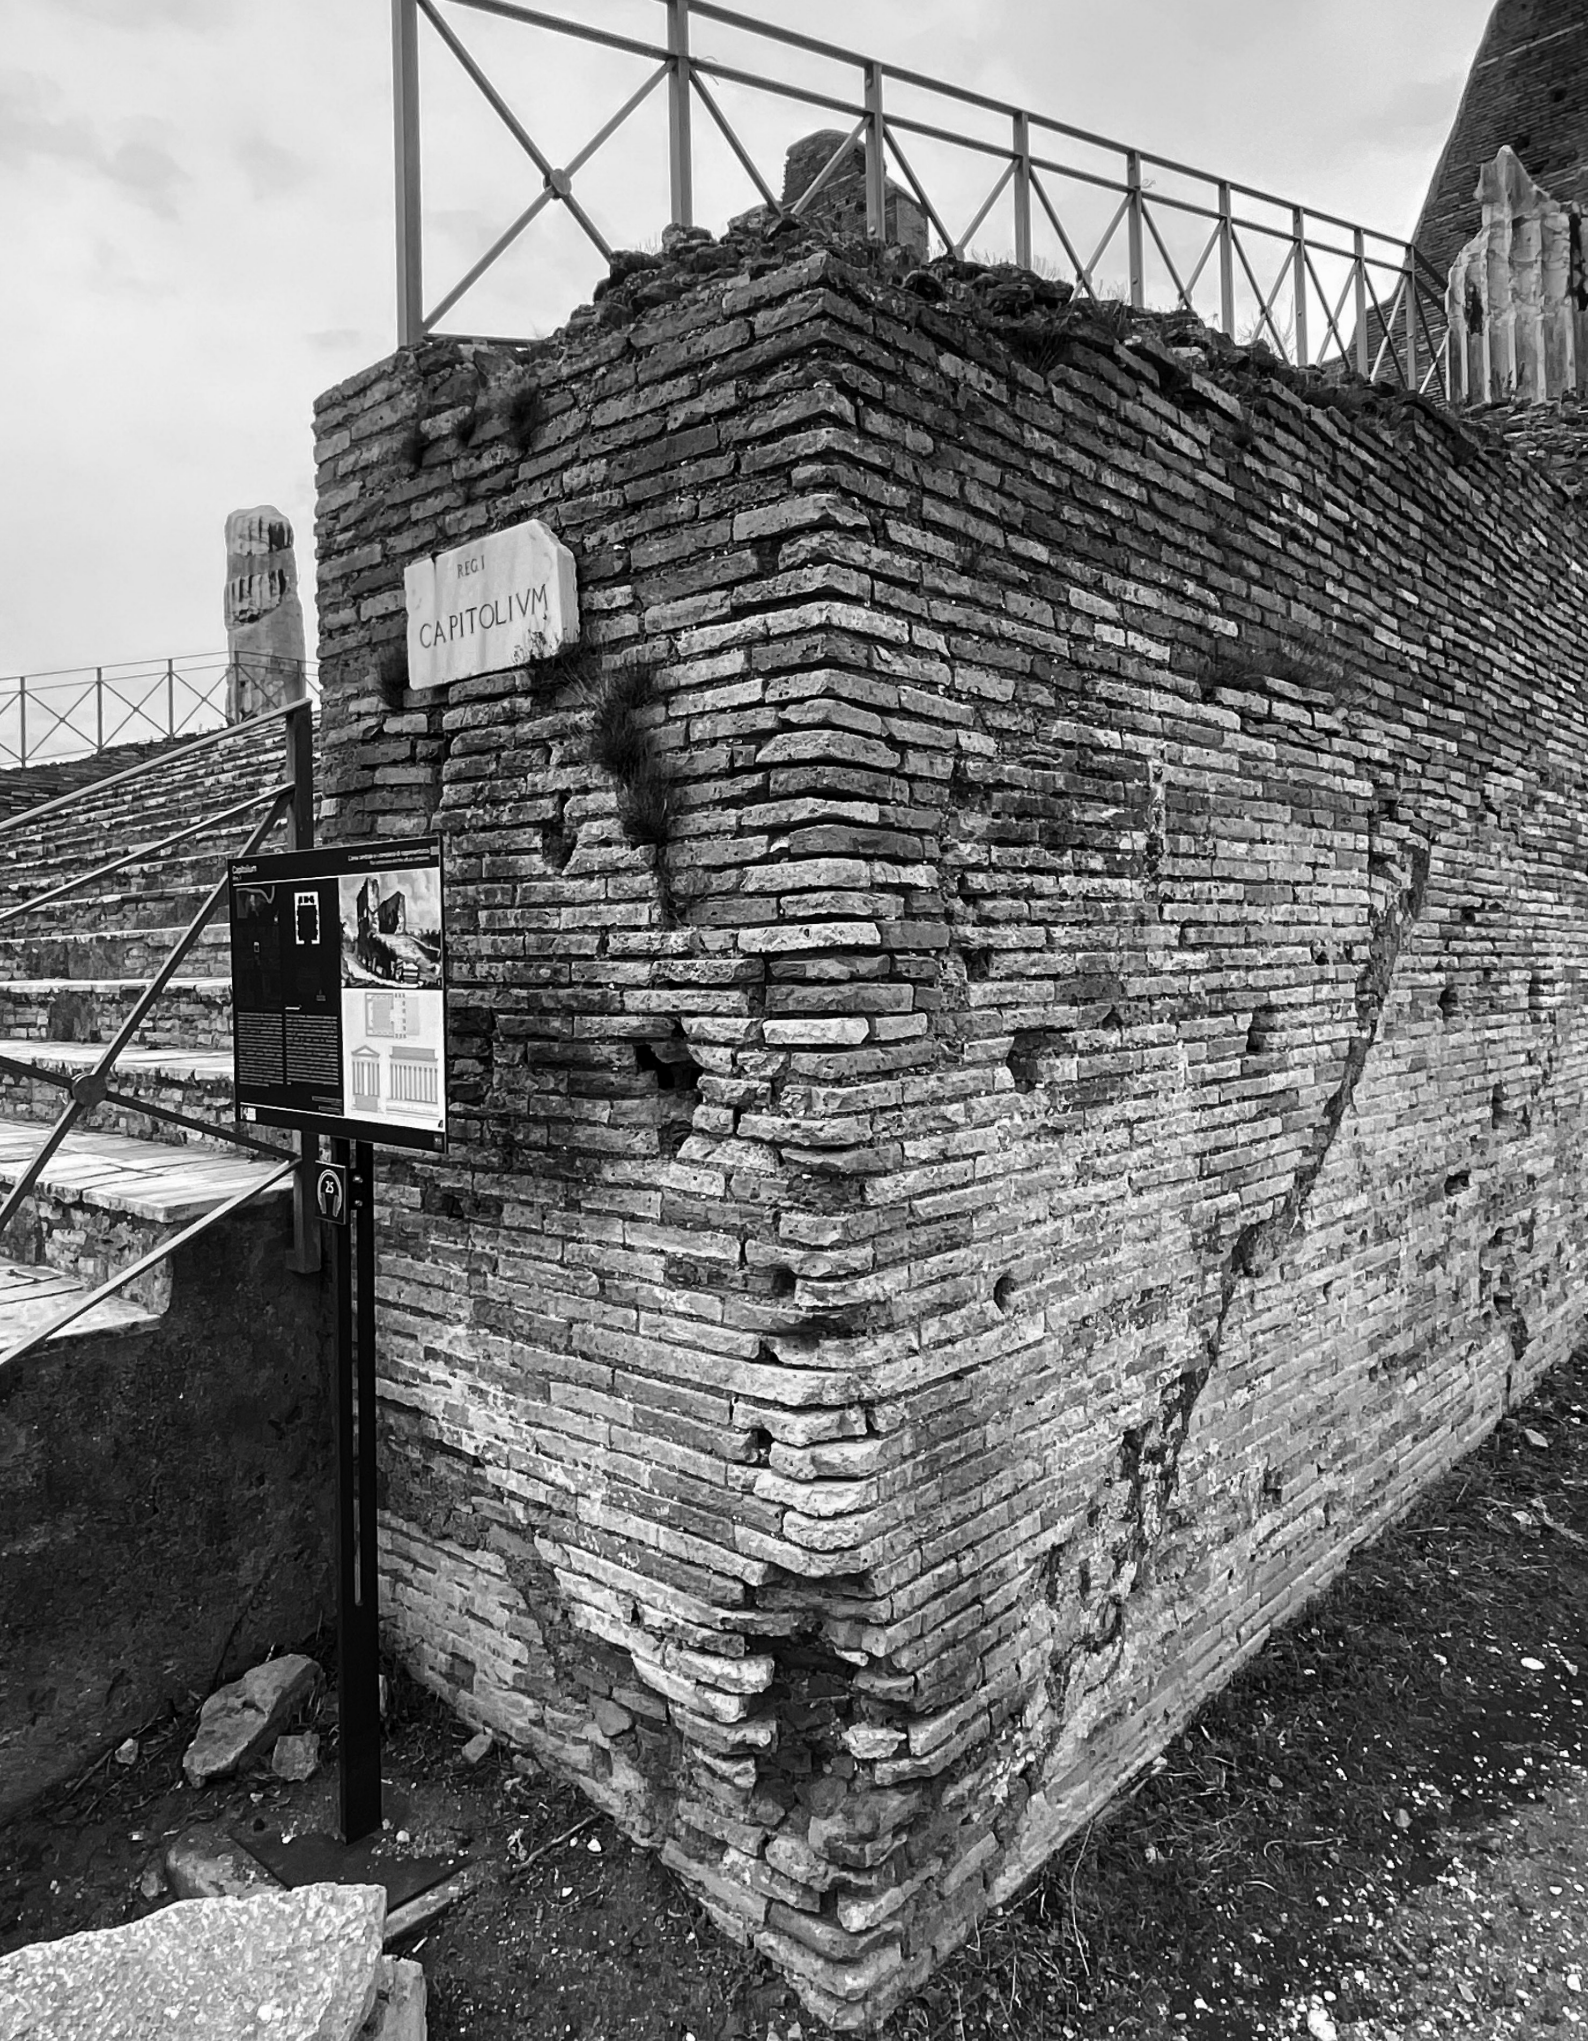
Fig. 1

Ostia Antica Archaeological  
Park. Capitolium, east façade.  
Detail of the eastern buttress,  
2025, (Photo by L. Pecchioli).

Structural mechanics principles, including masonry arch behaviour and the virtual arch model, are employed to reconstruct thrust lines, equilibrium conditions, and collapse mechanisms under horizontal loading. Comparison with experimentally and historically documented masonry failure mechanisms further contributes to distinguishing possible seismic effects from other processes, such as settlement, material fatigue, and environmental deterioration (Cangi, 2005). Within the Fo-rum of Ostia Antica, several monuments exhibit masonry damage patterns that have been interpreted as possible evidence of seismic effects (Pecchioli et al., 2018). These include diagonal fractures, corner cracking, localised detachments, out-of-plane deformations, and rotational and torsional phenomena affecting walls and piers, all of which are commonly associated with seismic loading in masonry struc-tures. Although none of these features can be regarded as individually diagnostic of an earthquake, their recurrence across different buildings provides an important comparative context for the present investigation, whose primary focus remains the Capitoli-um (fig. 1).

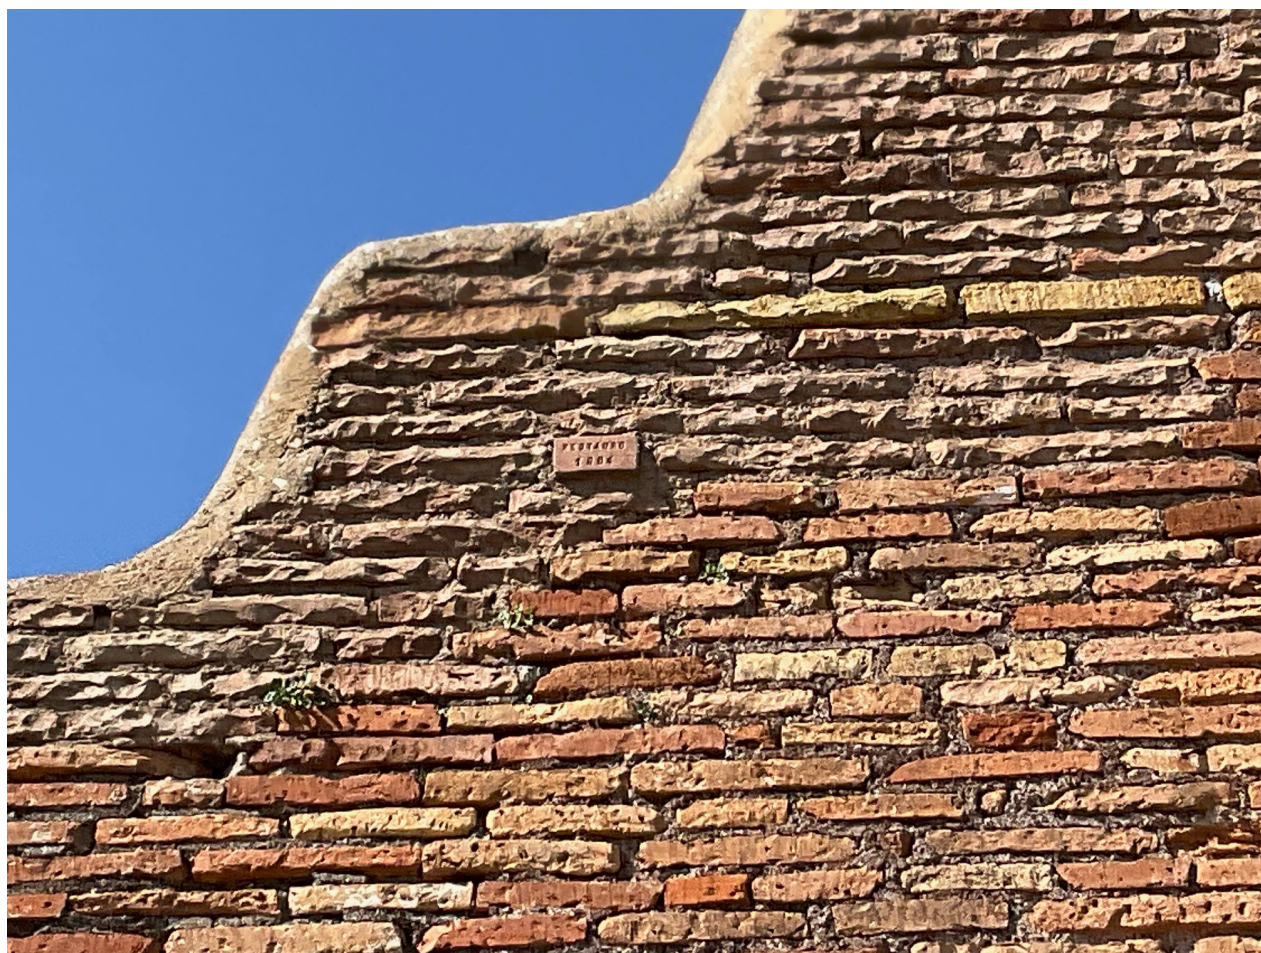
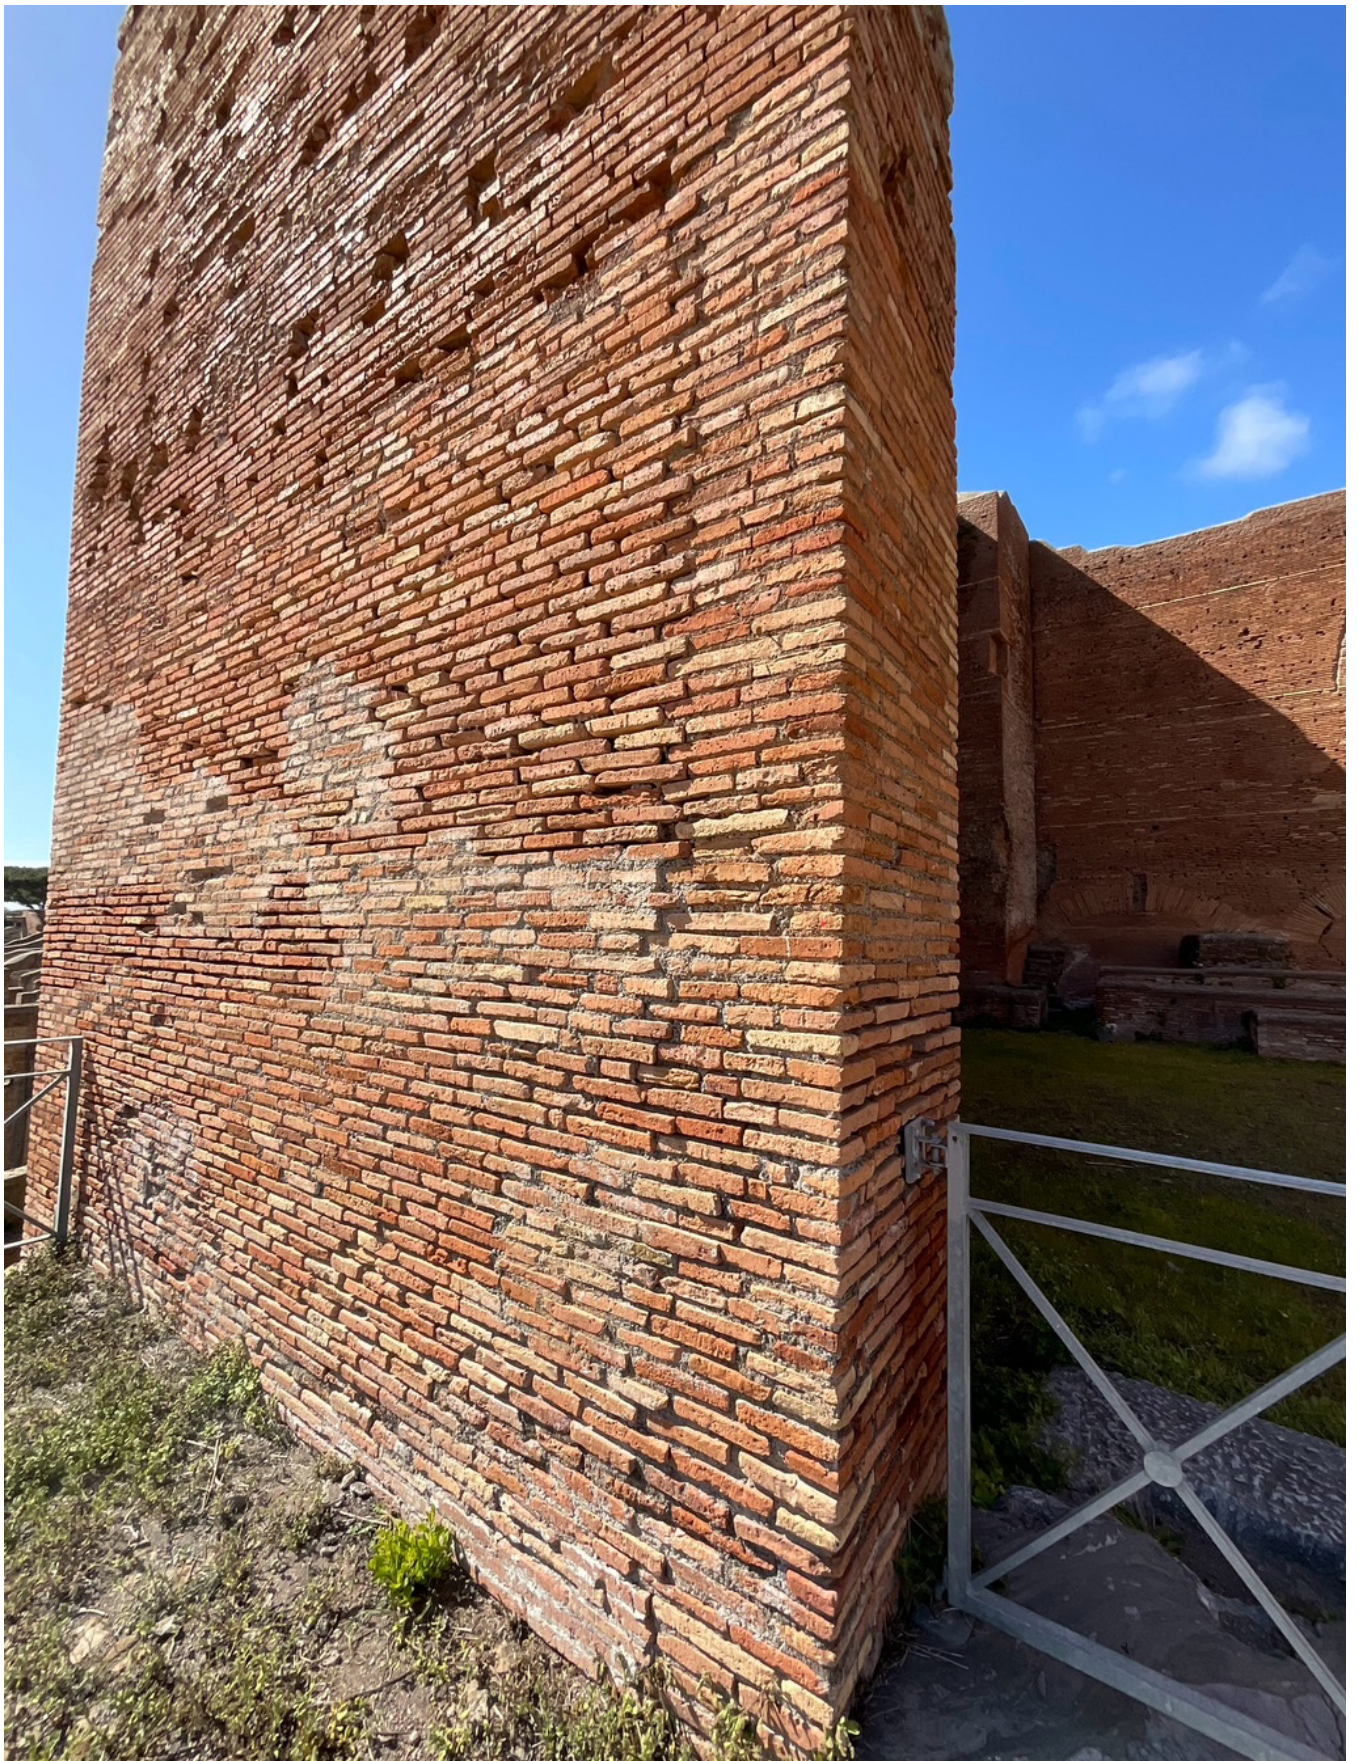
Figg. 3-4  
Details of interventions  
employing a bush-hammered  
surface finish (1964) and  
a sawtooth profile (south  
exterior of the cella), 2025,  
(Photo by L. Pecchioli).

toration techniques appear to rely on mimetic infill strategies, including toothed bonding (addentellato or saw-tooth joints). Another identifiable method is the so-called sottoquadro, visible at the left entrance pier of the cella, where restoration surfaces are deliberately set back from the original face to ensure material legibility and differentiation.

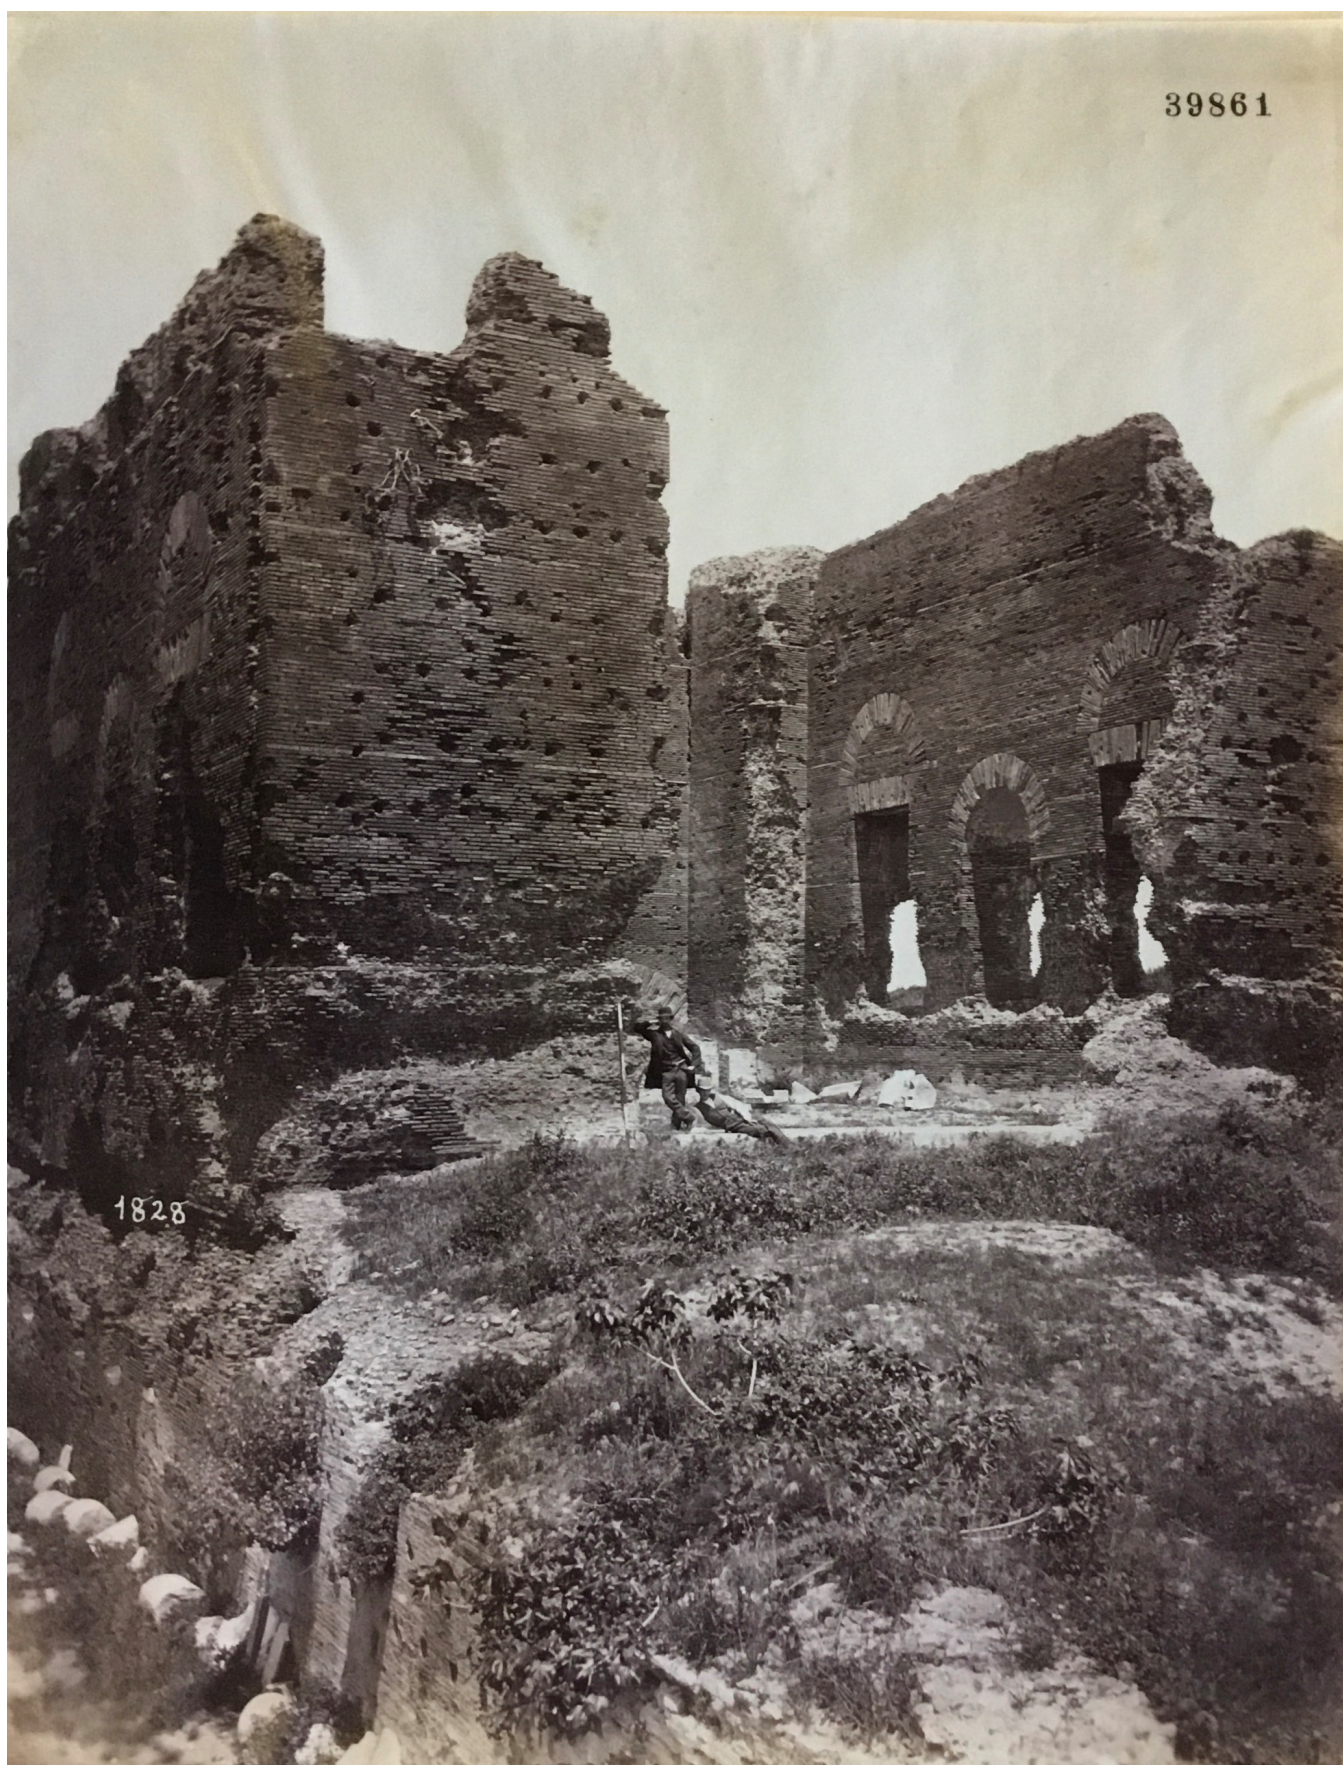
Fig. 5

Capitolium (date as reported in the archival source, 1828): damage to niches and masonry curtain; staircase not yet constructed. Source: Istituto Nazionale di Archeologia e Storia dell'Arte, Fondo Lanciani, colloc. Roma XI, 31, 39861.

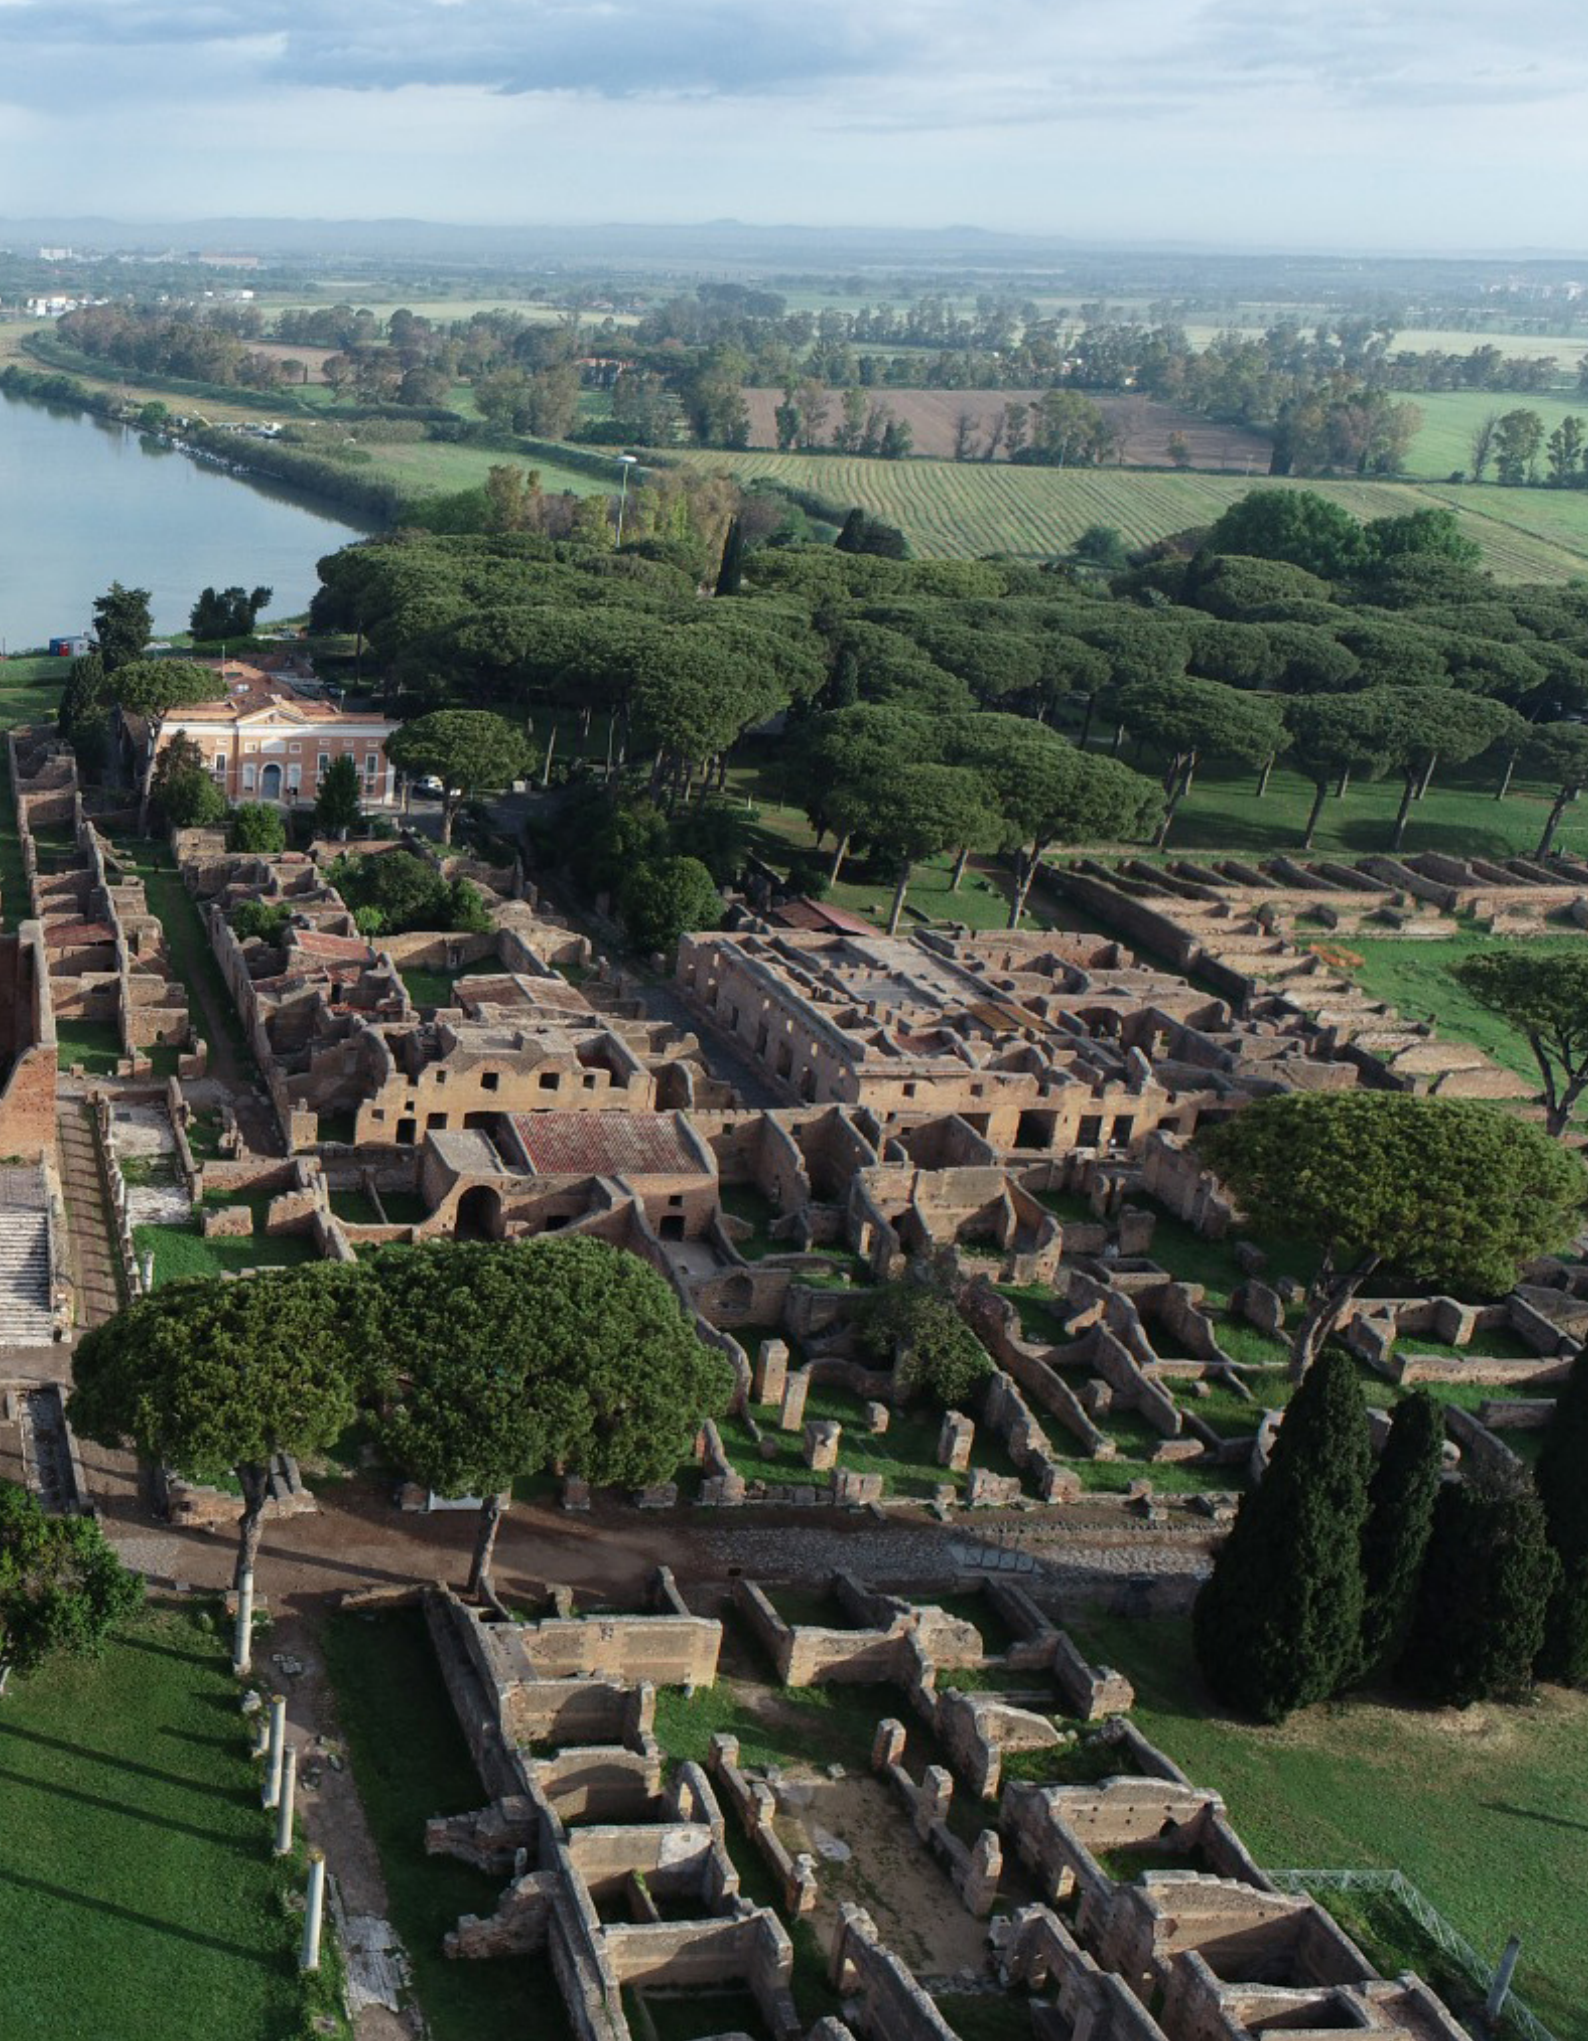
**Fig. 7**

One watercolour by H. Labrouste (1802) illustrating the state of preservation of the Capitulum. Source: Istituto Nazionale di Archeologia e Storia dell'Arte, Fondo Lanciani, colloc. Roma XI, 31, 2025, (Photo by L. Pecchioli).

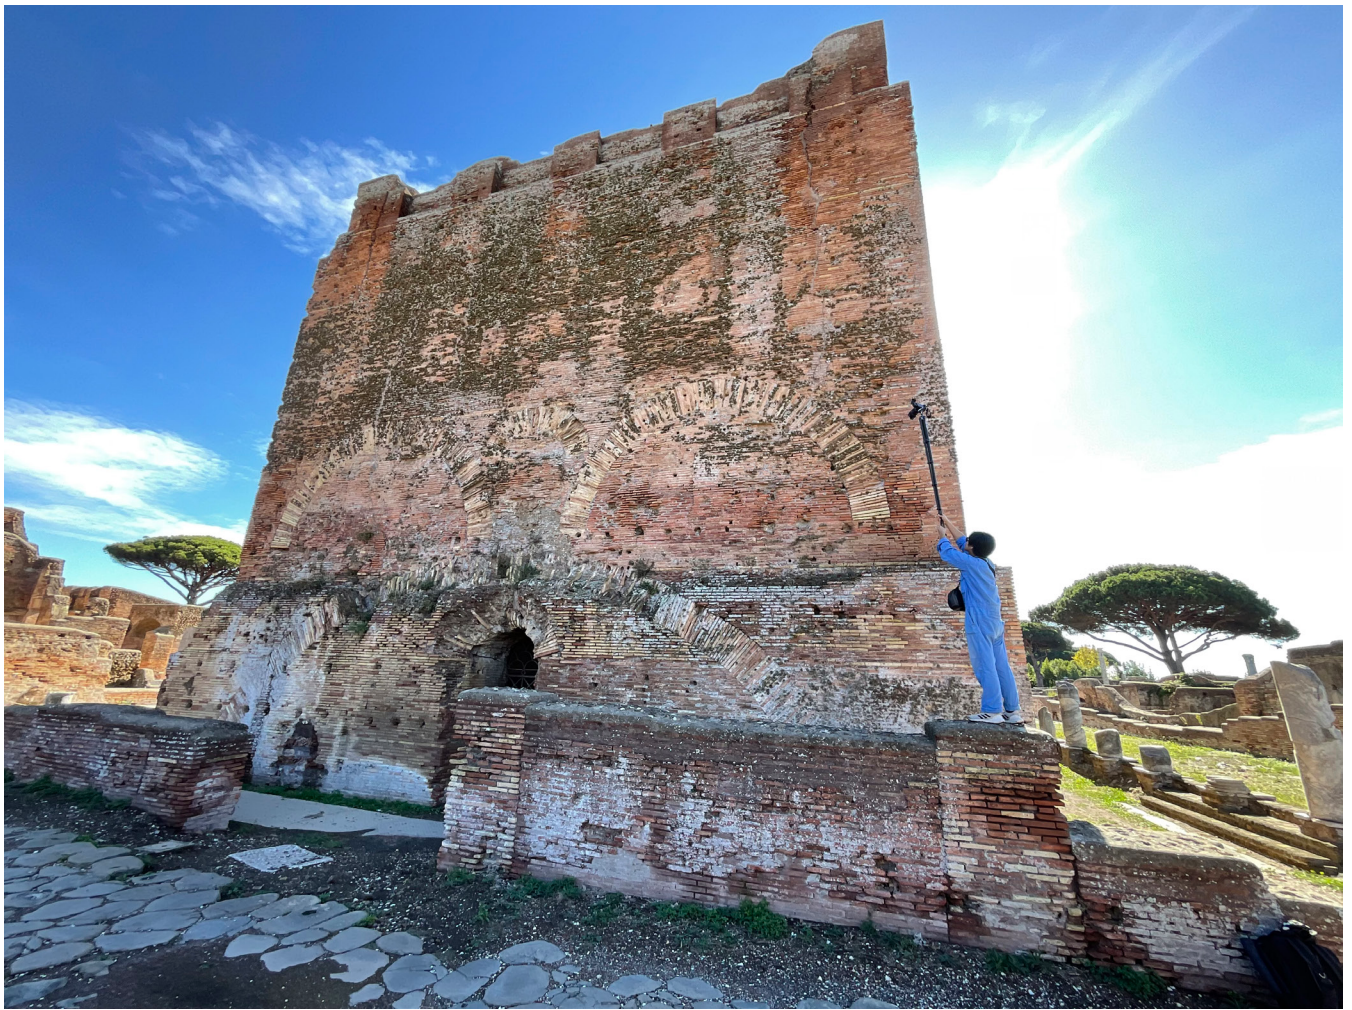
Recent monitoring activities, including environmental surveys and laser scanning (fig. 8), indicate that the groundwater level is located approximately 2.40 m below ground level and that the monument may be affected by long-term soil subsidence phenomena (Hori et al., 2017). Since 2016, the Parco Archeologico di Ostia Antica has implemented a dedicated monitoring strategy for the Capitolium, providing continuous information on its conservation condition and on geometric and morphological variations over time. These data are essential for distinguishing active deformation processes from stabilised damage patterns and for supporting the interpretation of crack evolution. The Forum area, where the Capitolium is located, lies at a slightly higher elevation than the south-western sector of the archaeological site. This difference, together with the heterogeneous characteristics of the alluvial deposits, may influence water circulation and contribute to localised deterioration processes.

Fig. 8  
High-resolution laser  
scanning survey by Kyushu  
University (Takuro Ogawa |  
Yoshiki Hori) for PAOA.

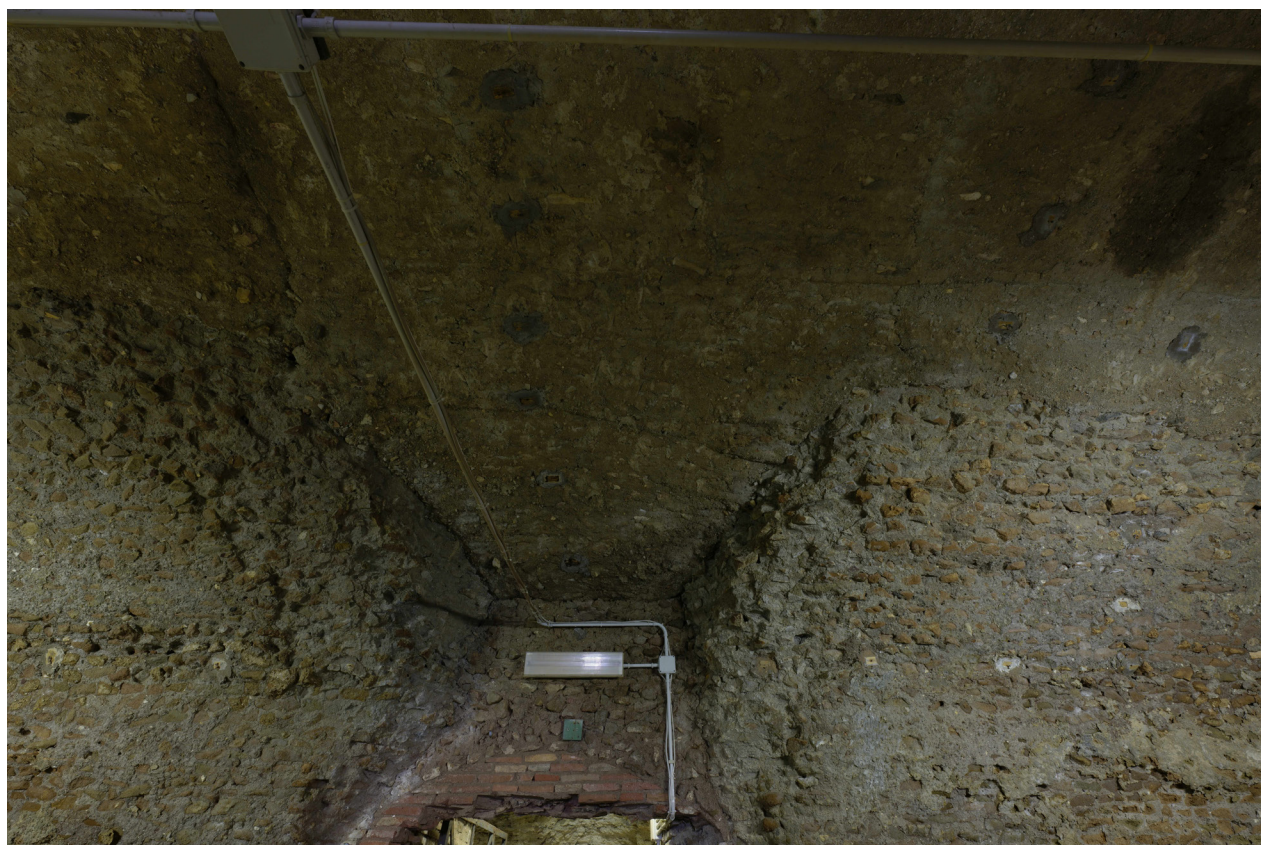
Fig. 9

Shows a close-up of the vault surfaces with different corroded iron cramps attached to wooden elements. These cramps are probably remnants of an old suspended system, potentially used for lighting or storage, rather than for structural support.

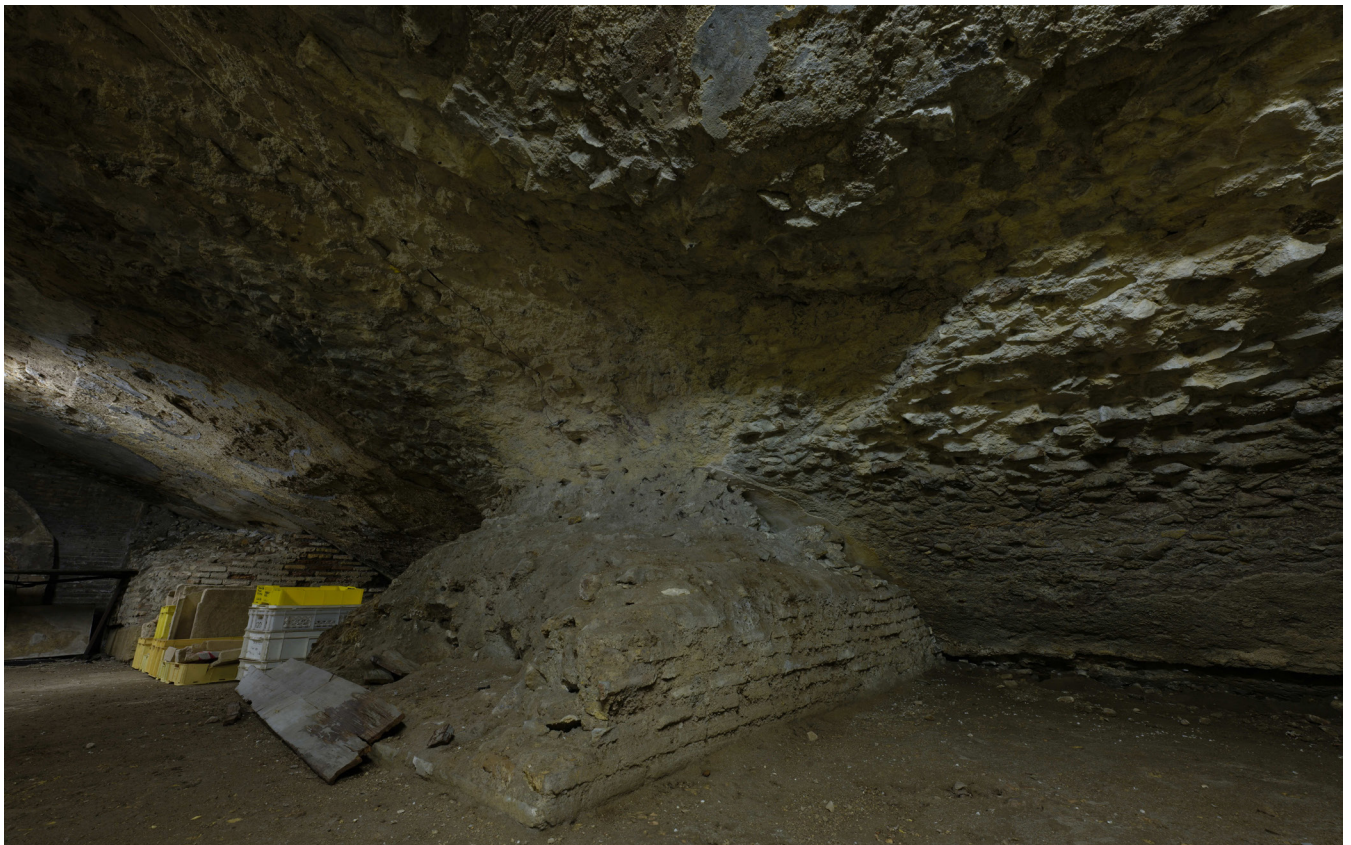
**Fig. 10**  
Room IV, basement below the staircase, with localised masonry structural supports inserted shortly after construction, 2024, (Photo by L. Pecchioli).

Geotechnical and environmental factors are particularly relevant to interpreting the present condition of the structure (fig. 10). Both the Forum area and Regio V are affected by subsidence related to the characteristics of the local subsoil, which consists of heterogeneous alluvial and coastal deposits with variable mechanical behaviour. These conditions may have contributed to differential settlements, foundation deformations, and gradual changes in the equilibrium of the masonry over time.

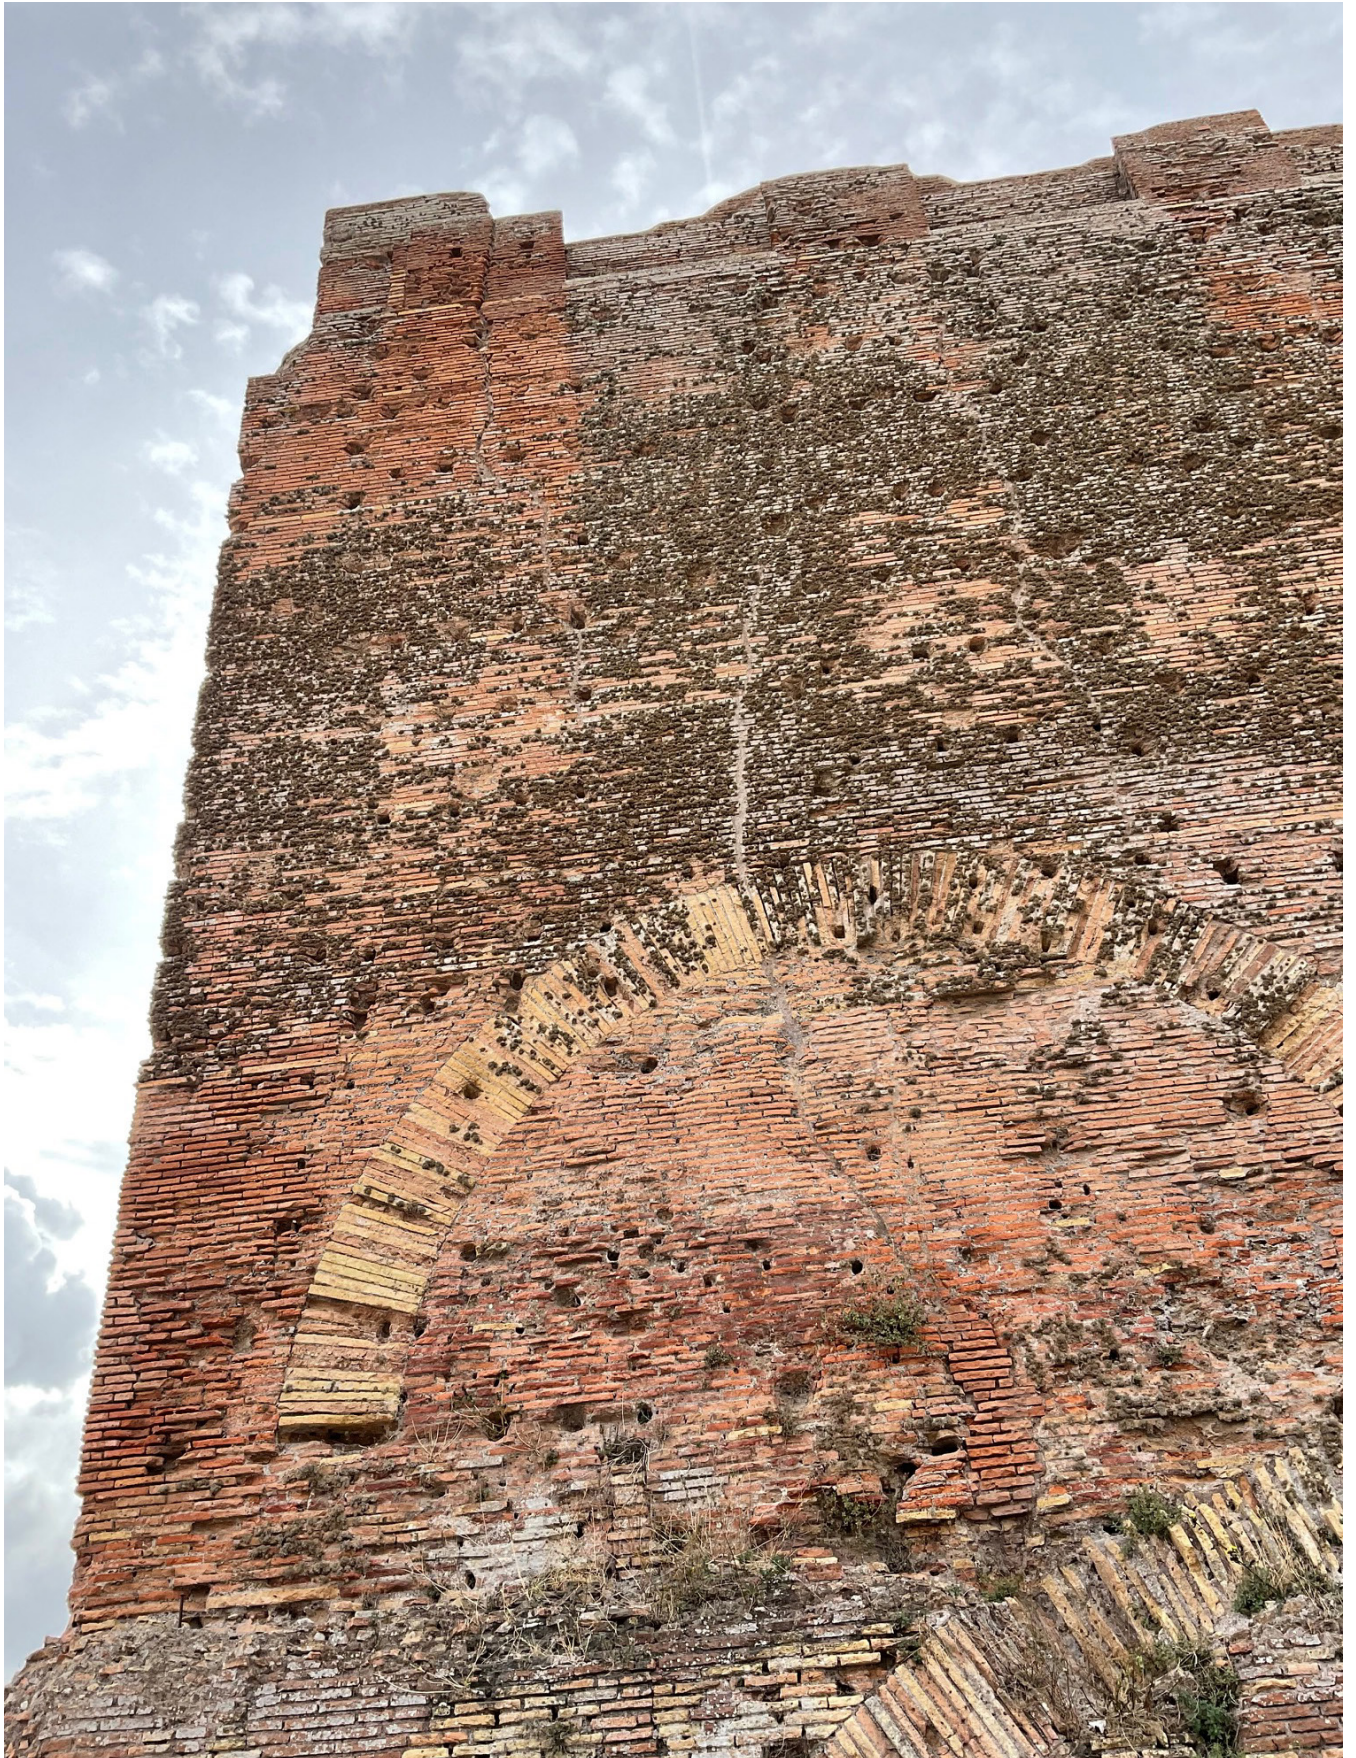
Fig. 11  
North façade corner showing  
structural rotation and crack  
patterns with successive  
repair phases, 2025,  
(Photo by L. Pecchioli).

ticularly within the podium, are therefore evaluated in relation to local structural conditions, foundation behaviour, and ongoing monitoring data rather than directly interpreted as seismic evidence (fig. 11).

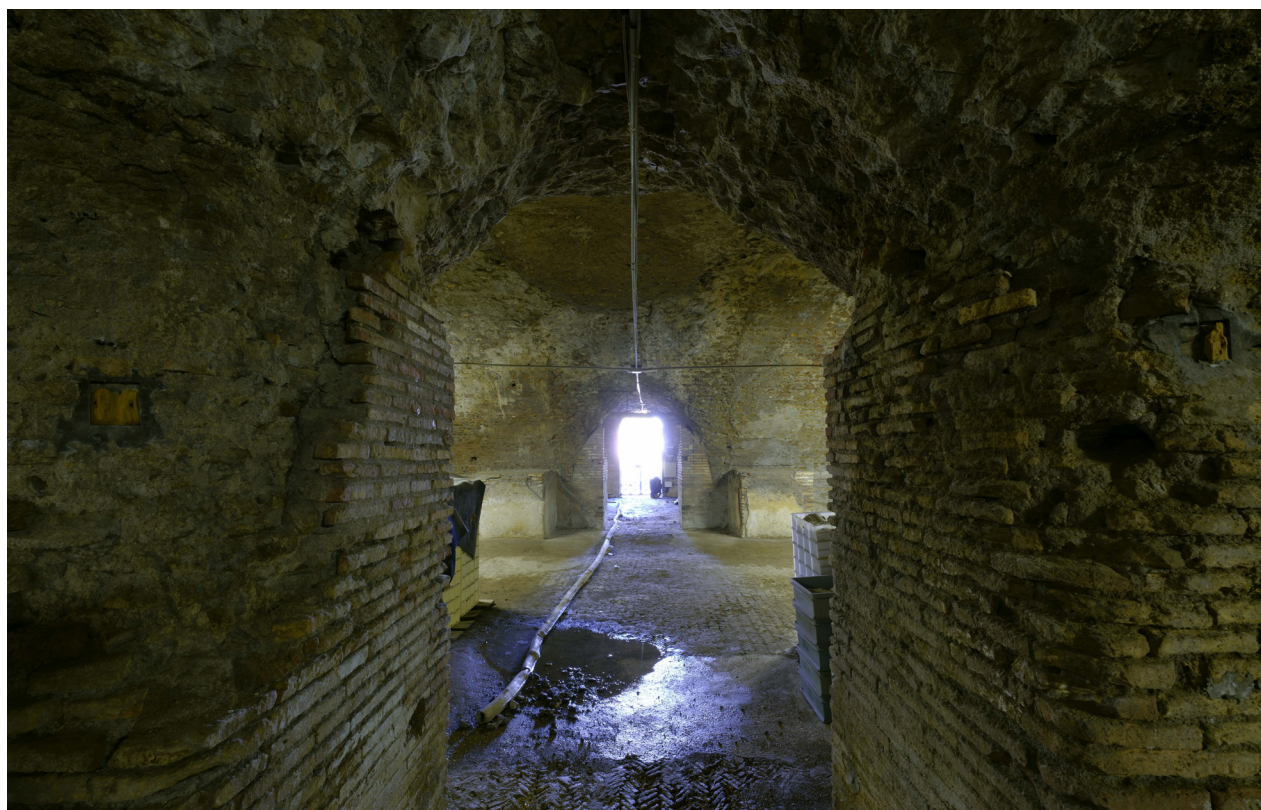
**Fig. 12**  
Photo from the third chamber of the podium, showing the residual traces of the original central reinforcing arches preserved in the second chamber. The image highlights the exceptional quality of the opus caementicium vault construction.

Following current archaeoseismological approaches, seismic hypotheses are assessed using a multi-criteria framework that evaluates the convergence of independent evidence, including stratigraphic relationships, construction phases, repair sequences, environmental conditions, and regional seismic history (Rodríguez-Pascua et al., 2011). At the Capitolium, some observed deformation patterns are compatible with mechanisms associated with seismic loading; however, none can currently be considered diagnostic when analysed in isolation. The absence of a clearly identifiable and synchronised archaeological collapse horizon indicates that the present condition of the monument reflects the interaction of processes developed throughout different chronological phases rather than the consequence of a single catastrophic event (fig. 12).
