# Roman Construction and Seismic Damage. Insights from the Capitolium of Ostia Antica

Laura Pecchioli

Institut für Kunstgeschichte, Bauforschung und Denkmalpflege,  
Technische Universität Wien, Austria

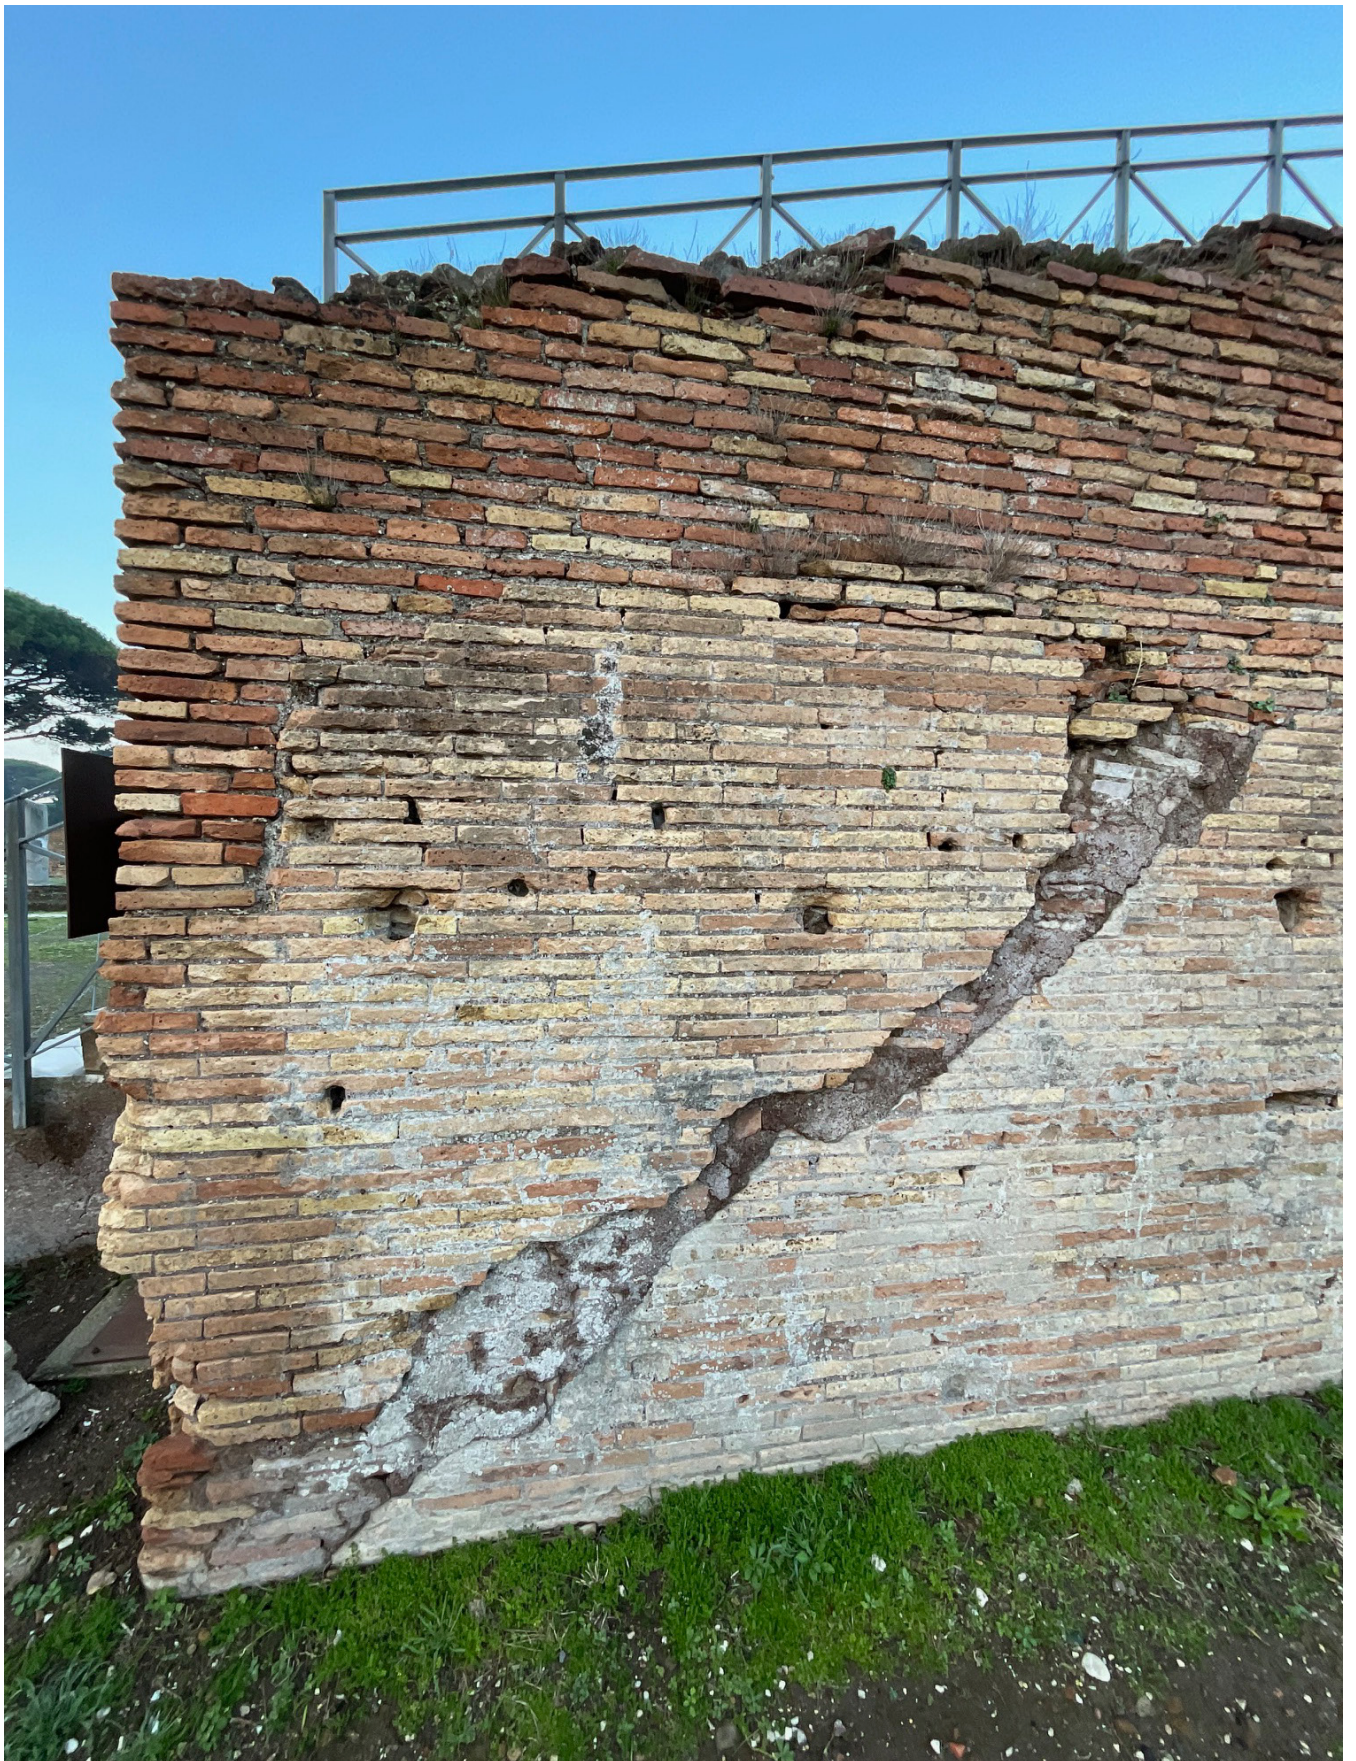
**Fig. 13**  
Detail of the eastern buttress showing an ancient repair of damage potentially related to seismic activity, characterised by rotation and in situ sliding of the upper terminal masonry of the staircase; minor traces of the same mechanism are also visible on the western side, 2025 (Photo by L. Pecchioli).

fig. 8), demonstrate that structural movements had already occurred and were addressed in antiquity. Although these repairs cannot be considered conclusive evidence of seismic damage, they are compatible with deformation mechanisms that may also occur under seismic loading (fig. 13).

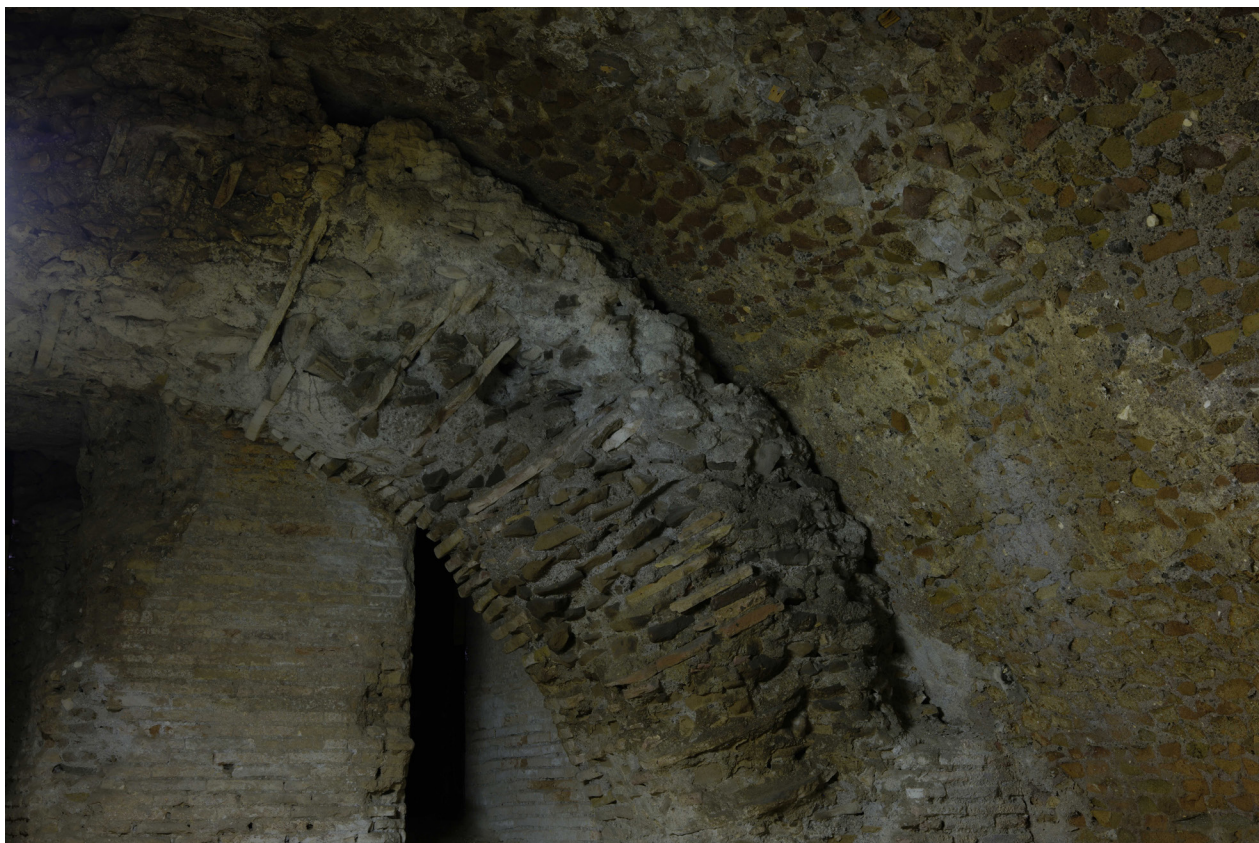
**Fig. 14**  
Post-construction intervention  
involving the insertion of two  
relieving arches (Room 2,  
basement level, eastern side).  
The use of bipedales within  
the opus caementicium is  
clearly visible, along with  
traces of the wooden centring  
(centinatura), 2024-2025  
(Photo by Laura Pecchioli).

tion of material authenticity and the legibility of the monument's successive phases of construction, transformation, and repair (figs. 14-15). The Capitulum should therefore be understood as a structure shaped by continuous modification, in which original construction processes, later interventions, and restoration campaigns are closely interconnected.
