# Reconstruction of Vallaurý's Staircase at the Sanayi-i Nefise Mektebi: A Preservation Approach and the Recovery of Memory

## Abstract

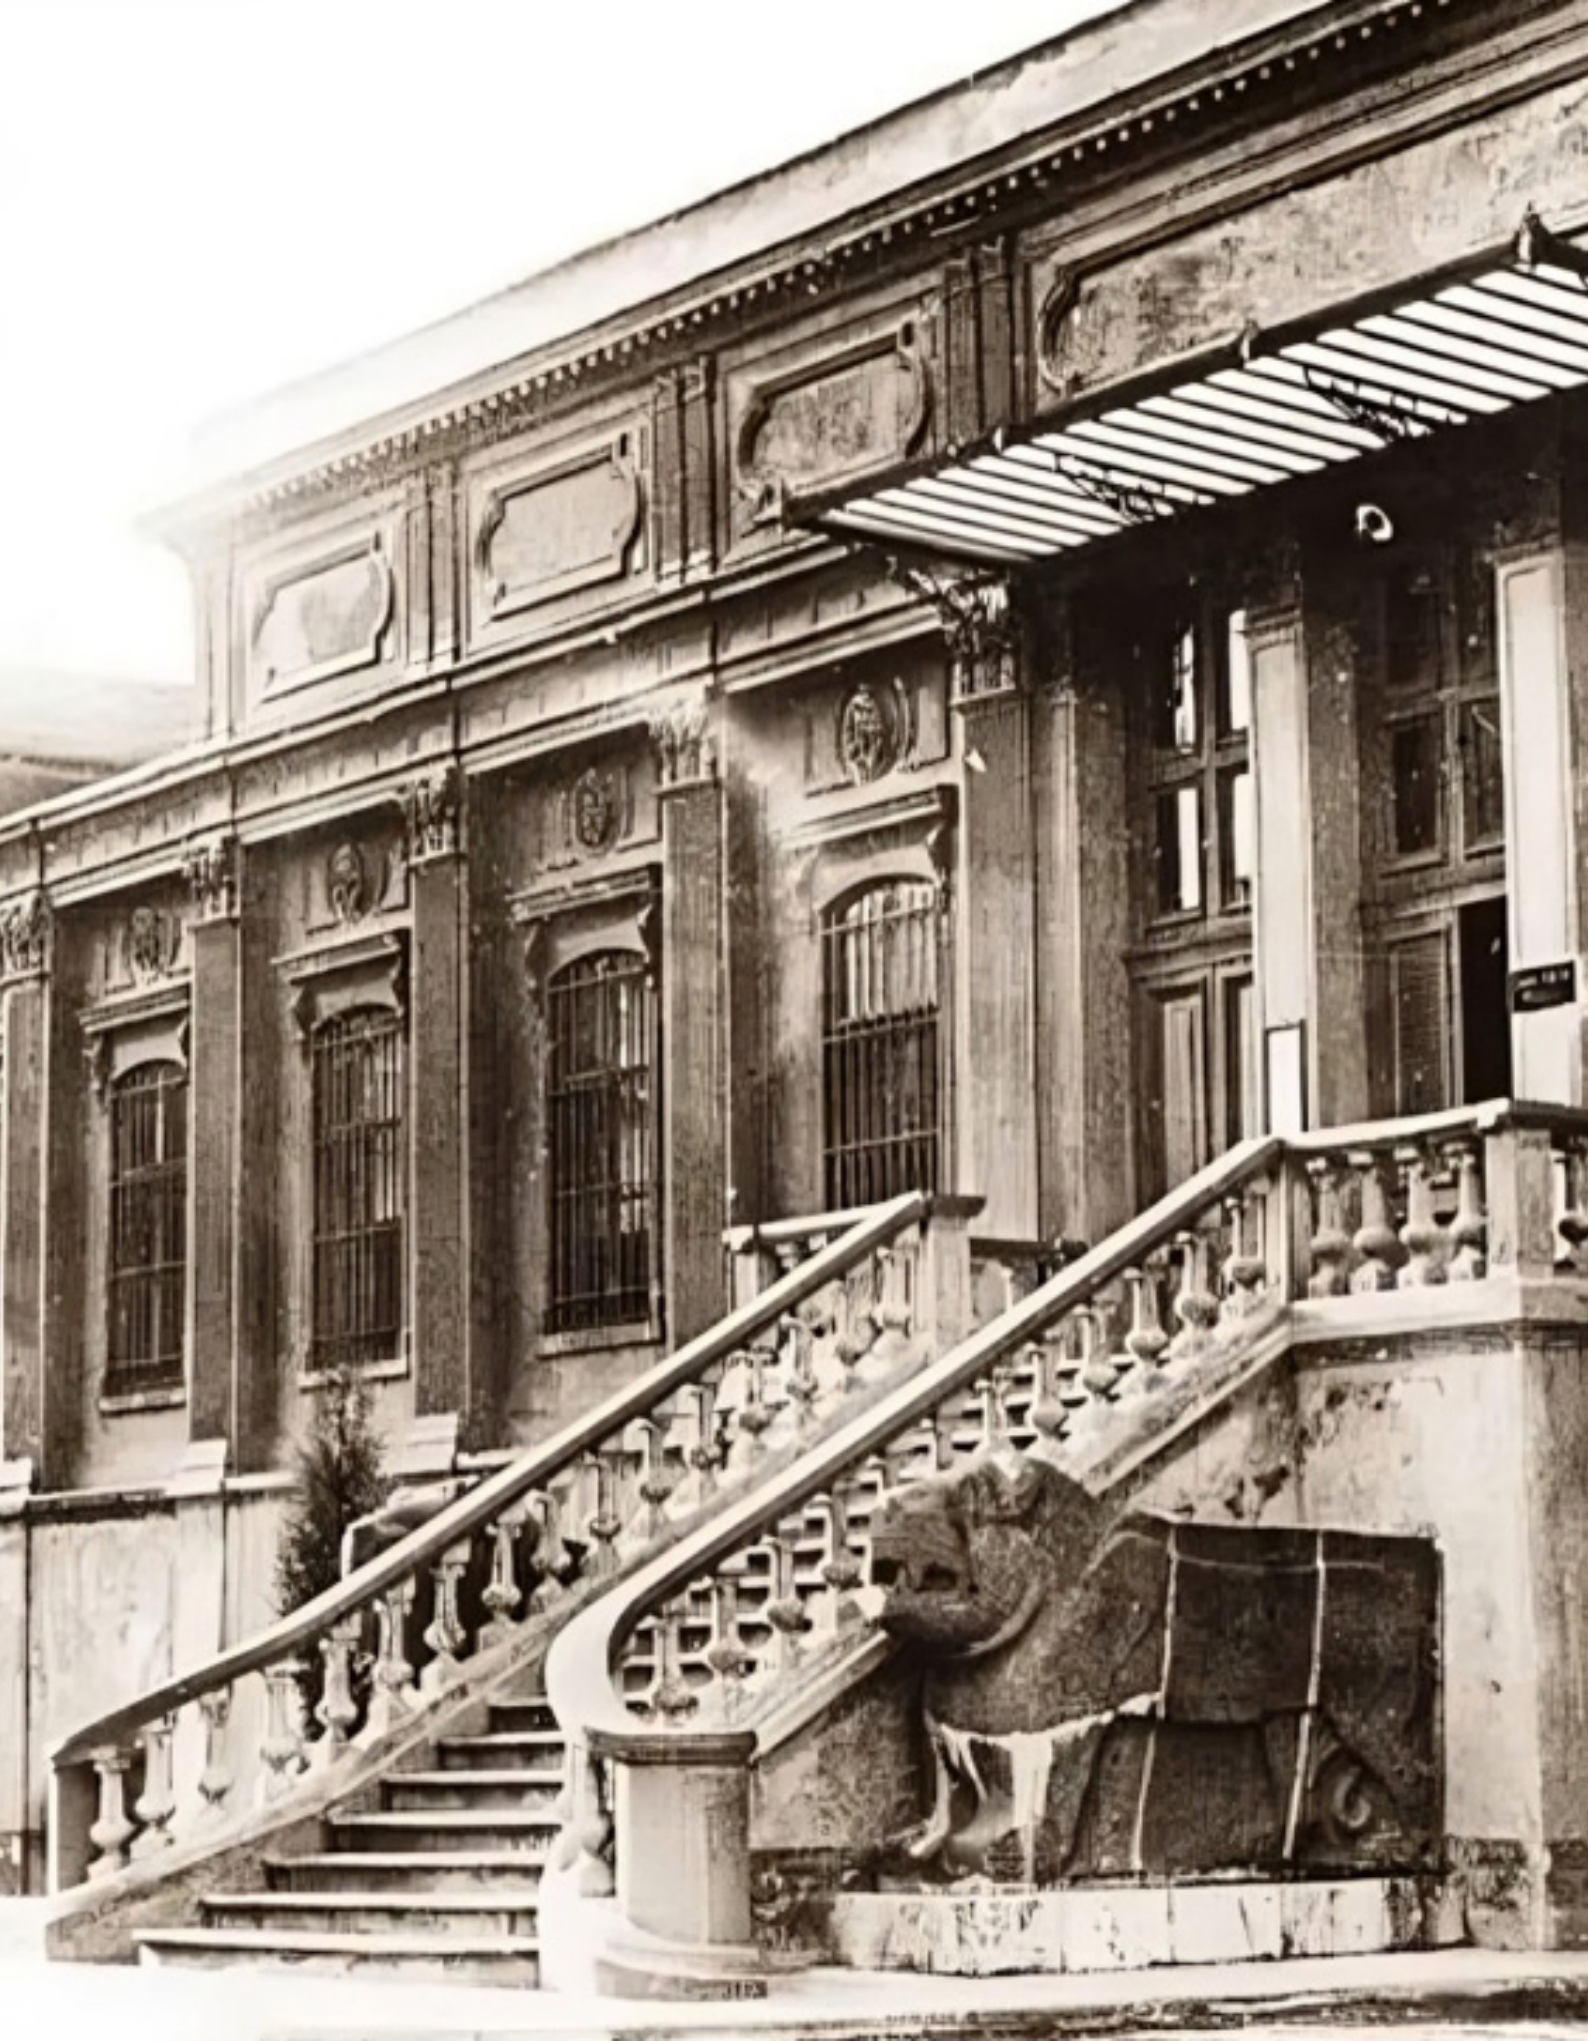
Fig. 1

Original view of the Sanayi-i Nefise Mektebi (today the Museum of the Ancient Orient) with its main entrance staircase designed by Alexandre Vallaurý (Source: Istanbul Archaeological Museums Archive).

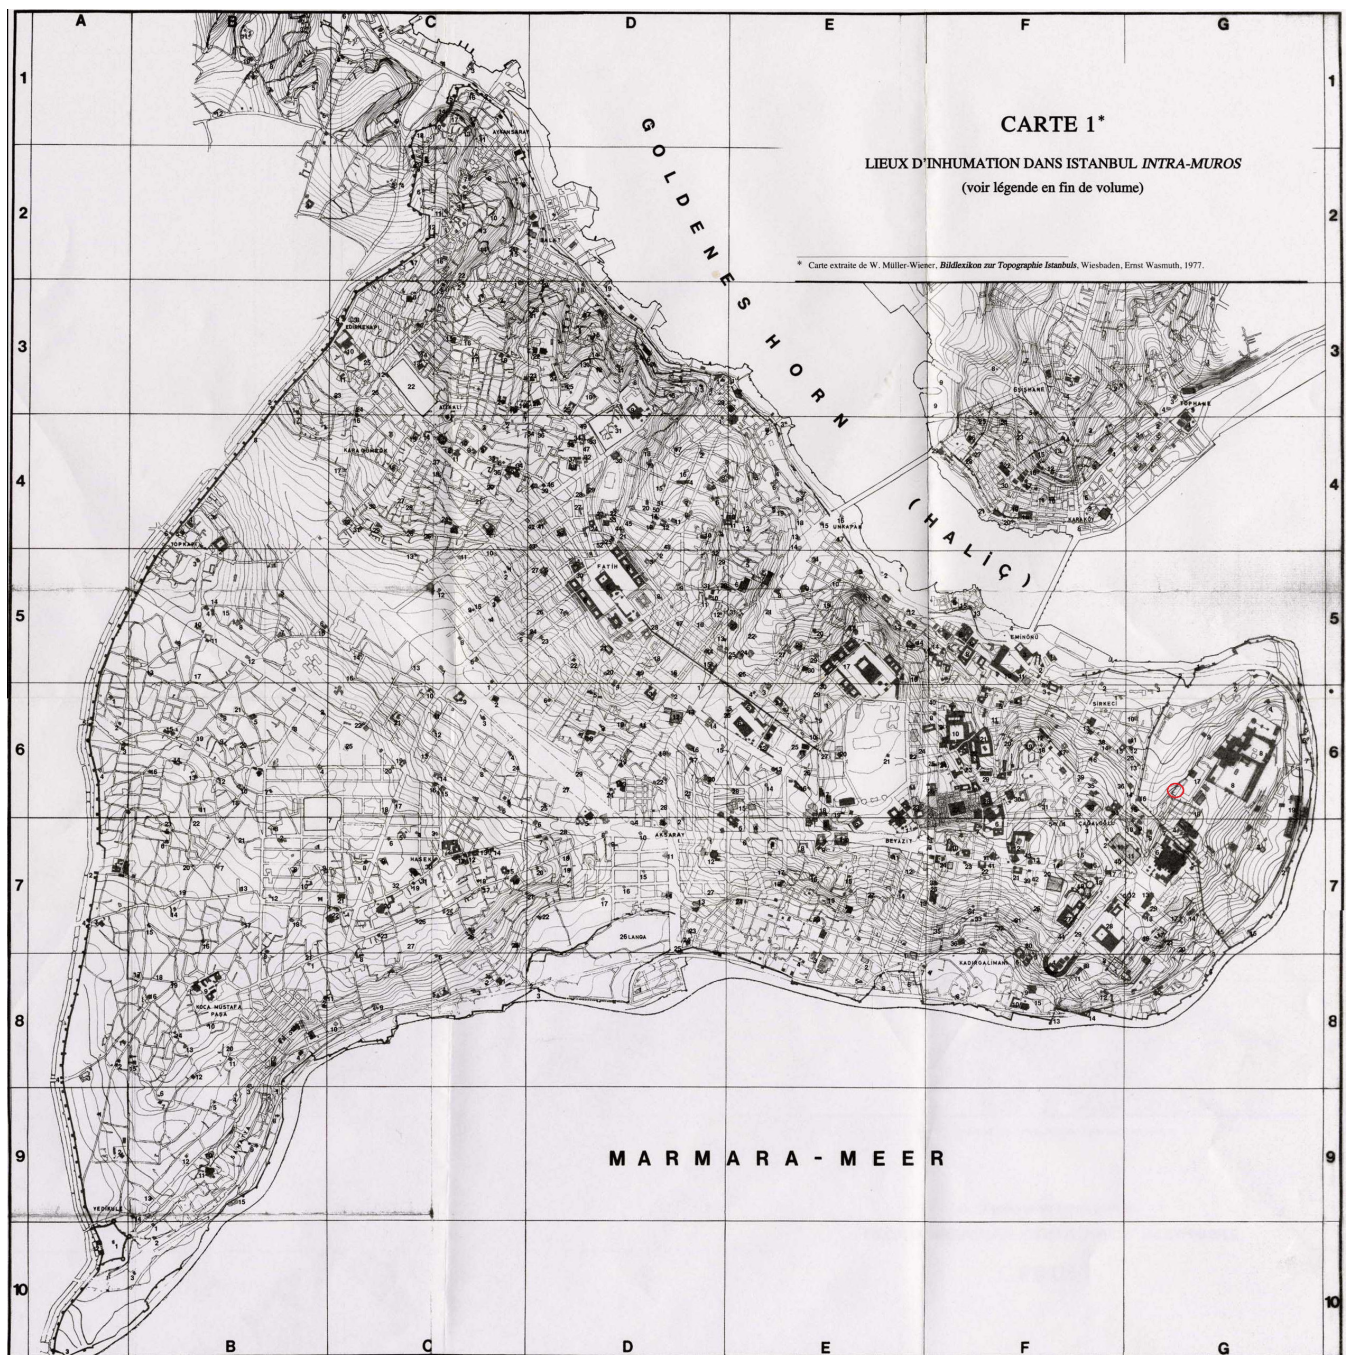
Fig. 2  
Site plan of the historic peninsula of Istanbul showing the location of the Sanayi-i Nefise Mektebi (today the Museum of the Ancient Orient) within the First Courtyard of Topkapı Palace (indicated by the red circle). (Source: Müller-Wiener 1977, SALT Research).

and museological complex of outstanding archaeological and architectural significance (fig. 2). This spatial context is essential to understanding the building's original dialogue with its monumental neighbours and the significance of its subsequent transformation.

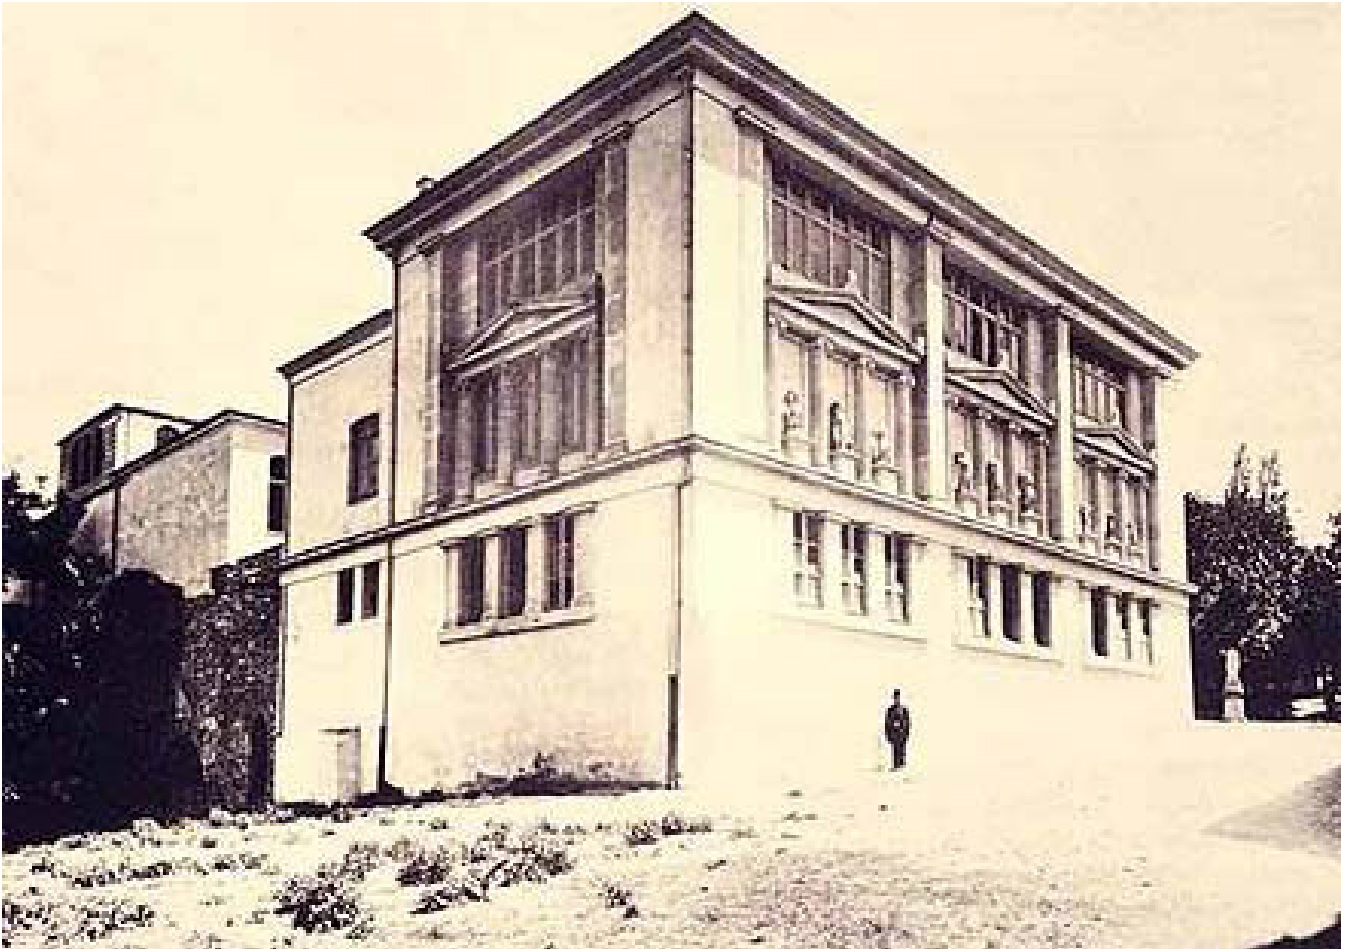
**Fig. 4**  
Original building of the Sanayi-i Nefise Mektebi (today the Museum of the Ancient Orient). View from Osman Hamdi Slope, Eminönü, Gülhane, Istanbul (Source: Istanbul Archaeological Museums Archive).

The original building sits opposite the Archaeological Museums, between Osman Hamdi Bey Slope and the Tiled Pavilion, on Byzantine foundations. It is one of the most elegant Neo-Classical structures of its period (Pasinli, 2017). The rear façade overlooks Gülhane Park. The building is a single-storey masonry structure. Access to the entrance is provided by a high staircase. The staircase was an integral com-

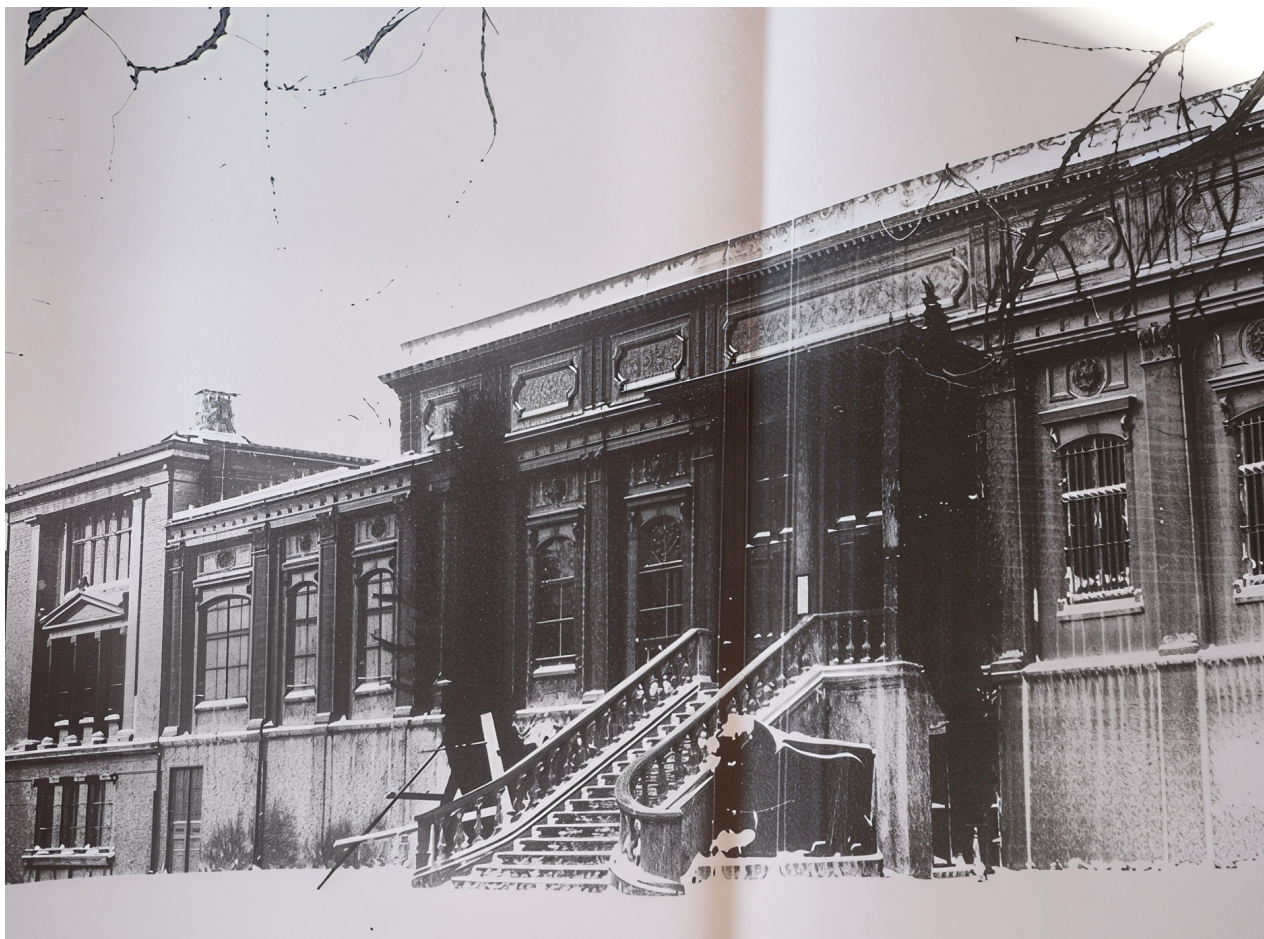
**Fig. 5**  
The Sanayi-i Nefise Mektebi  
building with the extensions  
added in 1892 and 1911 (Source:  
Istanbul Archaeological  
Museums Archive).

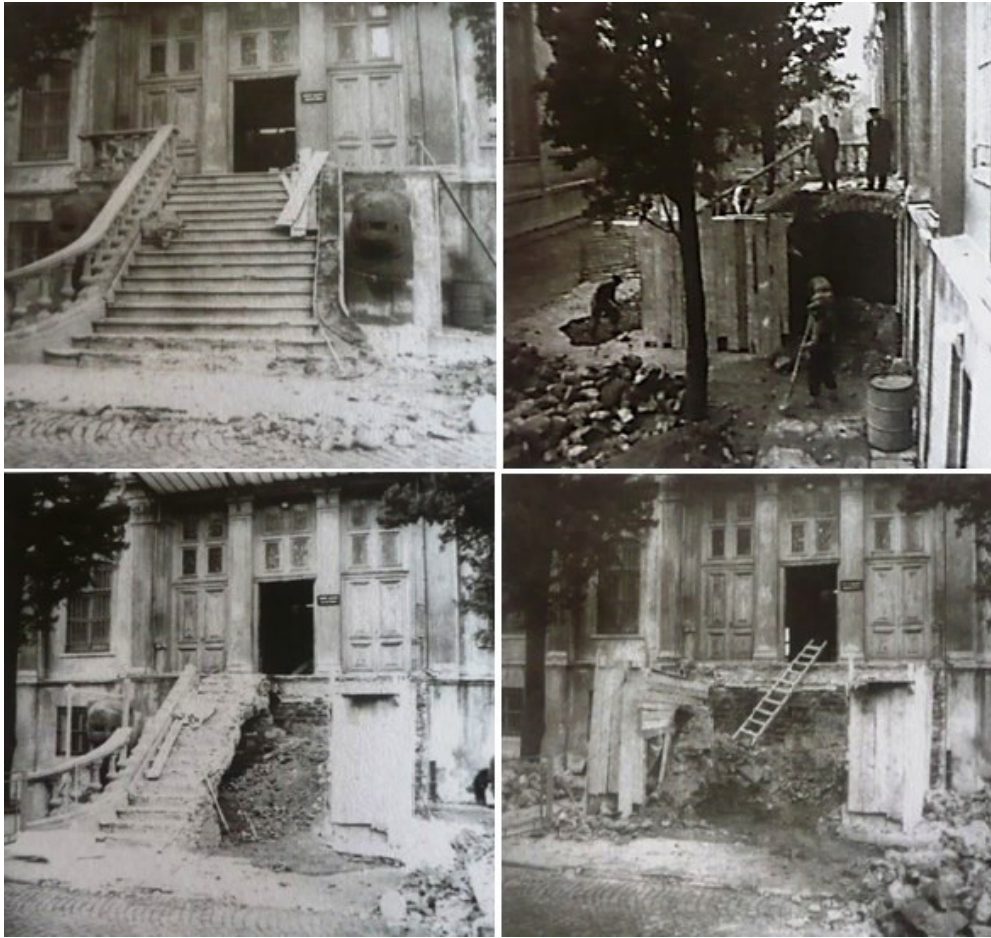
Fig. 6  
Demolition of the original staircase and entrance during the 1963-1974 conversion of the Sanayi-i Nefise Mektebi into the Museum of the Ancient Orient (Source: Istanbul Archaeological Museums Archive, Istanbul Directorate of Surveying and Monuments Archive, Council for the Conservation of Cultural and Natural Property Archive, 1998).

um design philosophy of the period, which prioritised flexible exhibition spaces and unobstructed visitor circulation over the preservation of original architectural features. In this context, the high entrance staircase was removed, access was provided at ground level, and a wide reinforced concrete canopy was built above the entrance. Masonry walls were thinned, and niches were created for display cases (Pasinli, 2017). The project architect for this phase was N. Eldem. The demolition process is documented in figure 6.

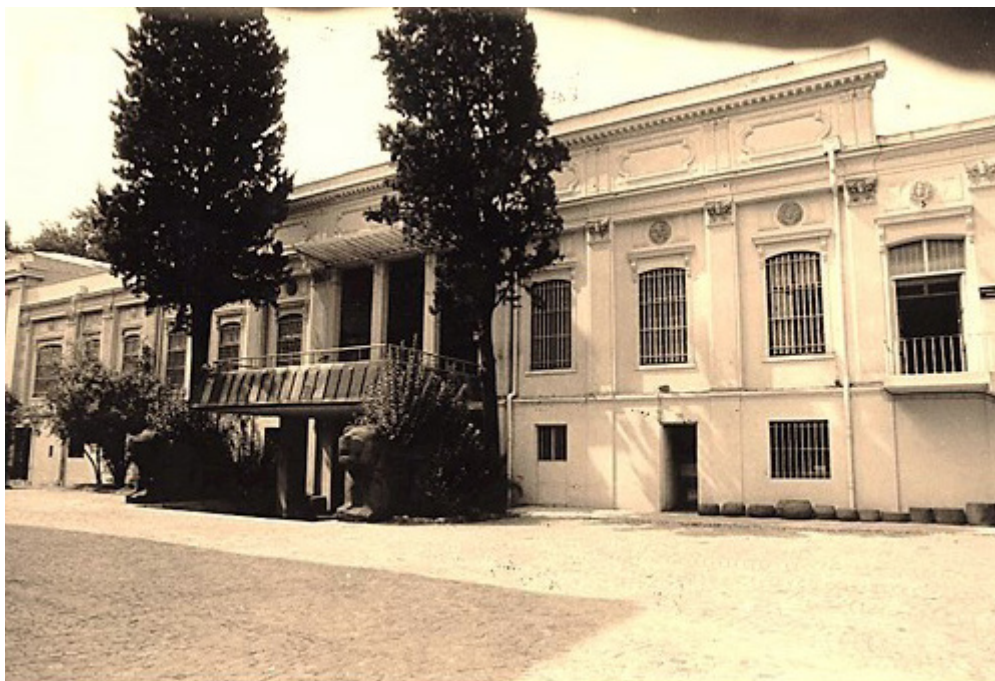
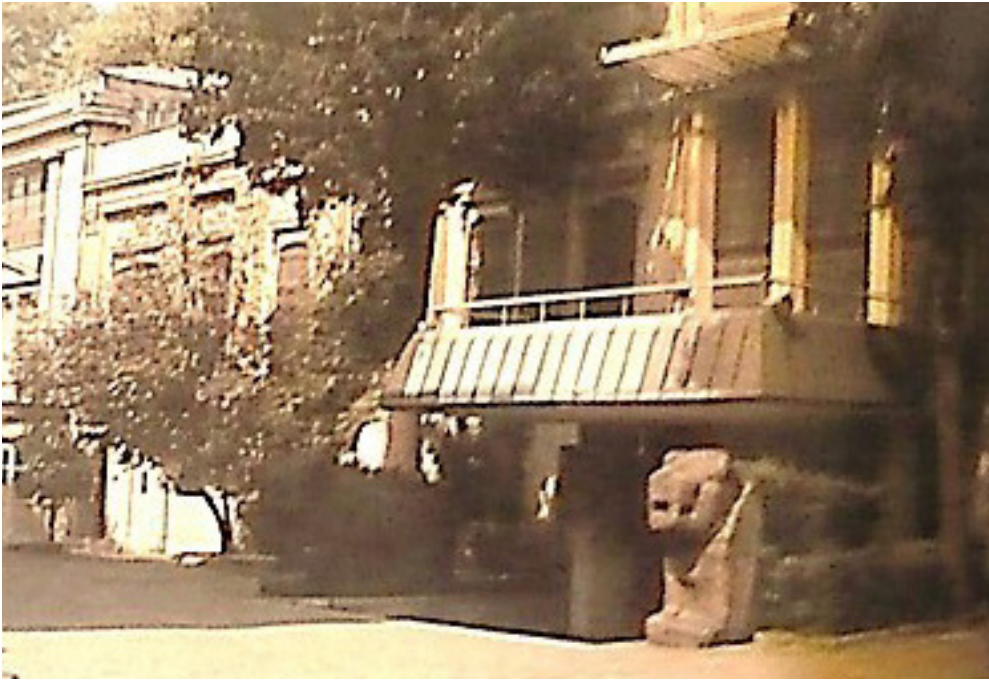
Fig. 7

Reinforced concrete canopy built in place of the original staircase (current page); entrance façade of the Museum of the Ancient Orient during the 1963-1974 period (opposite page) (Source: Istanbul Directorate of Surveying and Monuments Archive; Billur, 2020; SALT Research, Gülhane Collection).

The resulting interventions are shown in figures 7 and 8. Figure 7 displays the reinforced concrete canopy that replaced the staircase, alongside the altered entrance façade. Figure 8 illustrates four major modifications from the same period: roof light wells, the Osman Hamdi Slope façade, the reinforced concrete projection on the Gülhane Park façade, and the exhibition halls.

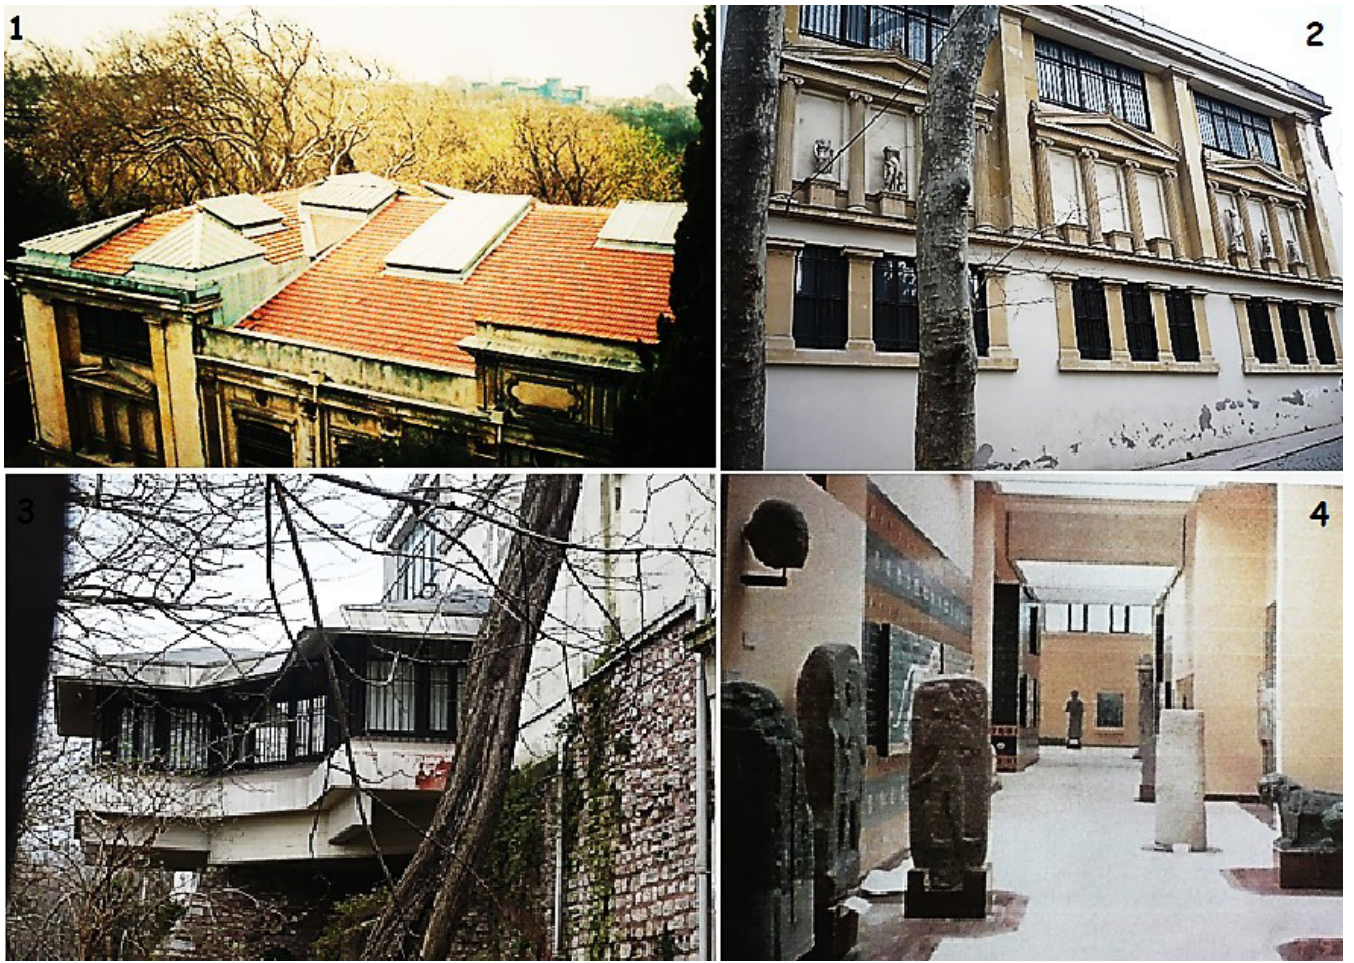
Fig. 8

Interventions during the 1963-1974 conversion: (1) roof light wells, (2) Osman Hamdi Slope façade, (3) reinforced concrete projection on the Gülhane Park façade, (4) exhibition halls (Source: Istanbul Directorate of Surveying and Monuments Archive; Billur, 2020).

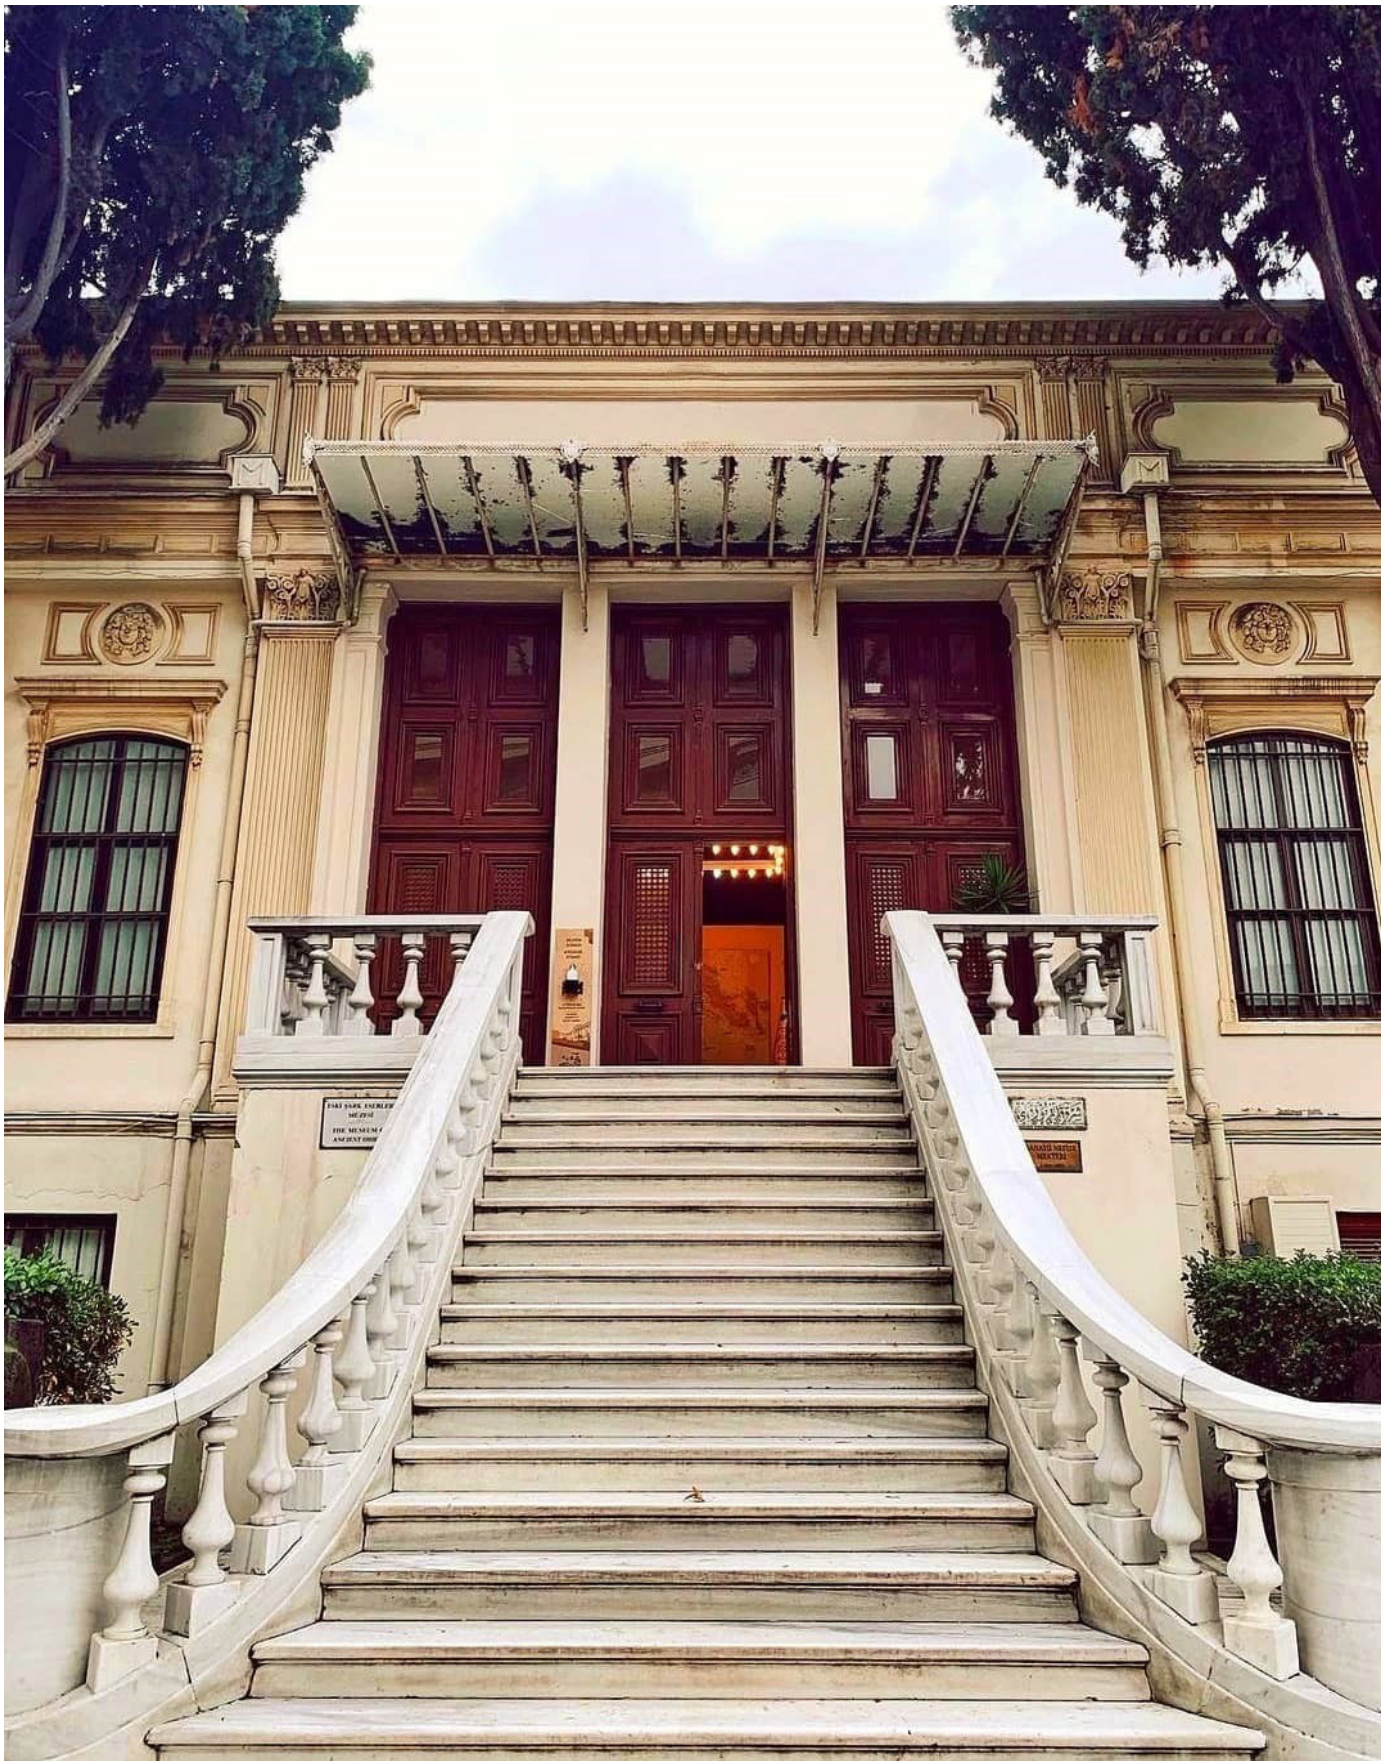
Fig. 10  
Restituted and reconstructed  
entrance staircase of the  
Sanayi-i Nefise Mektebi,  
front view (Source: Turkish  
Museums, 2022).

The completed reconstruction is shown in fig. 10, and a post-restoration view from the museum archive is provided in figure 11.

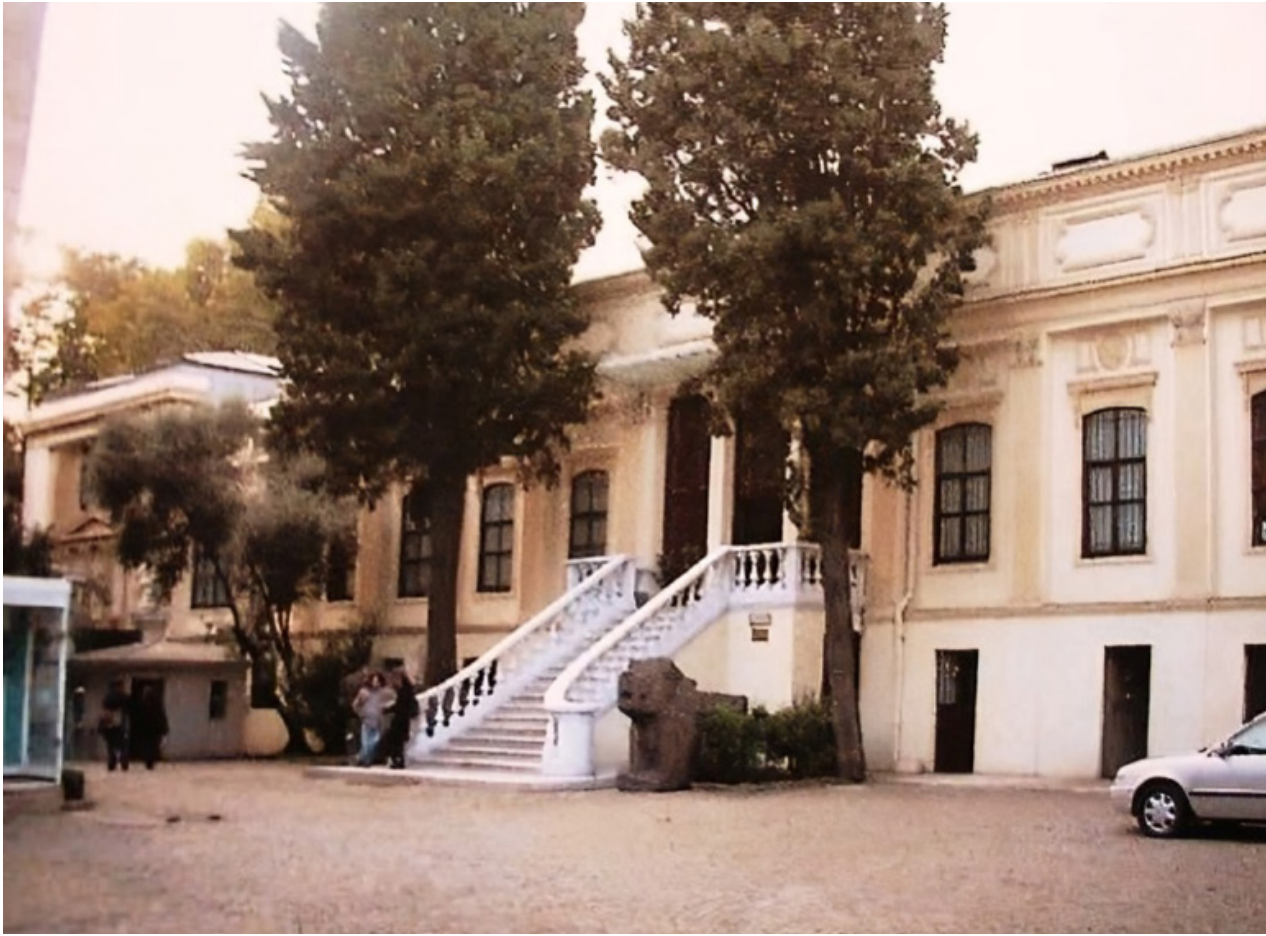
Fig. 11  
Post restoration view of the  
restituted staircase at the  
Museum of the Ancient Orient  
(Source: Istanbul Directorate  
of Surveying and Monuments  
Archive; Billur, 2020).
