Documentation strategies for a non-invasive structural and decay analysis of medieval civil towers: an application on the Clock Tower in Pavia

Sandro Parrinello, Raffaella De Marco, Alessia Miceli

DICAr - Dipartimento di Ingegneria Civile e Architettura, Università degli Studi di Pavia, Italia

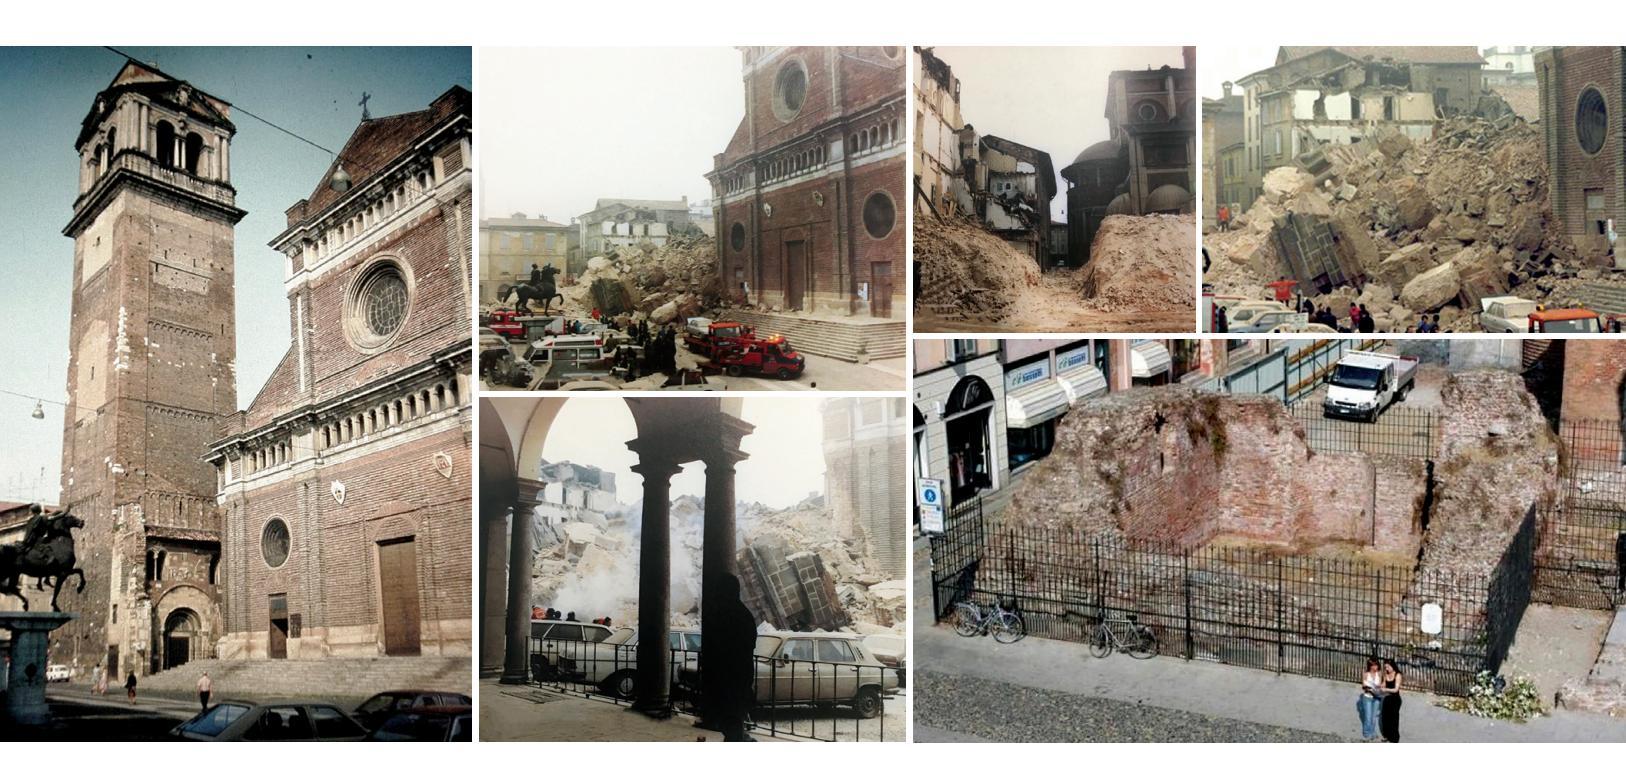
Fig. 4

The medieval Civic Tower of Pavia: before (on the left) and after the collapse in 1989 which also damaged the urban aggregates of the area (Stabile, 1992), until the present ruins near the Cathedral of Pavia (on the right) (Photo Panorama, 17 March 2015). This context has prompted public and administrative interest among the need for a specific knowledge strategy dedicated to the civil towers of Pavia. The monitoring of their overall state of conservation aims to be concentrated on the phenomena of material alteration, oscillation and structural deformation. The goal is to highlight the instability mechanisms already affecting the buildings to guide intervention operations and to reduce the conditions of potential risk within the dense area of the city.
