Digital documentation of the Franciscan Observance architecture in Umbria. Preliminary surveys and analysis for conservation purposes

Stefano Bertocci, Federico Cioli

DiDA Dipartimento di Architettura, Università di Firenze

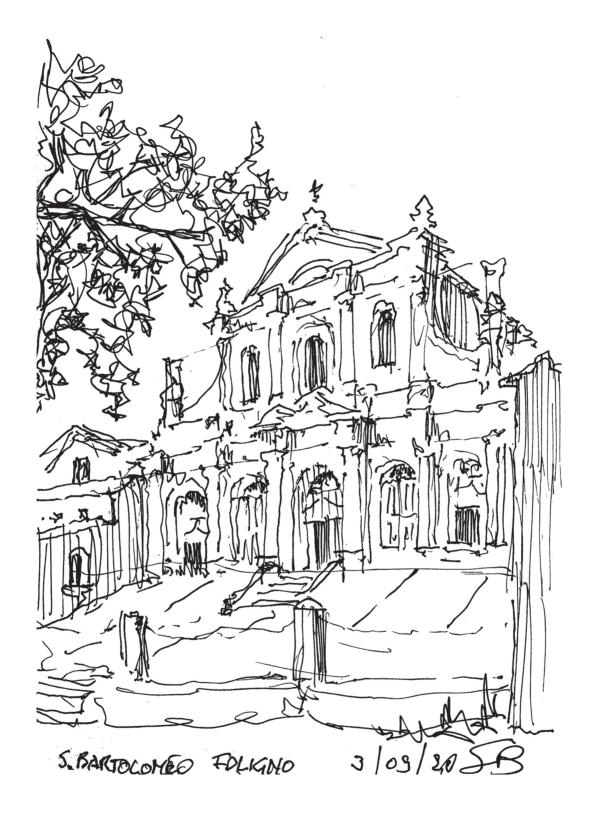
Fig. 1 Sketch of the facade of the church of San Bartolomeo. Drawing by Stefano Bertocci

a census, carried out through data-sheet catalogue, which involved the three participating European countries. These investigations aimed at developing safeguard strategies for religious complexes at risk – such as abandoned Portuguese and Spanish monasteries and those subject to seismic risk in the Umbria Region – and strategies of connection and use of heritage to promote cultural and sustainable tourism. This contribution focuses on one of the identified case studies, the convent of San Bartolomeo near Foligno (PG). It addresses the issue of heritage documentation methodology through integrated 3D laser scanner digital survey techniques and SfM/IM photogrammetry close range and UAV. The investigations aim at developing a preliminary diagnostic framework of the San Bartolomeo complex after the damage suffered in the 2016 earthquake in Central Italy (Fig. 1).

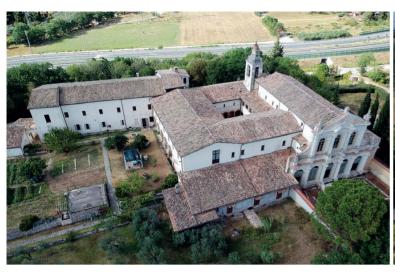
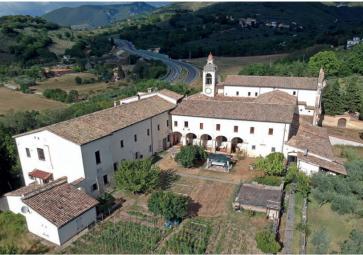
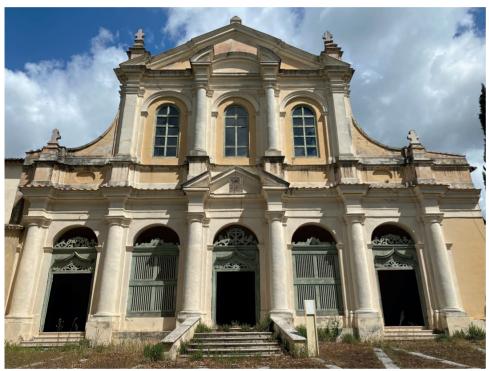
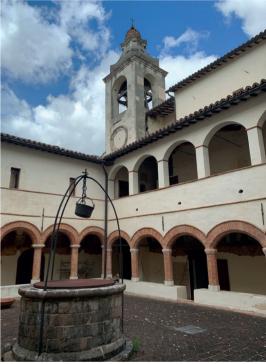
Fig. 3

Aerial views of the convent of San Bartolomeo showing its relationship with the environmental context.

Pictures of the facade of the church of San Bartolomeo and the cloister with the bell tower and the well.

The Monte Marano complex near Foligno was built in 1408 by Ugolino Trinci and completed in 1415 by his son Niccolò⁴ to house the friars of the regular Franciscan Observance⁵ (Bertocci et al., 2023). The position of the complex, now bordered by the urban periphery, combined with the consequences of the recent earthquake in Central Italy in 2016, which also affected this area, making this place of worship partly unusable, have put the complex at risk. The church, initially in sober Franciscan style with a single nave covered with wooden trusses, was equipped with a quadrangular vault covered with a cross vault with faceted ribs supported by polygonal corbels: "a vault of good Gothic architecture airs high in the choir" (Biondi, 1969, p. 50). The wooden choir of the friars, transferred here in the sixteenth century, has the curvilinear shape of the original apsidal structure and had late fifteenth-century stalls with panels decorated with wooden inlay (Figg. 3-4).

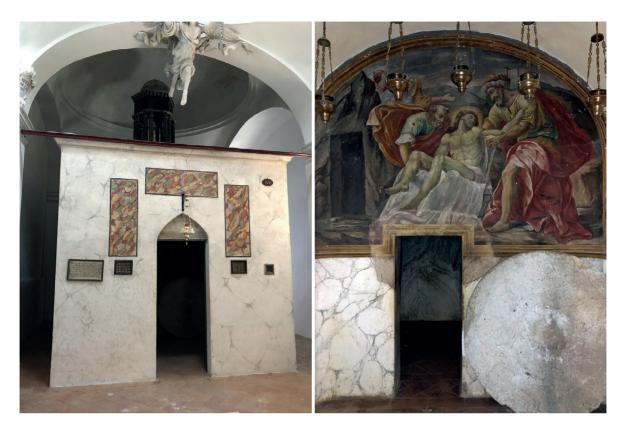
Fig. 5
Pictures of the chapel of the
Holy Sepulchre and detail of
the internal fresco.

16th-century version, built thanks to the indications provided in 1609 by Fra Bernardino Amico da Gallipoli⁷, a Franciscan who held the position of Custos in the Holy Land starting from the end of 1560 (Minutoli et al., 2021). Above the aedicule stands an angel holding a scroll, while two showcases closed with glass affixed to the facade testify to the fidelity of the reproduction of the Holy Sepulchre: one walled up to the right and the other to the left of the access with a small wooden model of the sepulchre and some relics of the Holy Land with a brief inscription declaring their origin (Fig. 5).

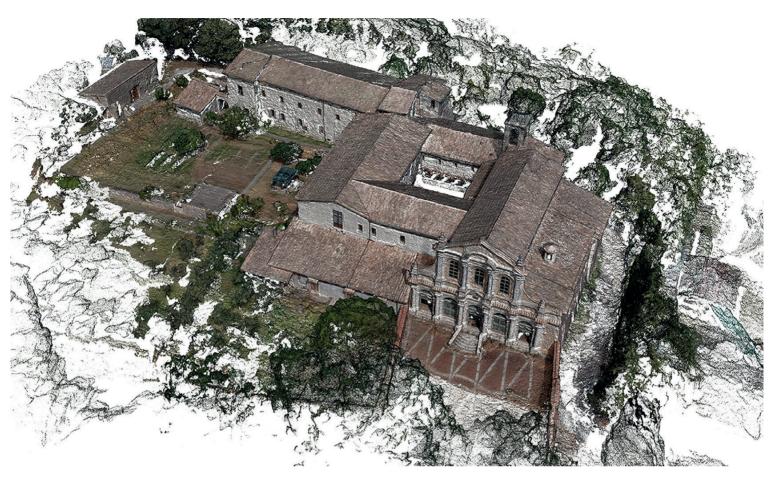
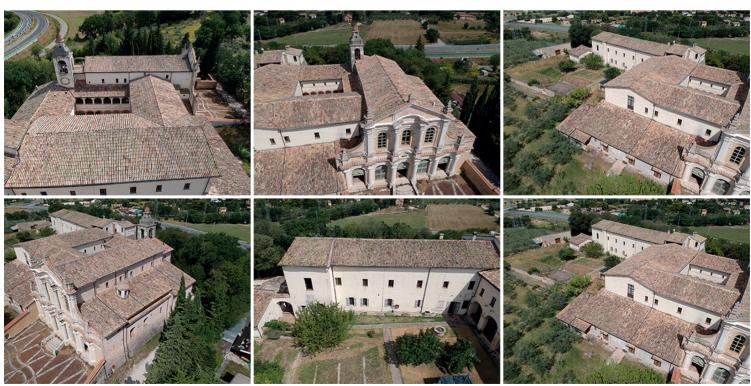
opposite page
Fig. 9
Textured 3D mesh model of the convent obtained by SfM/IM photogrammetric survey.

Starting from August 2020, two main digital survey campaigns investigated the complex, carried out through the collaboration between the University of Florence and the University of Ferrara. The first survey campaign, carried out using a Faro Focus 3D-X330 instrument, involved the exteriors and monumental rooms of the church, the library, and the cloister for 142 b/w scans. The laser-scanner survey has been integrated through the SfM/IM UAV photogrammetric survey, which involved the acquisition of about 750 aerial photographs using a DJI Mavic Mini 2 drone, processed using the Agisoft Metashape software. These acquisitions compensate for the missing information related to colour and materials, providing data regarding the conditions and morphology of the roofs and the state of conservation of the surfaces. The images acquired through the post-production processes allow the creation of three-dimensional mesh models, which, appropriately scaled thanks to the metric reference of the laser-scanner 3D point cloud, enable to export of reliable orthoimages that constitute the optimal support for the diagnostic and stratigraphic investigation (Figg. 8-9).

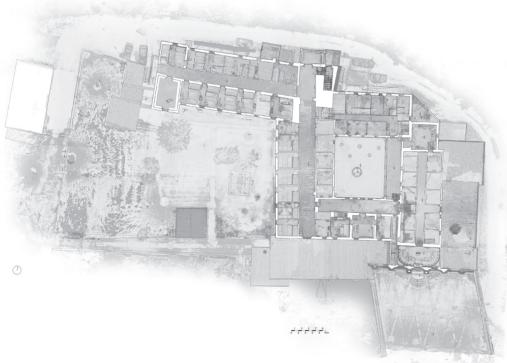
Fig. 12 above

Ground floor plan. On the right the church of San Bartolomeo with the chapel of the Holy Sepulchre.

Plan of the first floor with the dormitories and the novitiate.

1:50 scale) the model was sectioned by horizontal and vertical section planes. This process aims at investigating whether the misalignment of the section lines of the point clouds is less than the desired centimetre (max. error found: 0.6 cm). The documentation obtained constitutes valuable unreleased material for reconstructing the network of relationships that linked the monastic complex to the surrounding territory and the other religious settlements in the area, compromised by recent urban developments, helping to define a more complete and coherent reference framework with the purposes of the F-ATLAS project. The drawings, combined with the direct investigations on the 3D model relating to the axiality of the facades through the elevation map, contribute at defining an initial diagnostic framework to develop a recovery and consolidation project (Figg. 12-13).
