Margins and Limits of Local Protection in Budapest. Salient Examples and the Case of the Körszálló Hotel

Abstract

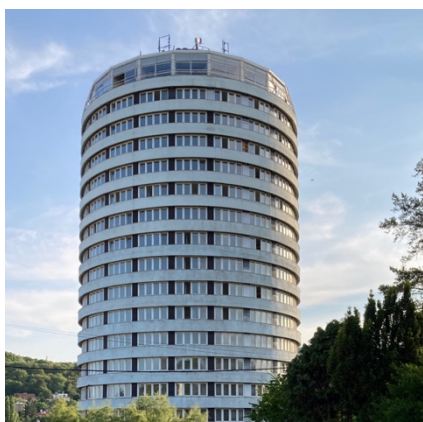
Fig. 1 Budapest, Körszálló, Tower (Bittenbinder, 2025).

Known to locals as Körszálló (Circle Hotel), Hotel Budapest was built 1964-67 by the designs of architect Szrogh György (1915-99)¹². The building comprises a 64-metre-high cylindrical tower on top of a low-rise slab. The tower contains the hotel rooms and the rooftop bar, while the slab features the lobby, restaurant, wine bar, and all the necessary supporting functions, such as the kitchen and offices¹³. Its architecture was allegedly inspired by Polónyi Károly’s hotel in Siófok (planning since 1958)¹⁴ and has similarities to projects abroad¹⁵. Overall, Körszálló was part of a larger hotel programme, which, starting in the 1960s, aimed at new accommodation facilities for tourists – from ‘socialist brother states’ and the ‘West’. As such, it embodies a paradigm shift in foreign politics, which sought to establish a more liberal attitude to international travelling. Back then, the construction of Körszálló was considered innovative given the use of ‘sliding’ concrete formworks, which had so far only been applied in industrial architecture like agricultural silos or water towers¹⁶. The collocation of the hotel at the foot of the Buda hills was subject to debates due to its exceptional height in the low-rise cityscape of Budapest¹⁷. In the 1970s, Hotel Budapest became highly popular among tourists and those looking for nightlife. With time, Körszálló entered the collective urban memory¹⁸.

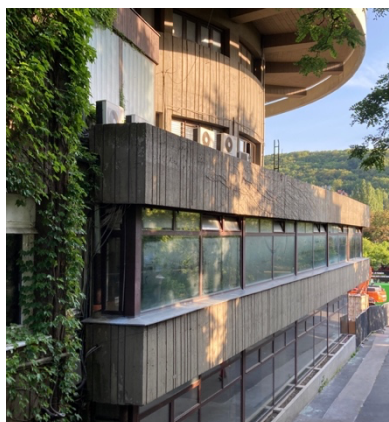
Fig. 2 Budapest, Körszálló, Flat Slab (Bittenbinder, 2025).

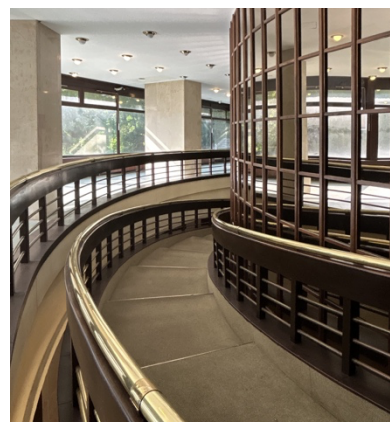
Fig. 3 Budapest, Körszálló, Interior / Staircase (Györfy, 2024).

- ³⁰ Including the changes to the truncated cone-shaped roof due to the 1994–97 renovation.
- ³¹ At the completion the wood panelling appeared also on the arched façade and in the window openings. The solid railing of the stair was still made of curved reinforced concrete.
